PLAN REVIEW MATRIX – MID-PENINSULA HOUSING PROJECT SITE – CAPITOLA ROAD – SANTA CRUZ, CA

MID-PEN HOUSING
1500 CAPITOLA ROAD MIXED-USE

OBSERVATIONS AND RECOMMENDATIONS PERTAINING TO TREE PRESERVATION:

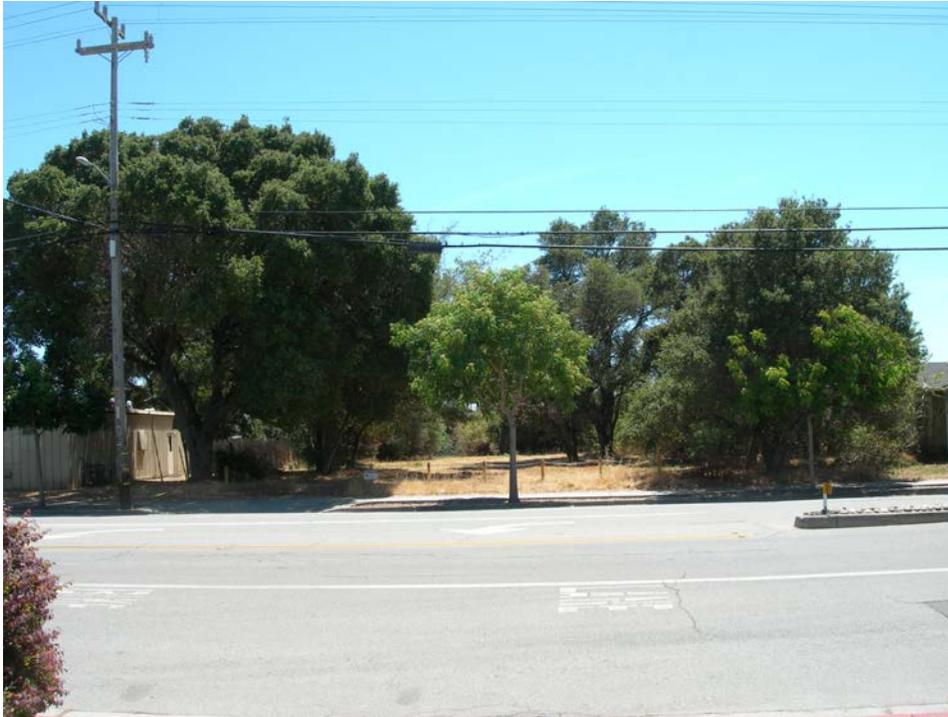
These three oaks are located in the northeast corner of the project site and are recommended for preservation and protection due to their good condition ratings. I recommend that these oaks are pruned to improve their structural conditions and appearance.

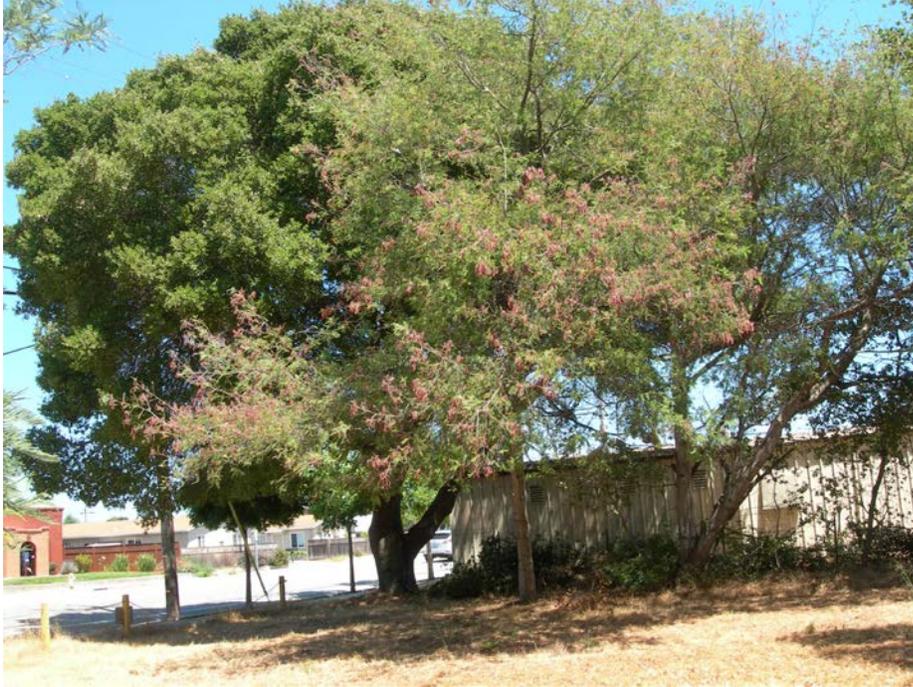
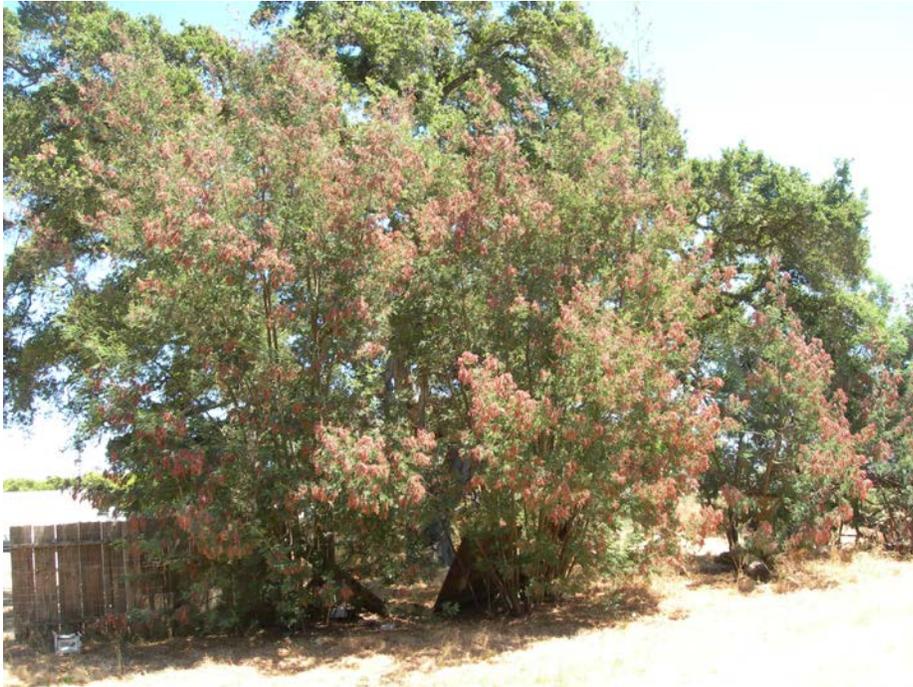
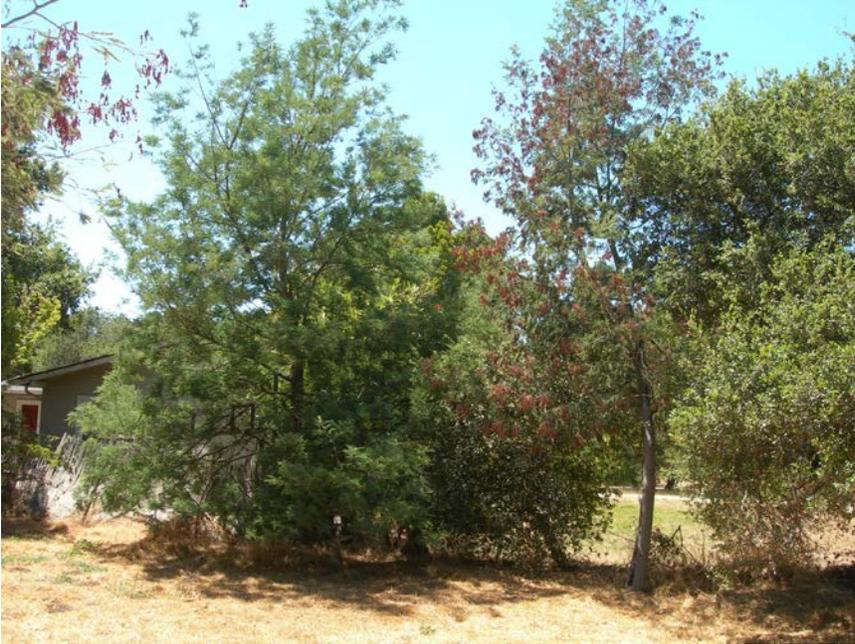
Tree's #2, #4, #6, #19, #21, #22, #32, #33 and #71 - Nine Bailey Acacia (*Acacia baileyana*):

The great majority of the Bailey Acacia trees on this site exhibit poor health and have poor structural conditions. This species is undesirable due to its invasive nature. All of the Bailey Acacia Trees on this site are recommended for removal.

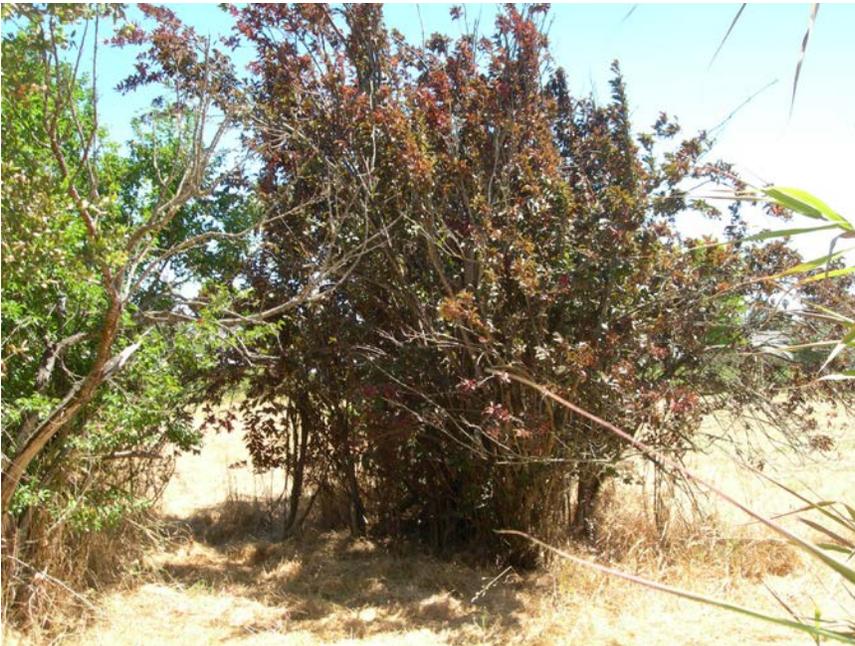
Tree's #10, #17, #20, #23 and #72 - Five Wild Plum Trees (*Prunus spp.*):
Tree #11 - Purple Plum (*Prunus cerasifera*):

These Wild Plums comprise of clusters of individual trunks. All of the plums are recommended for removal because they are potentially invasive and have poor health and structure ratings.

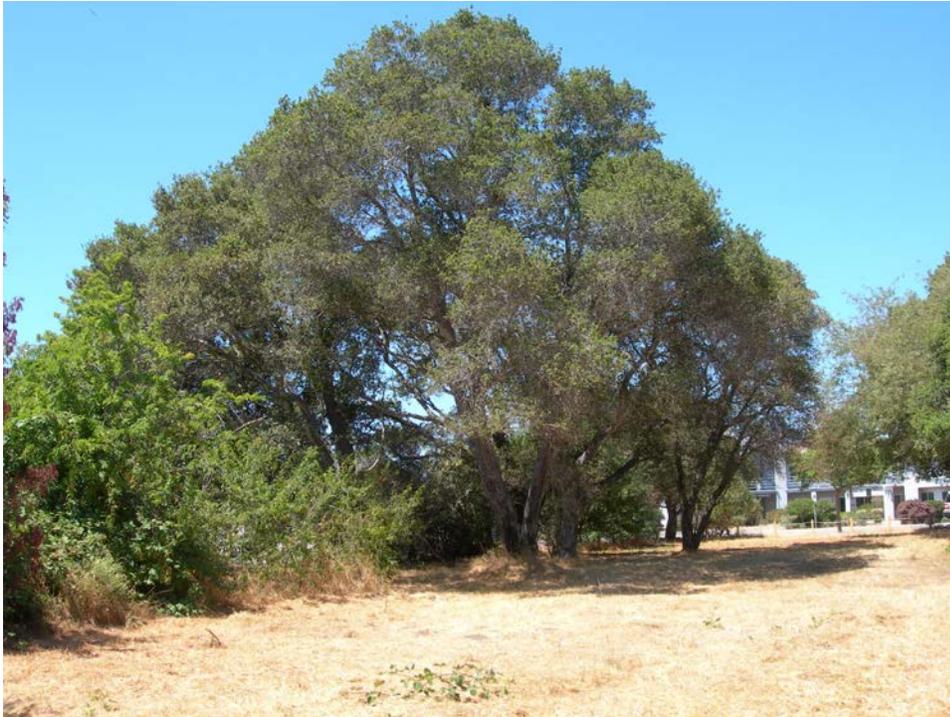
Tree #26 - 20-inch DBH Coast Live Oak:

This tree is located within the grouping of oaks located to the east of the residence at 1500 Capitola road (Tree's #24 through #31). The six of the larger oaks within the group of trees are recommended for preservation and protection during the design and construction periods of this project.

I recommend that tree #26 is pruned to improve its structure and appearance. Remove larger dead wood and reduce end-weight in any heavy and overextended limbs (also referred to as end weight reduction in this report).

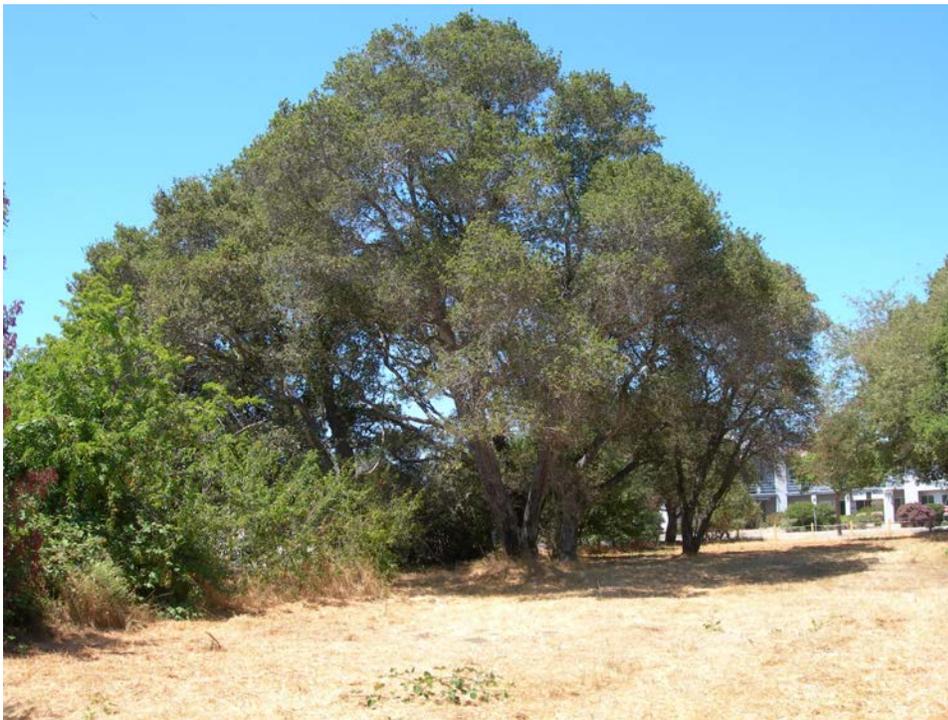
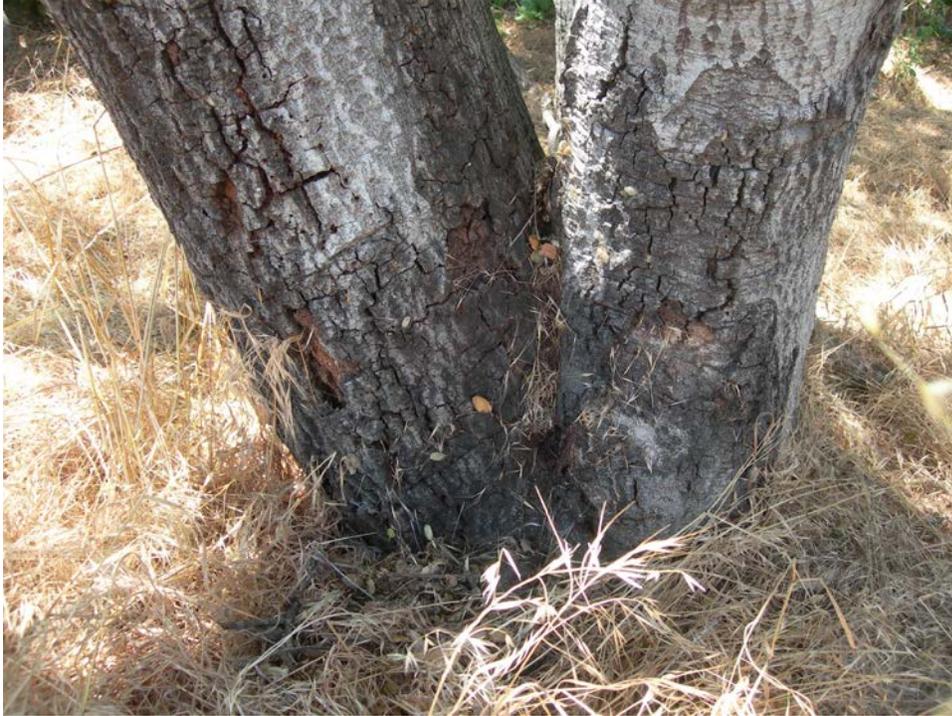
Tree #27 - 20, 17 & 8-inch DBH Coast Live Oak:

I recommend that this oak is preserved and protected during the design and construction periods of this project.

I recommend that this oak be pruned to improve its structure (reducing weight in the ends of heavier limbs and the remove larger dead wood). I also recommend that one or more support cables are installed between the codominant trunks in order to reduce the risk of trunk failures. Utilize 5/16-inch diameter EHS Grade Cable attached to 3/8-inch through rods, with amon-eyes as the attachment points.

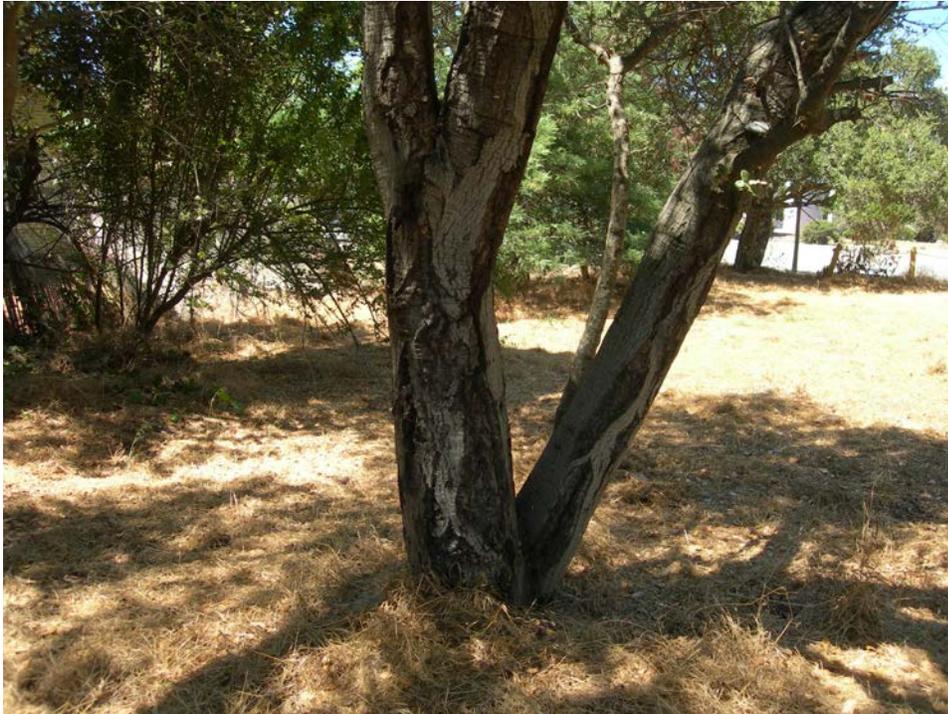
Tree #28 - 16-inch DBH Coast Live Oak:

I recommend that this oak is preserved and protected during the design and construction periods of this project.

I also recommend that one support cable is installed in between the two codominant trunks. Utilize 5/16-inch diameter EHS Grade Cable attached to 3/8-inch through rods.

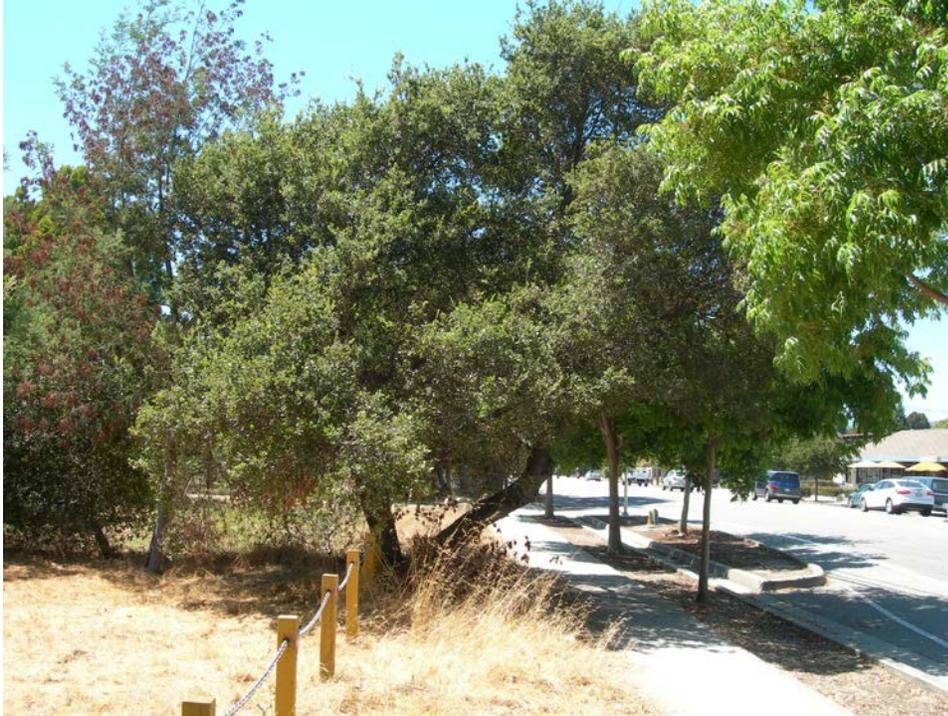
Tree #30- 16-inch DBH Coast Live Oak:

I recommend that this oak is preserved and protected during the design and construction periods of this project.

This oak is located next to the sidewalk at the front of 1514 Capitola Road. I noted that it will likely be situated within the entry way to the proposed parking area.

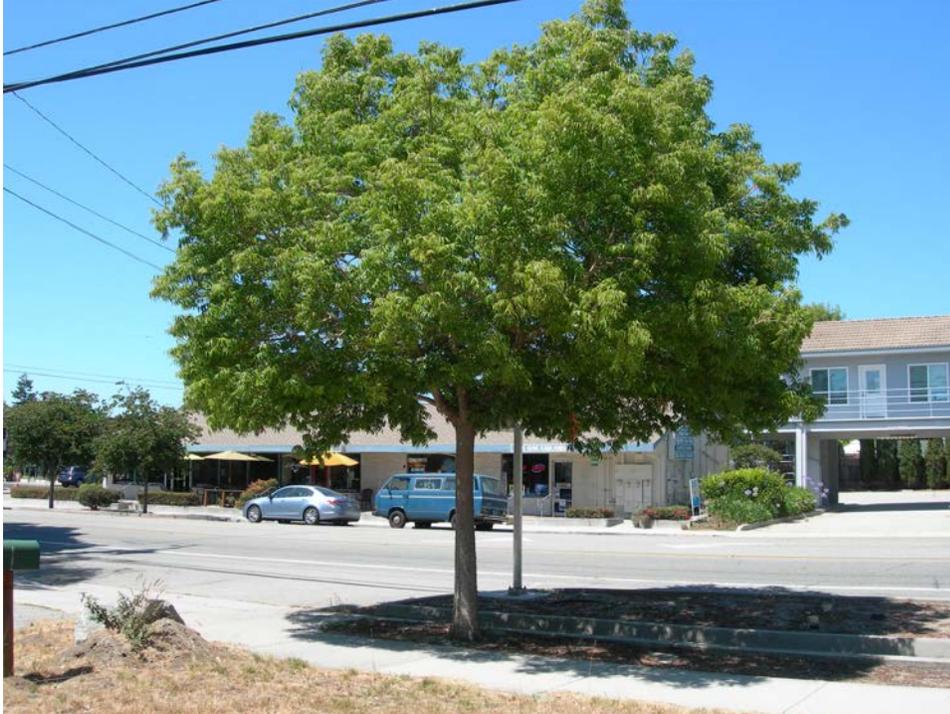
Tree's #35, #36, #37 and #152 - Four Chinese Pistache (*Pistacia chinensis*):

The four Chinese Pistache growing in the landscape strip between the sidewalk and the curb are attractive trees that exhibit good health and generally have good structural conditions. They are recommended for protection during the design and construction of this project, if at all possible.

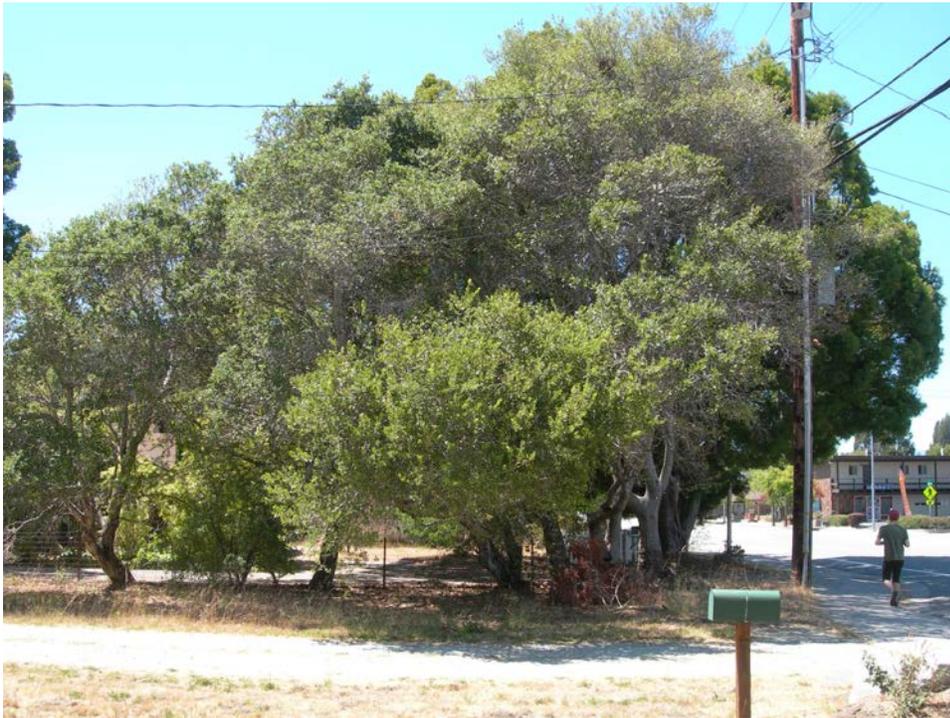
Tree #40 - 9 & 9-inch DBH Coast Live Oak:

Tree #41- 12-inch DBH Coast Live Oak:

I recommend that the oaks are pruned to improve their structures and appearance. Remove larger dead wood and reduce end-weight on any heavy and overextended limbs.

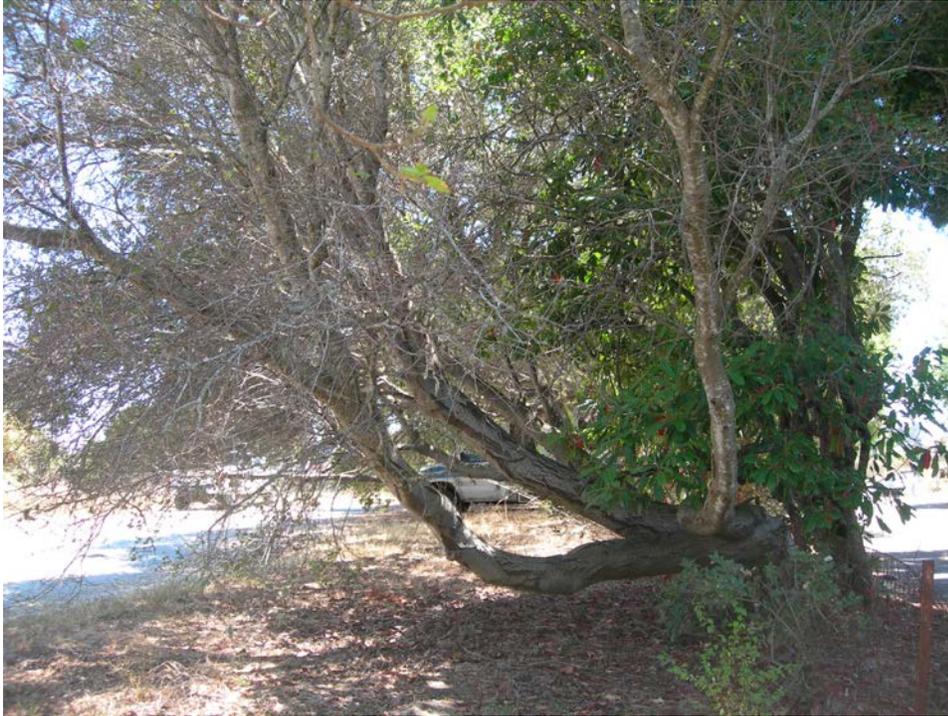
Tree #45- 12 & 10-inch DBH Coast Live Oak:

Located to the west of the house at 1500 Capitola road.

This oak is recommended for removal due to its poor structural condition. It has a poor codominant structure, having two scaffold limbs that are poorly attached at the common trunk. The oak has also developed an asymmetrical growth pattern resulting in a poor canopy shape.

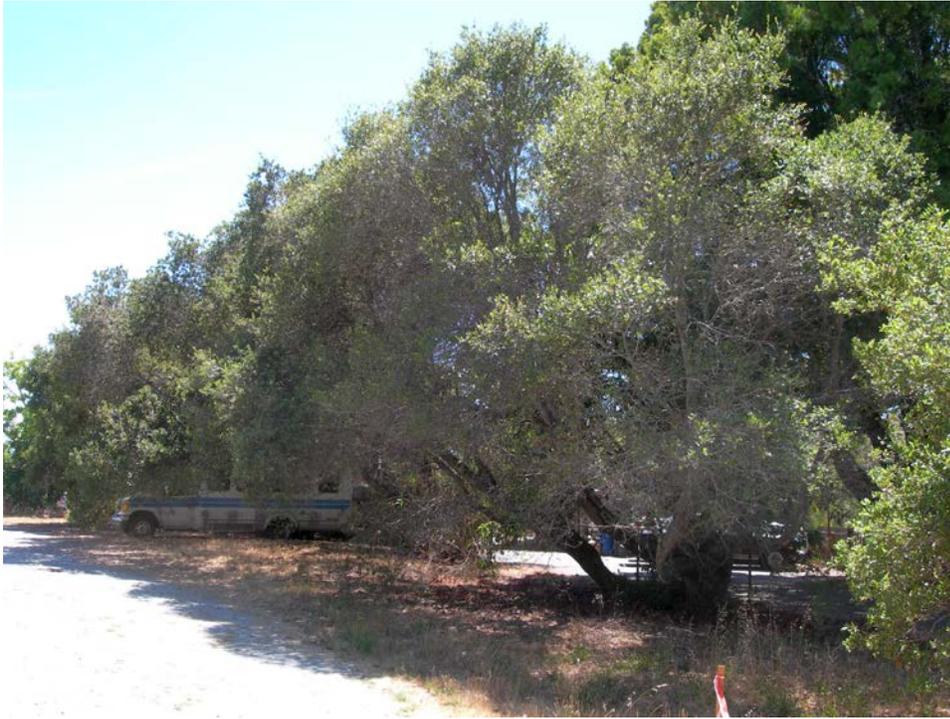
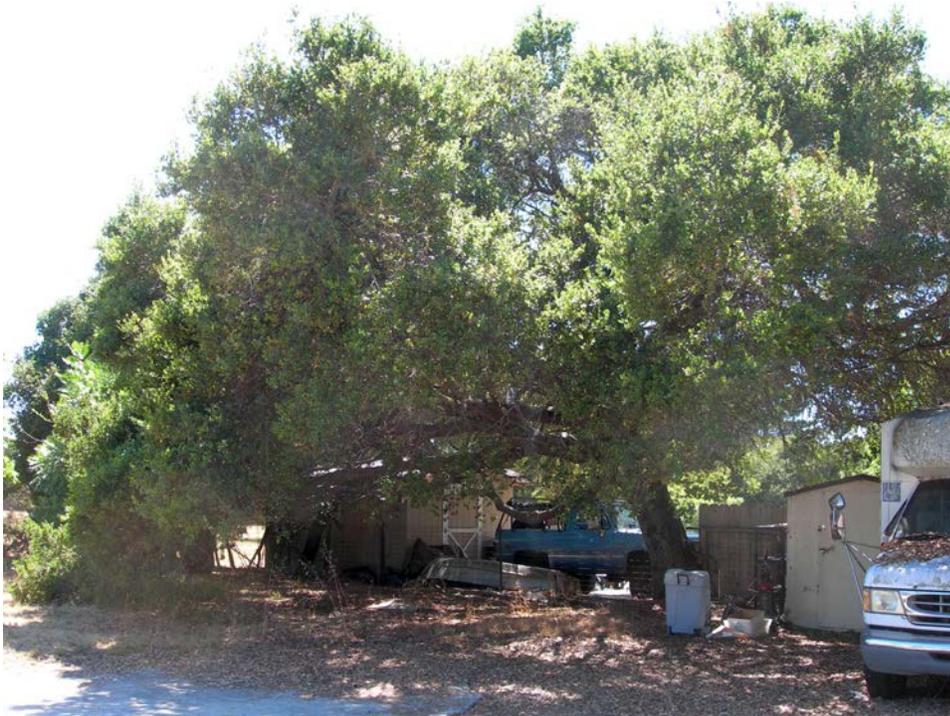
Tree #48 - 19-inch DBH Coast Live Oak:

Tree #49 - 25-inch DBH Coast Live Oak

These three oaks are located on the property boundary to the southwest of the house at 1500 Capitola Road. All three oaks are worthy of preservation based upon their condition ratings, however it appears that they will be situated within the construction footprint, as shown on the conceptual schematic provided to me.

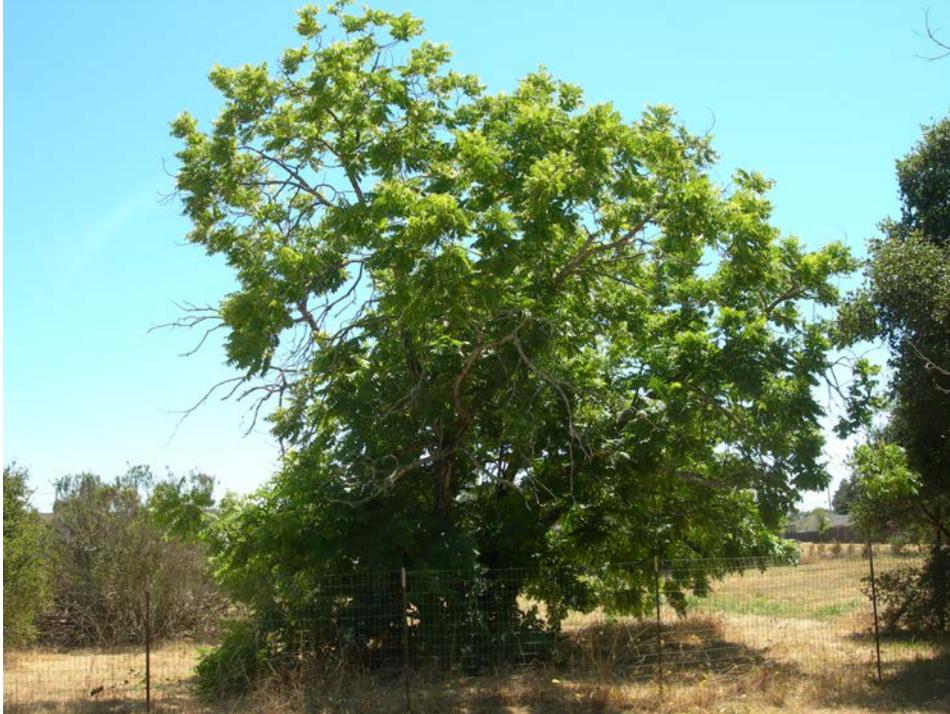
Tree #51 - 7, 8, 5, 5 & 5-inch DBH Black Walnut (*Juglans spp.*):

Tree #55 - 11, 11, 8 & 8-inch DBH Black Walnut:

Both of these Walnut trees are recommended for removal because they have regenerated from stumps and have poor structures.

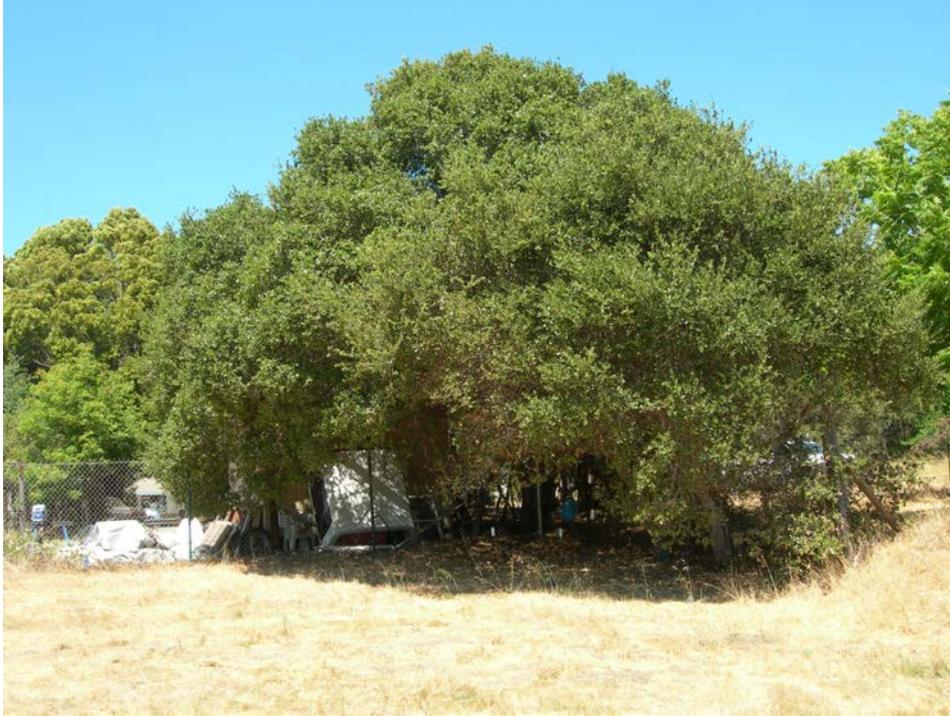
Tree #52 - 15-inch DBH Coast Live Oak:

These two oaks are located to the southwest of the house at 1500 Capitola road. The two oaks are worthy of preservation based upon their condition ratings, however it appears that they will be situated within the construction footprint as shown on the conceptual site plan provided to me.

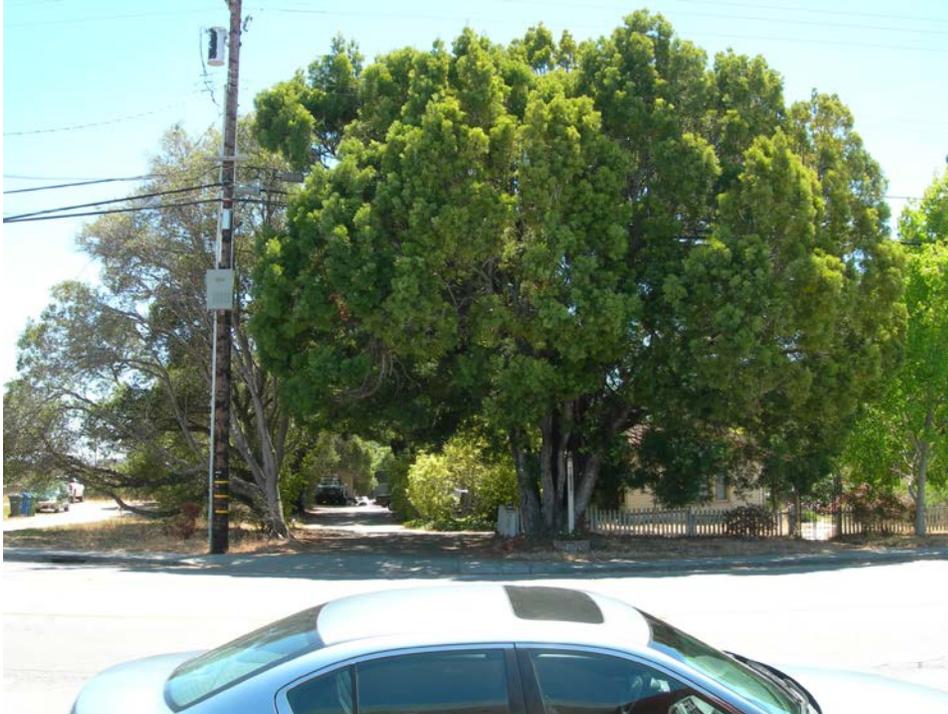
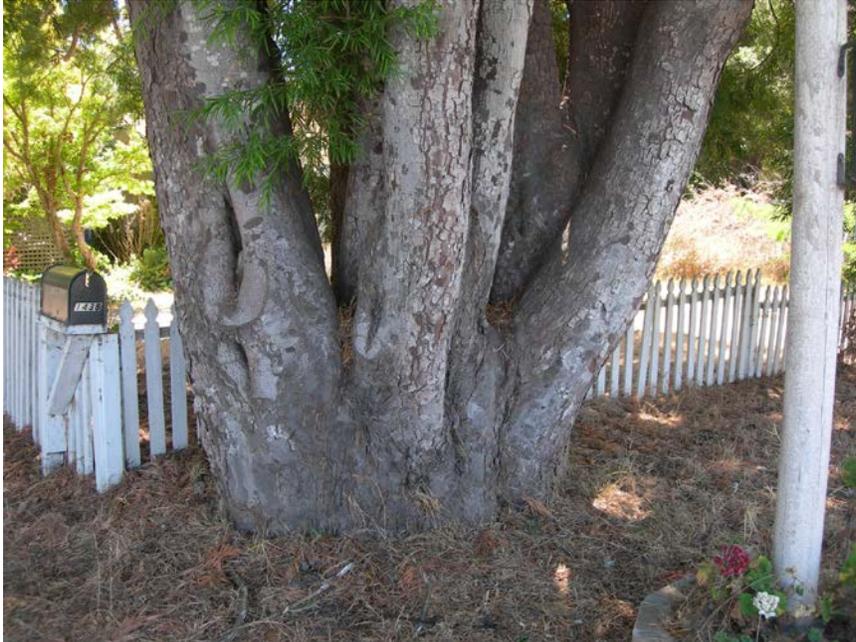
Tree #61 - 14, 21, 12, 10, 12, 13, 24-inch DBH African Fern Pine:

The tree is recommended for preservation based upon its condition rating and as long enough of the root zone can be preserved during construction. In the event that this tree can be preserved, it must be protected and pruned to improve its structure. Support cables must also be installed between the scaffold limb structure in order to improve its structural integrity.

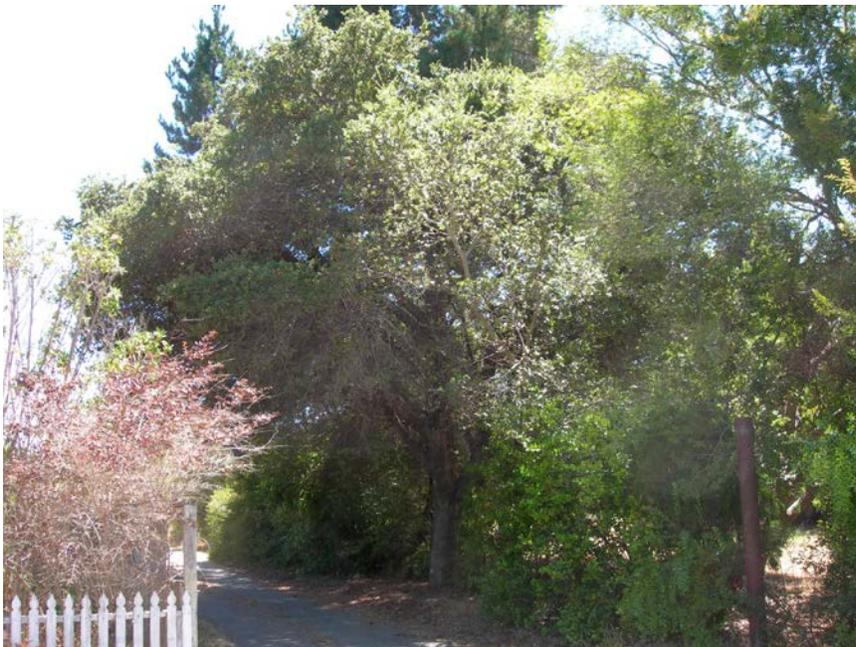
Tree #66 - 22-inch DBH Coast Live Oak:

This oak, exhibits good health and it has a fair structural condition. It is worthy of preservation if there will be adequate space for the protection of its Critical Root Zone Area during the design and construction phases of this project. I also recommend that this tree is pruned to improve its structural condition, if preserved.

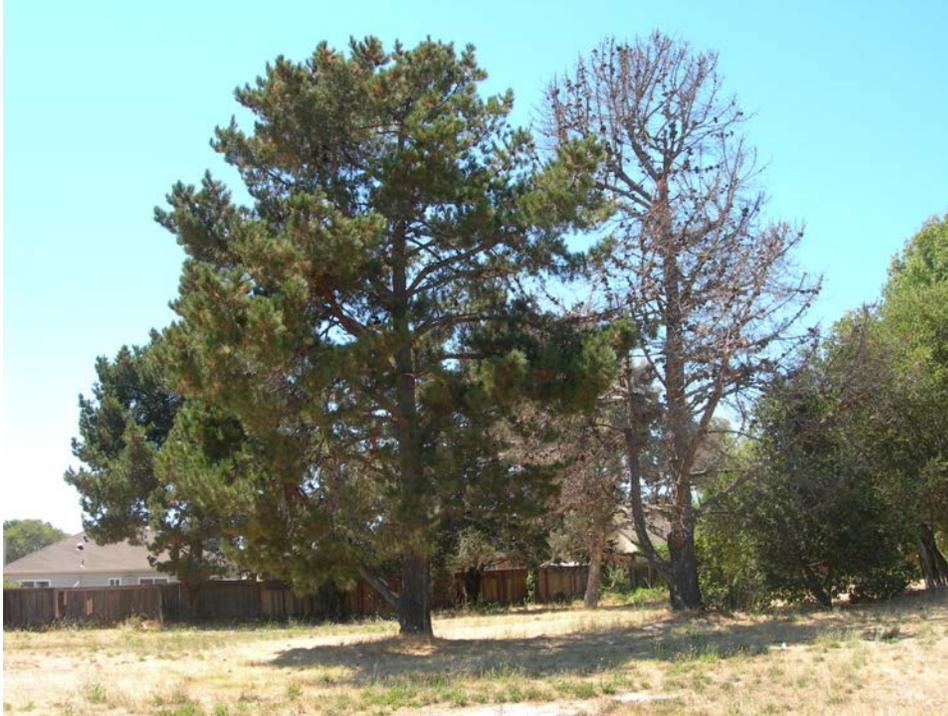
Tree #82 - 22-inch DBH Monterey Pine (*Pinus radiata*):

This pine has died as a result of the recent drought period and a resultant infestation by Red Turpentine Beetle (*Dendroctonus valens*) and Engraver Beetles (*Ips spp.*).

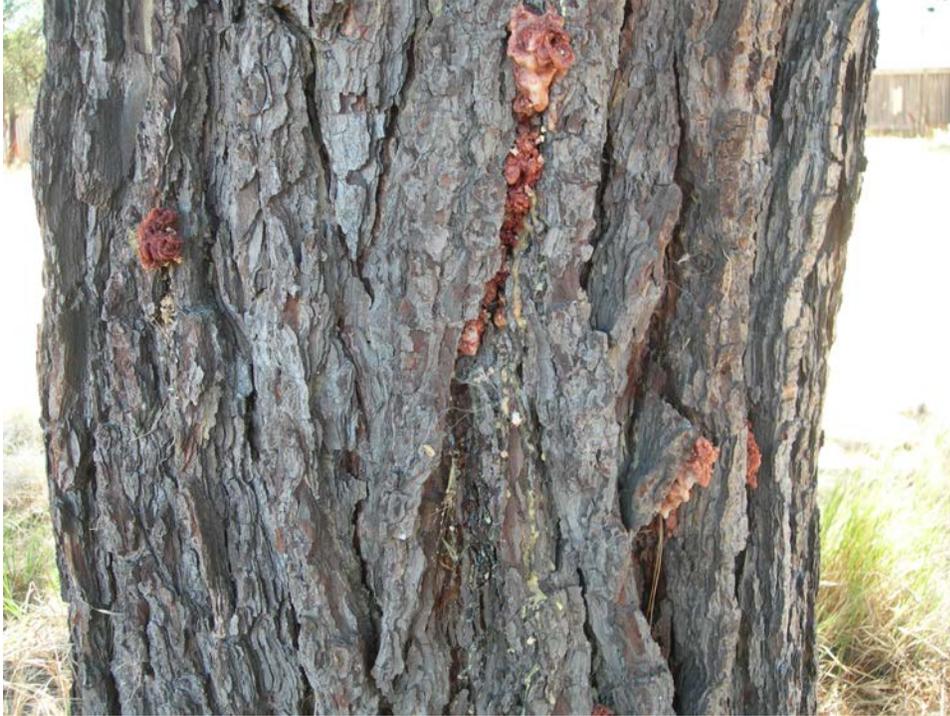
Tree #83 - 22-inch DBH Monterey Pine:

This pine is recommended for removal based upon its condition rating and location.

I noted that this pine has a significant infestation of Red Turpentine Beetle on its lower trunk. The tree is located within the footprint of the housing development as shown on the conceptual schematic provided to me.

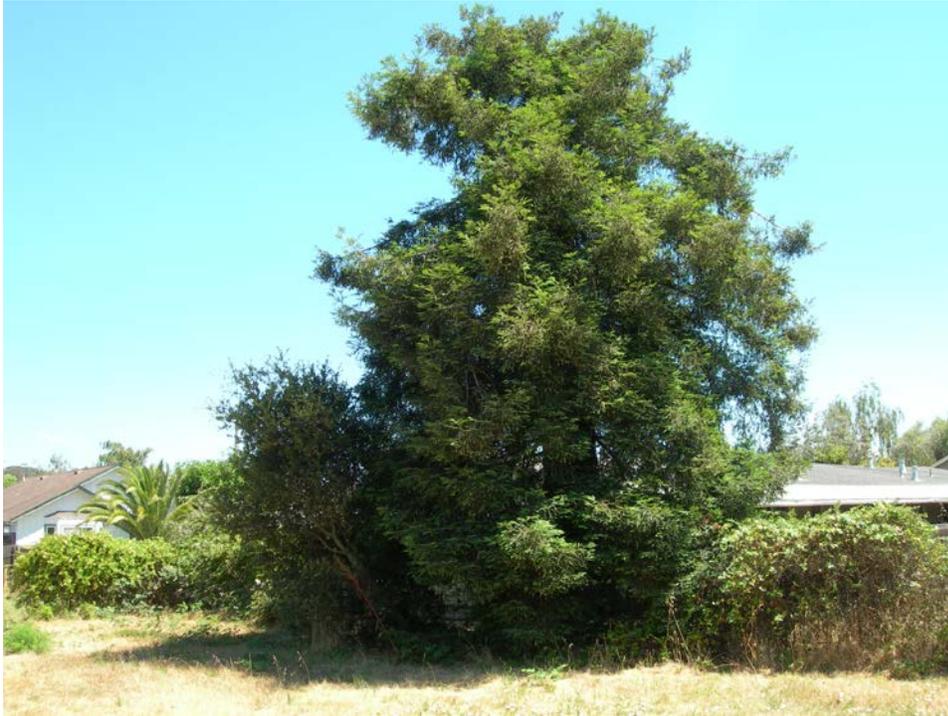
The tree is worthy of preservation and its Critical Root zone must be protected during the construction period. I recommend that construction disturbances are limited to the edge of the canopy drip-line if at all possible. The small Coast Live Oak next to it should be removed.

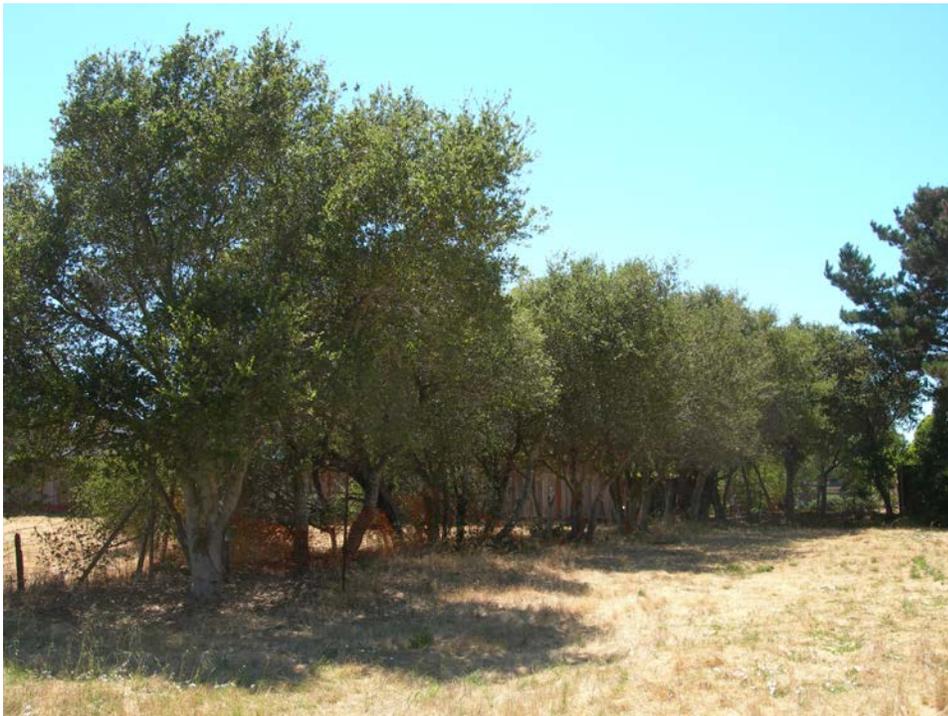
Tree's #86 through #88 - Three Coast Live Oaks next to the southern boundary:

A number of these trees are crowded close together and some of the poorer specimens could be removed to provide for more space between them.

The three Arizona Cypress Trees (*Hesperocyparis arizonica*) and the one Mayten Tree (*Maytenus boaria*) growing within this row of oaks should be removed because of their poor condition ratings.

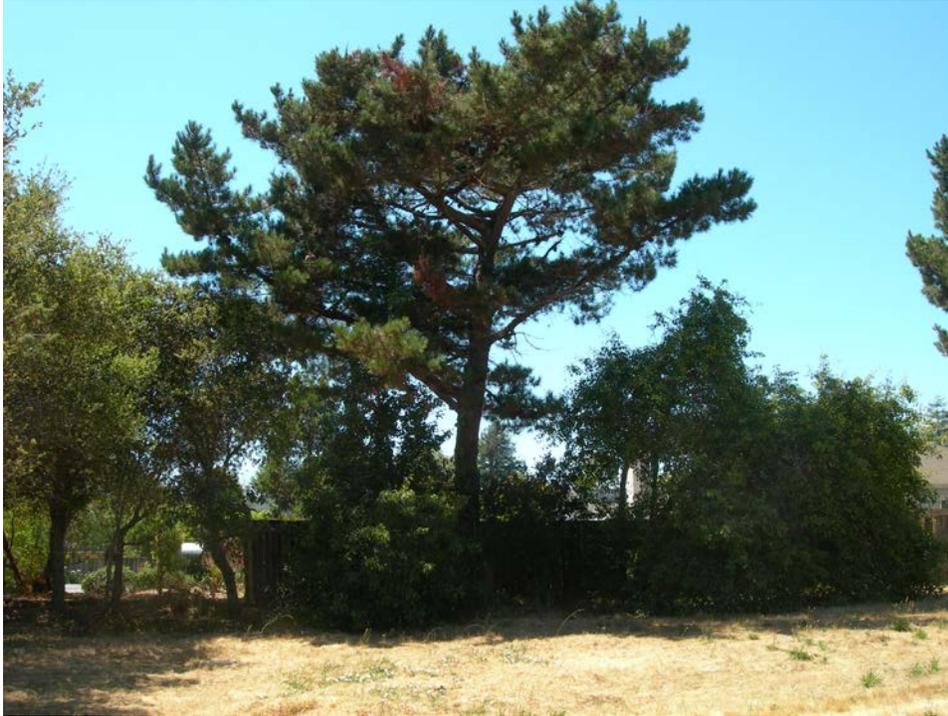
This mature pine is located on the west boundary of the project site. It is recommended for removal due to its poor condition rating and its close proximity to proposed construction disturbances. I noted that the top of the pine had been previously killed by Pine Pitch Canker (*Fusarium circinatum*) and that the loss of apical dominance resulted in the development of a heavy limb structure which is vulnerable to failure. I also noted a number of active Pine Pitch Canker infection sites in some of the limb ends.

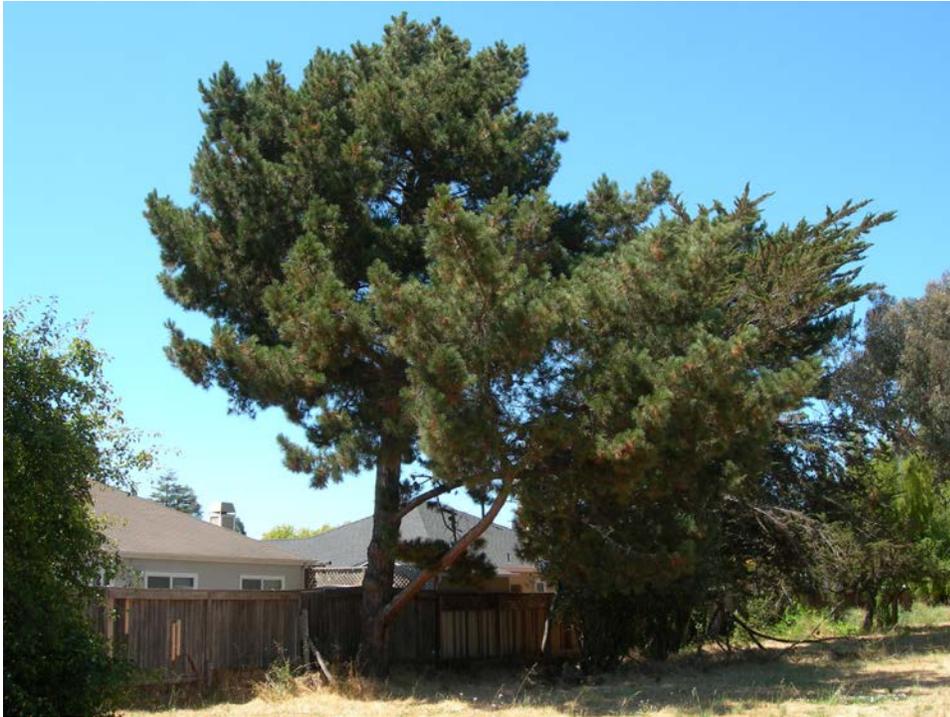
Tree #116 - 29-inch DBH Monterey Pine:

The tree is suitable for preservation based upon its condition rating, however I recommend that it is considered for removal because of its close proximity to the proposed parking area as represented on the conceptual site plan provided to me. The construction of the parking area as shown will likely result in significant root loss within the Critical Root Zone Area of this mature pine.

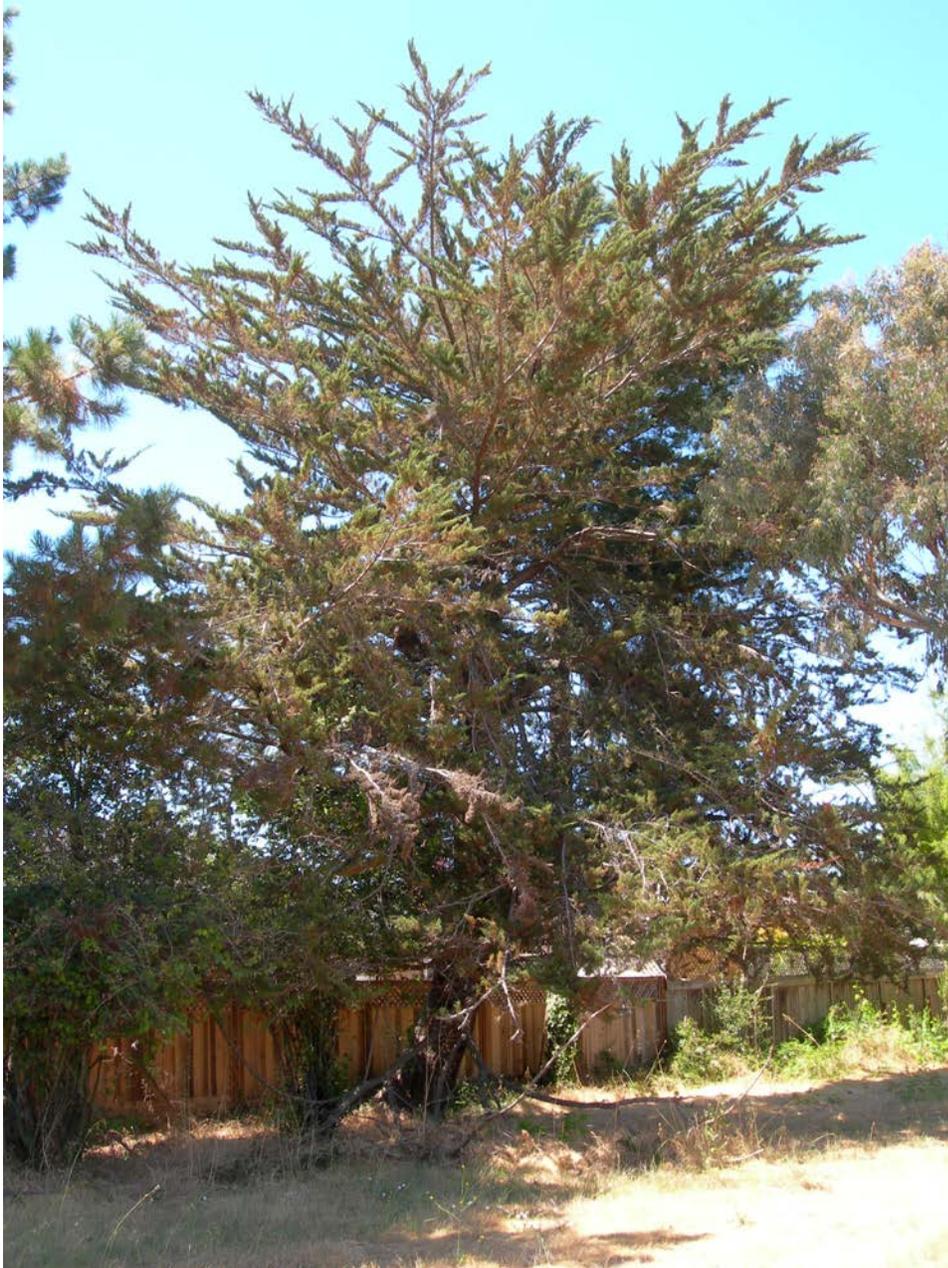
Tree #118 - 30-inch DBH Monterey Cypress (*Hesperocyparis macrocarpa*):

This large tree is located on the west boundary of the project site. It must be removed as it has partially failed in the ground as evidenced by its strong lean to the east and the heaved soil area observed on the west side of the trunk. The tree also exhibits fair to poor health at this time.

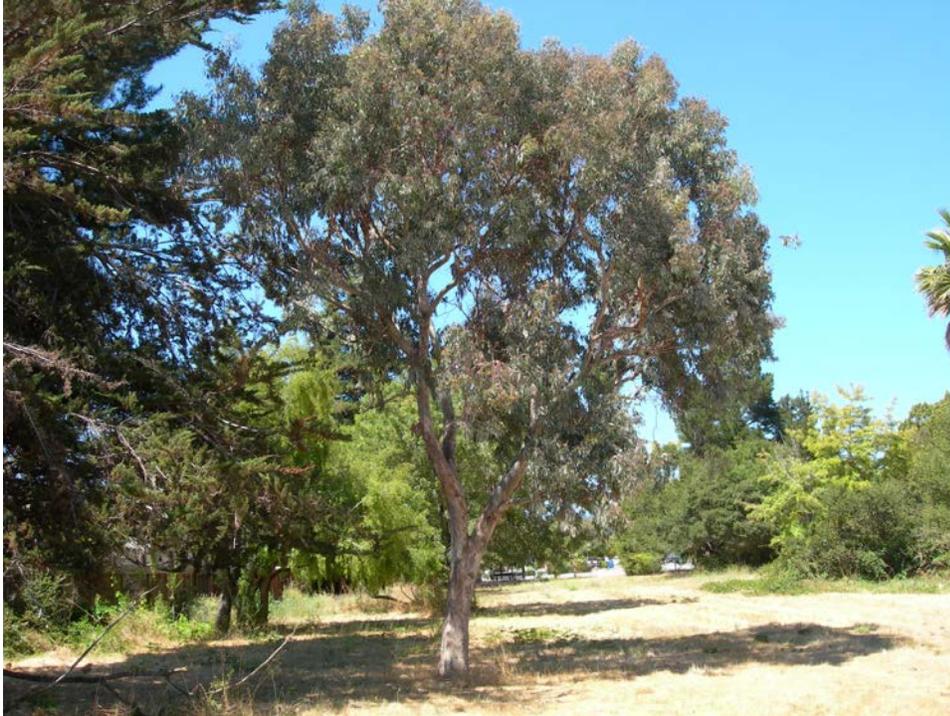
Tree #119 - 18-inch Eucalyptus Tree (*Eucalyptus spp.*):

This tree exhibits good health and has a good structural condition which makes it worthy of preservation. Unfortunately, it appears to be located within the development footprint.

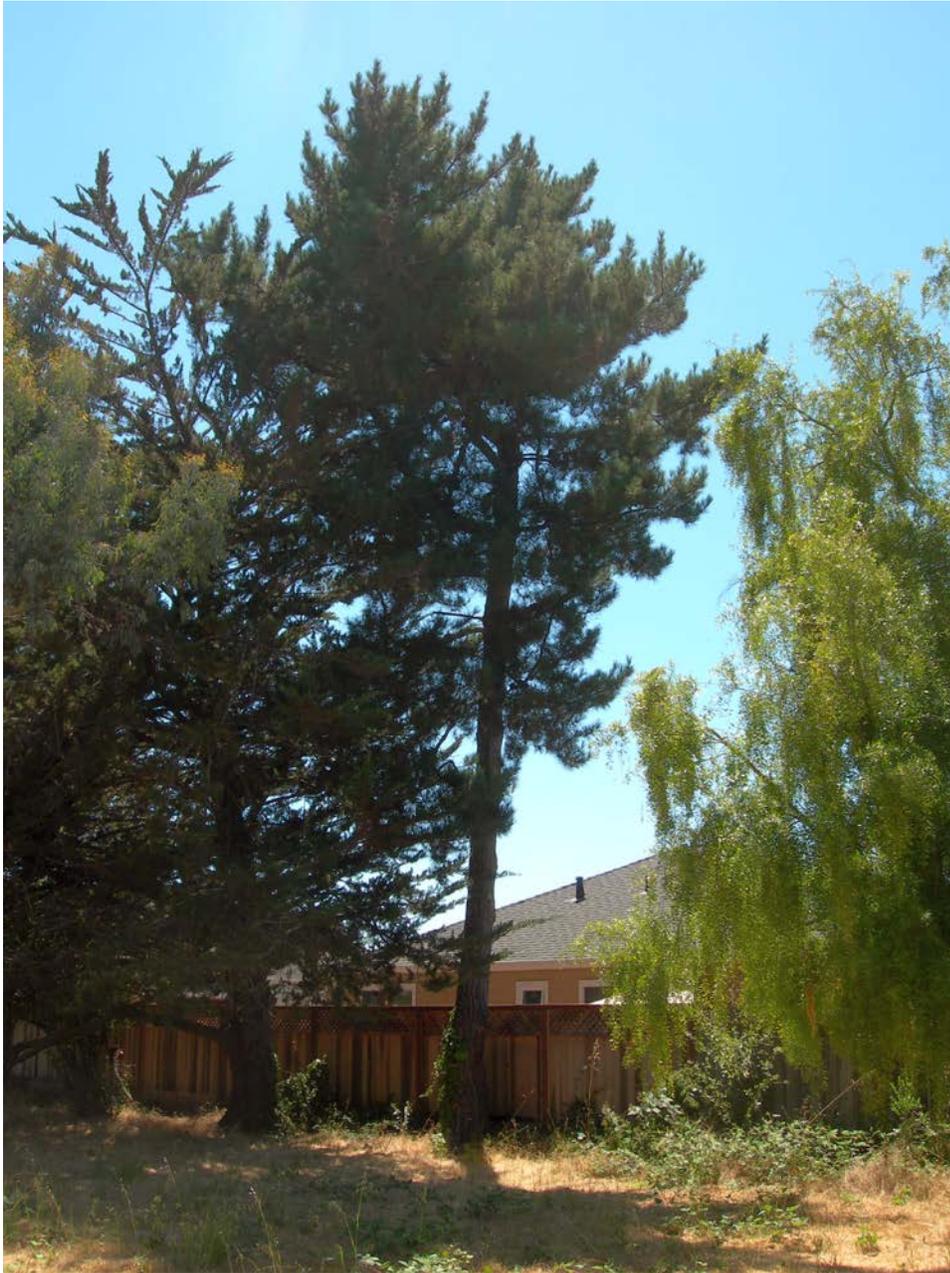
Tree #120 - 22-inch DBH Monterey Pine:

I recommend that this tree is removed because of its close proximity poor structure and its location next to the proposed parking area as represented on the conceptual schematic provided to me. The construction of the parking area as shown, will likely result in significant root loss within the Critical Root Zone Area of this mature pine.

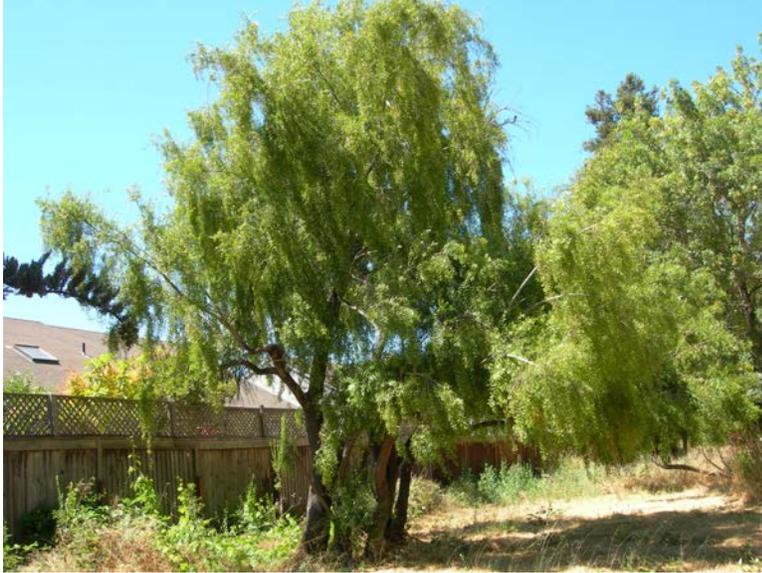
Tree's #121 through #123 - Three Mayten Trees:

These three trees are growing within close proximity to each other and they have fair overall condition ratings. I recommend that these crowded trees are removed and replaced with a more desirable species.
