PLAN REVIEW MATRIX – MID-PENINSULA HOUSING PROJECT SITE – CAPITOLA ROAD – SANTA CRUZ, CA

MID-PEN HOUSING
1500 CAPITOLA ROAD MIXED-USE

OBSERVATIONS AND RECOMMENDATIONS PERTAINING TO TREE PRESERVATION:

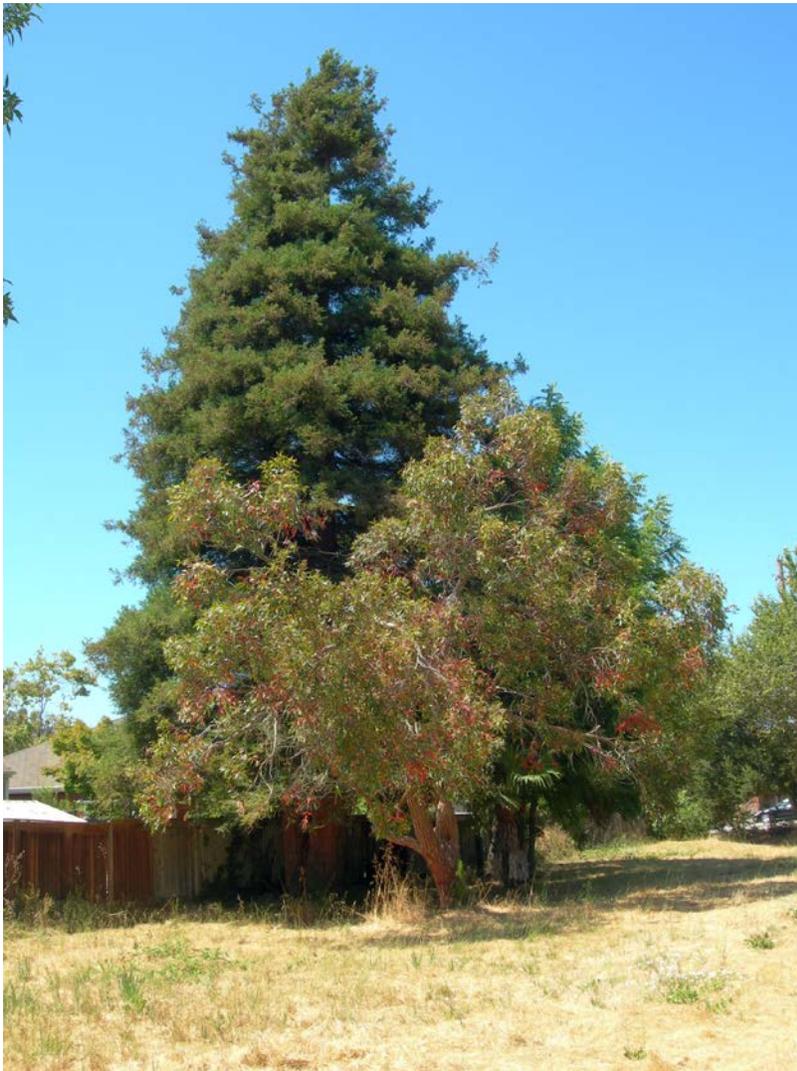
Tree #126 - 22-inch DBH Scarlet Flowering Gum (*Corymbia ficifolia*):

I noted that the conceptual site plan shows the proposed landscape area around this tree to be large enough in size to ensure the preservation of its Critical Root Zone Area.

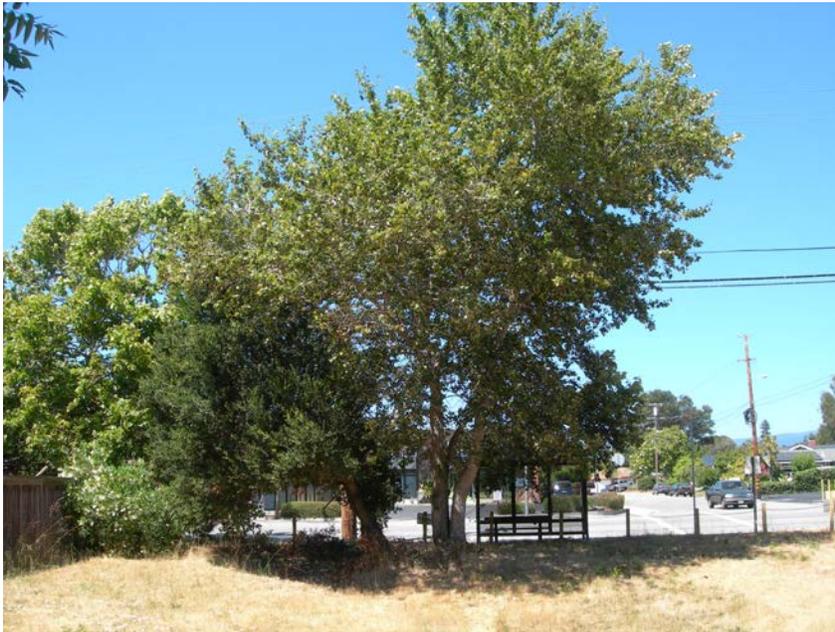
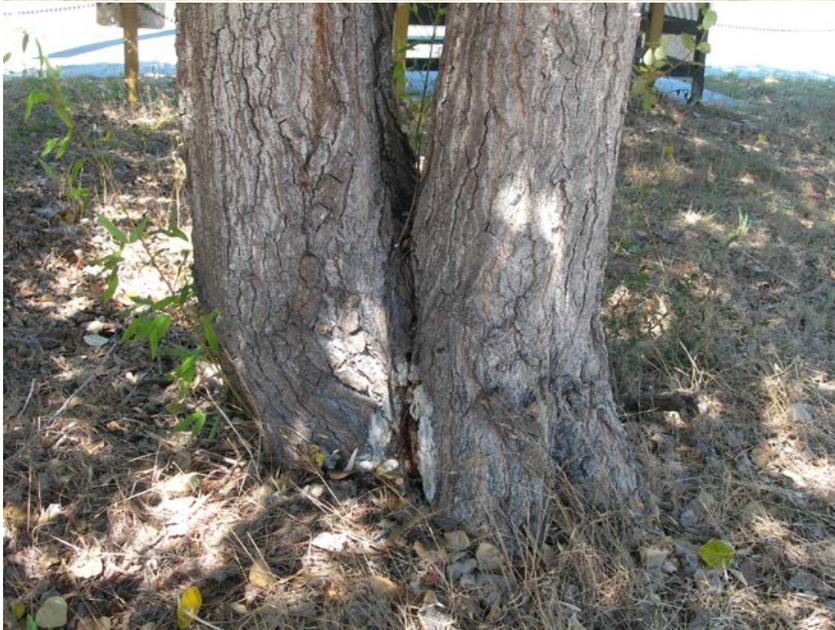
Tree #134 - 12 & 15-inch DBH Cottonwood Poplar (*Populus spp.*):

I recommend that this tree is removed because of its poor condition rating and its undesirable species characteristics. This species is not recommended for preservation as a landscape tree because of its weak growth pattern and invasive root growth habit.

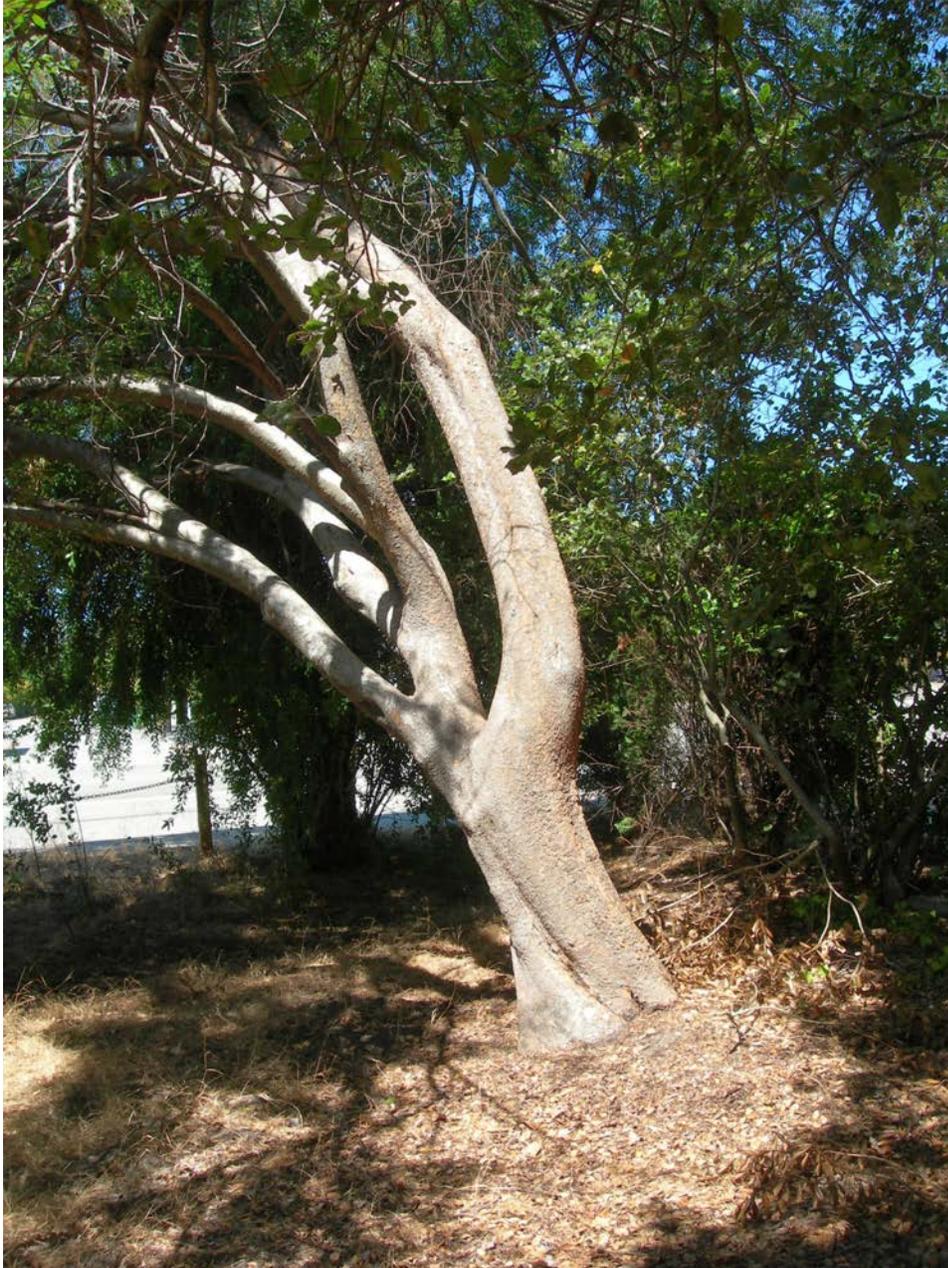
Tree #137 - 19-inch DBH Chinese Elm (*Ulmus parvifolia*):

This Elm has a very poor structure, having developed an asymmetrical growth pattern and heavy scaffold limb development on one side. I recommend that this tree is removed because it is vulnerable to failure at this time.

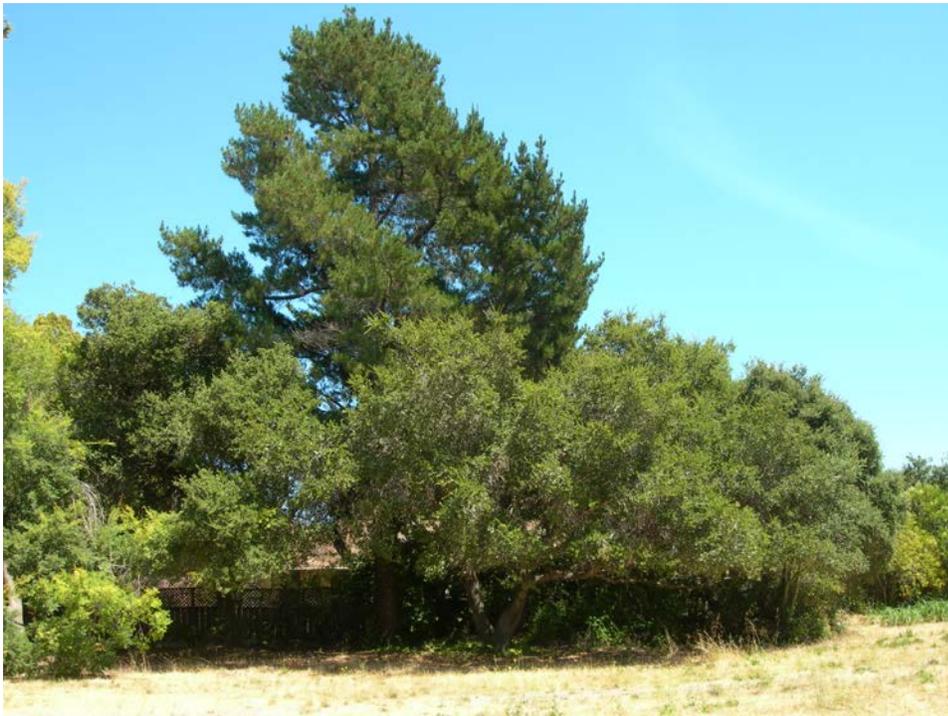
These four trees have DBH measurements equaling 13 & 16, 3 & 4, 13 and 7 & 9-inches, respectively. All of these trees are worthy of preservation based upon their condition ratings.

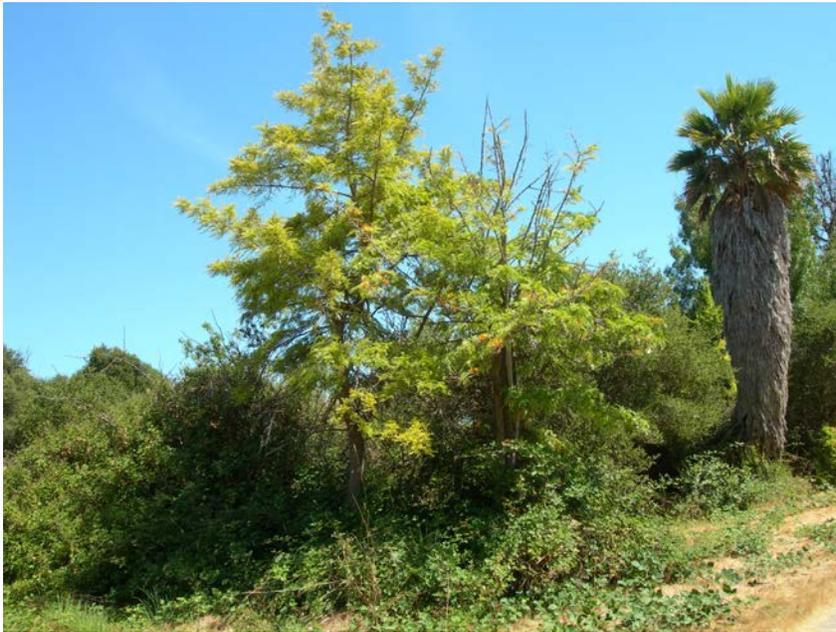
Tree's #144 & #146 - Two Silk Oaks (*Grevillea robusta*):

These trees are not worthy of preservation due to their poor condition ratings and appearance.

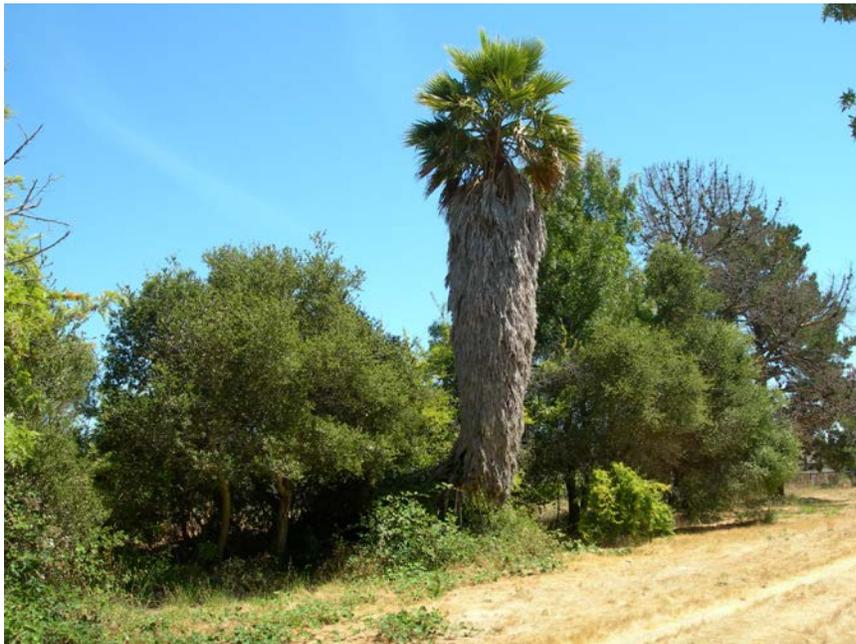
Tree's #147 through #149 - Three small Coast Live Oaks:

These young oaks have trunk diameters of less than 10-inches at 54-inches above grade. They are worthy of preservation, as long as a large enough area of landscape will be available for the protection of their rootzones.

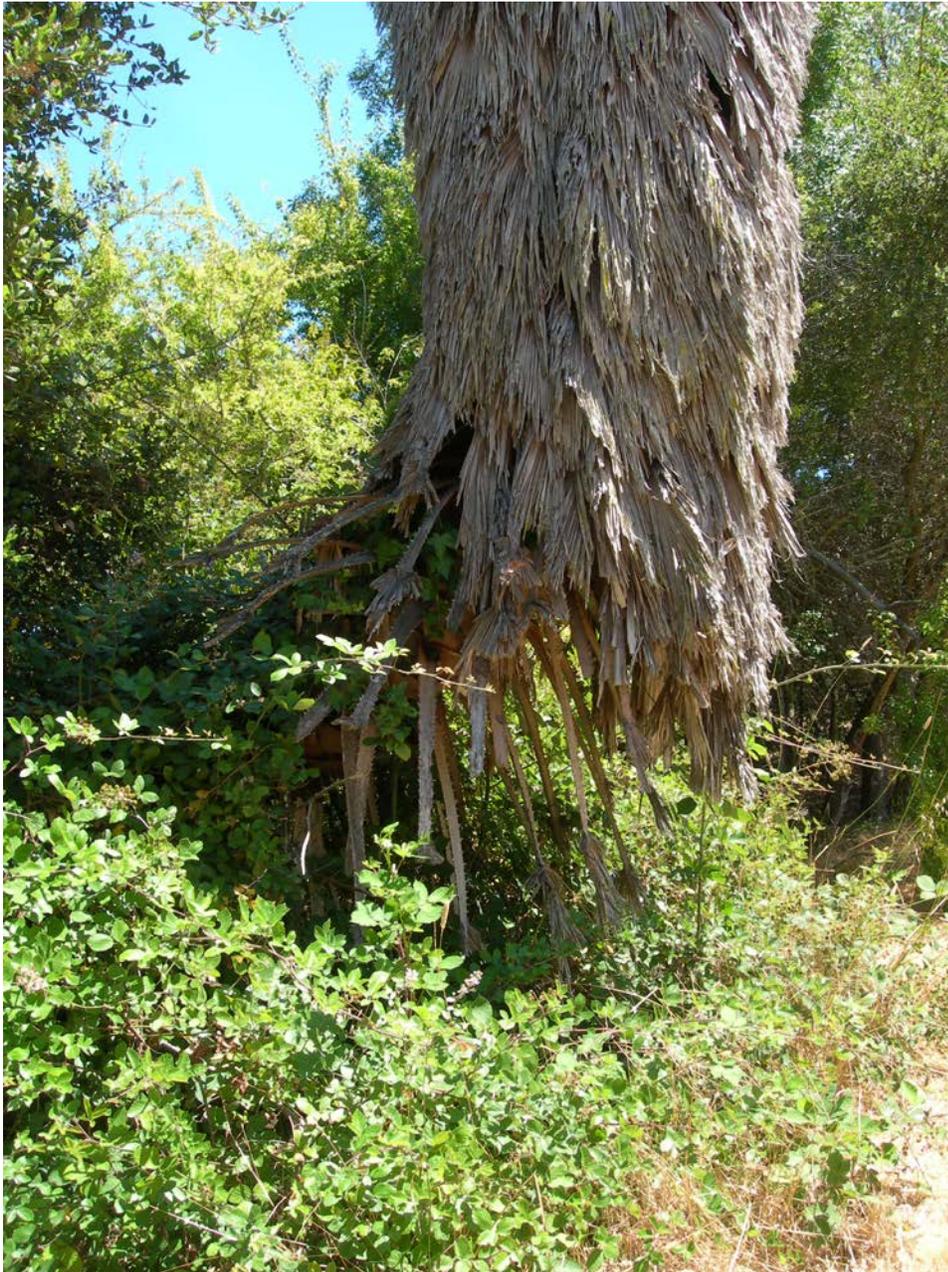
Tree #150 - 16-inch DBH Mexican Fan Palm:

This established palm is recommended for removal due to its poor growth pattern. The lower trunk has developed a large bow to the west, which is a significant structural defect.
