THE PRELIMINARY ARBORIST REPORT & TREE RESOURCE ANALYSIS CONCERNING THE PROPOSED
HOUSING DEVELOPMENT AT 2838 PARK AVENUE – SOQUEL, CALIFORNIA

Site visit by:
Nigel Belton – ISA Certified Arborist WE-0410A
February 18, 2022

Job – 2838 Park Ave. Soquel – 3.15.22

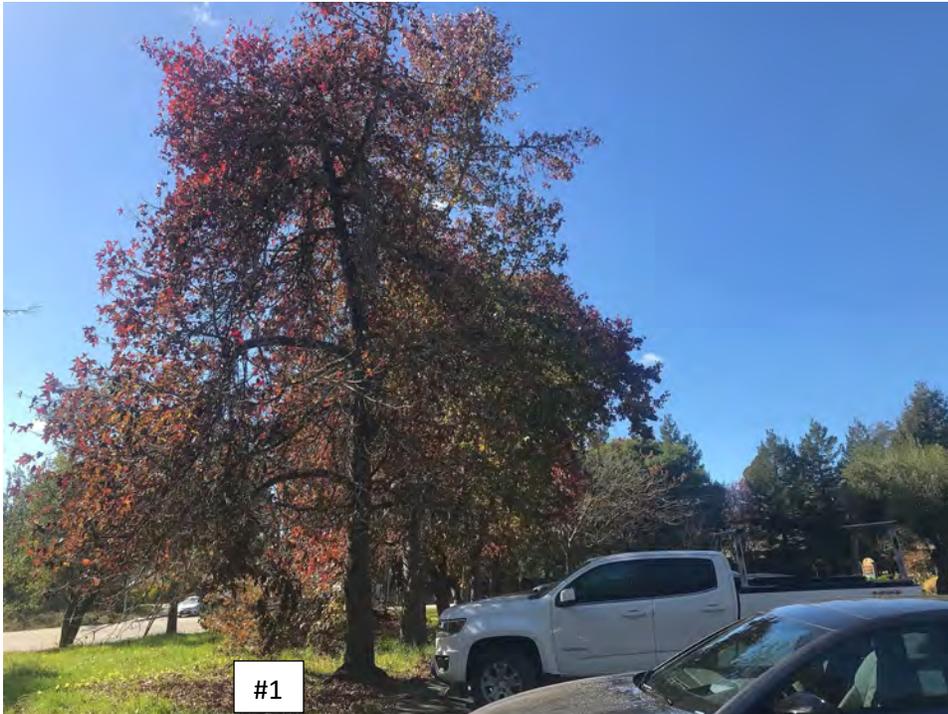
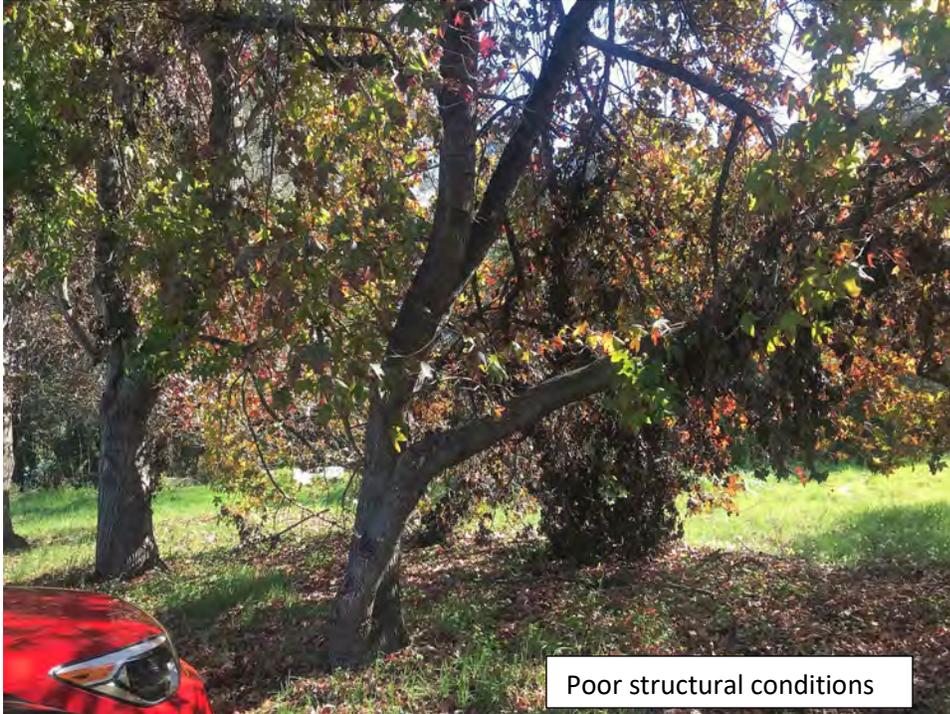
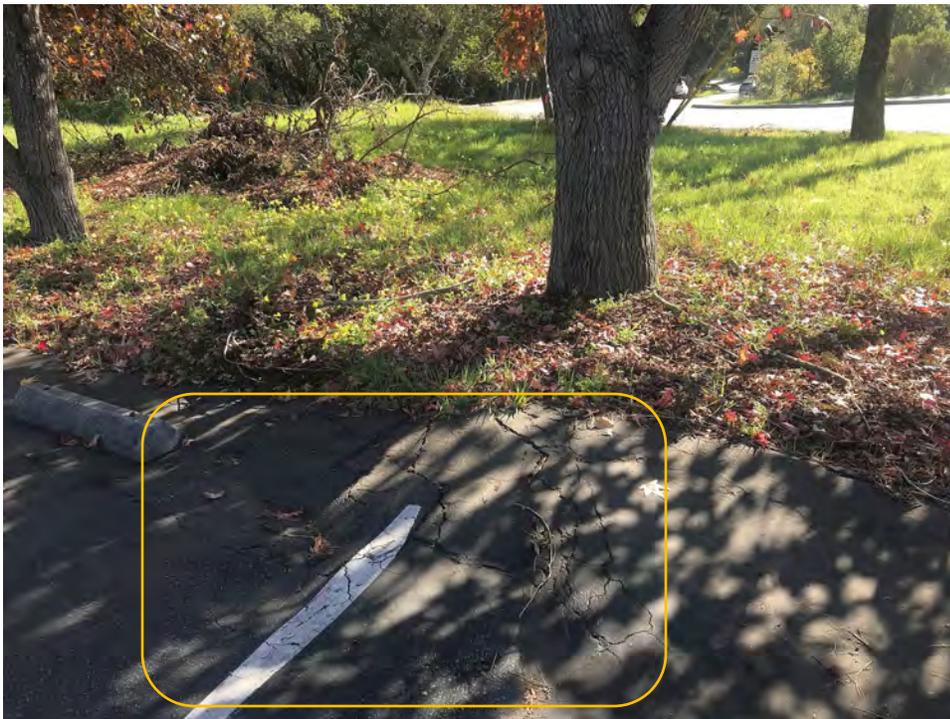
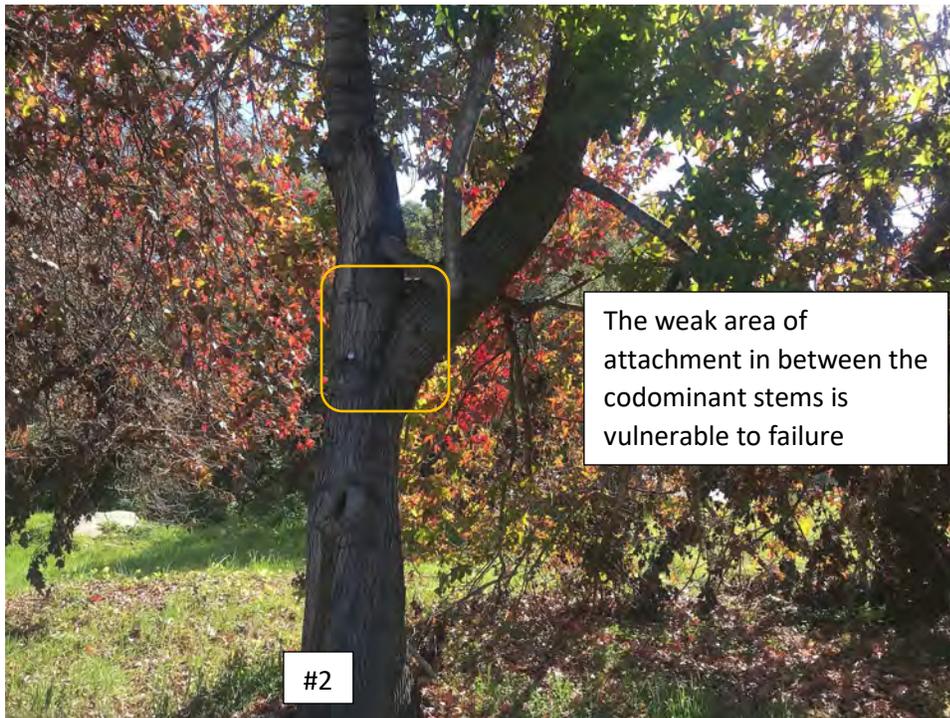
Tree #6 – 14-inch DBH Liquidambar:

These trees exhibit good health, as evidenced by their foliage condition. Five of the six trees have poor structural conditions because they have developed weak codominant growth patterns, consisting of multiple stems that share weak areas of attachment at the trunk or each other.

I observed that the roots of these Liquidambar are damaging the surface of the adjacent asphalt parking area.

I determined that Tree #2 is unsuitable for preservation because of its poor structural condition.

I determined that the other five trees require structural pruning and the installation of tree support cables in order to reduce the likelihood of tree failures occurring next to the parking stalls.

I determined that the five trees that are suitable for preservation must be protected during the construction period (with protective fences).

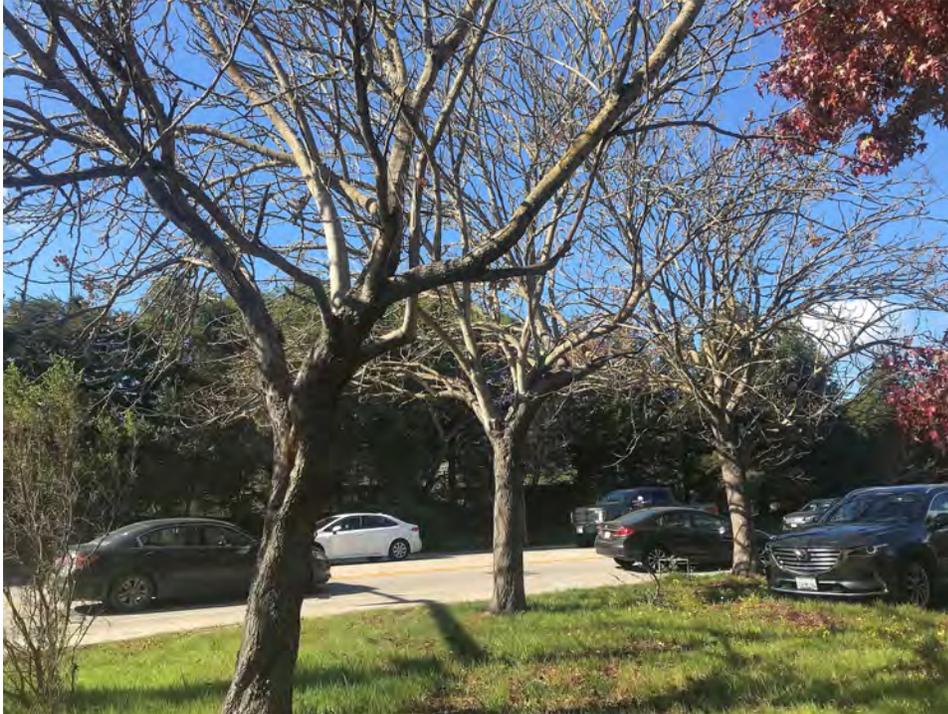
Tree #10 – 13-inch DBH Koelreuteria Tree:

These trees appear to be located on the Public Right of Way next to Park Avenue and Cabrillo College Drive. They exhibit good health and have fair structural conditions.

I determined that these trees will benefit from structural pruning work and that this work will also improve their appearance.

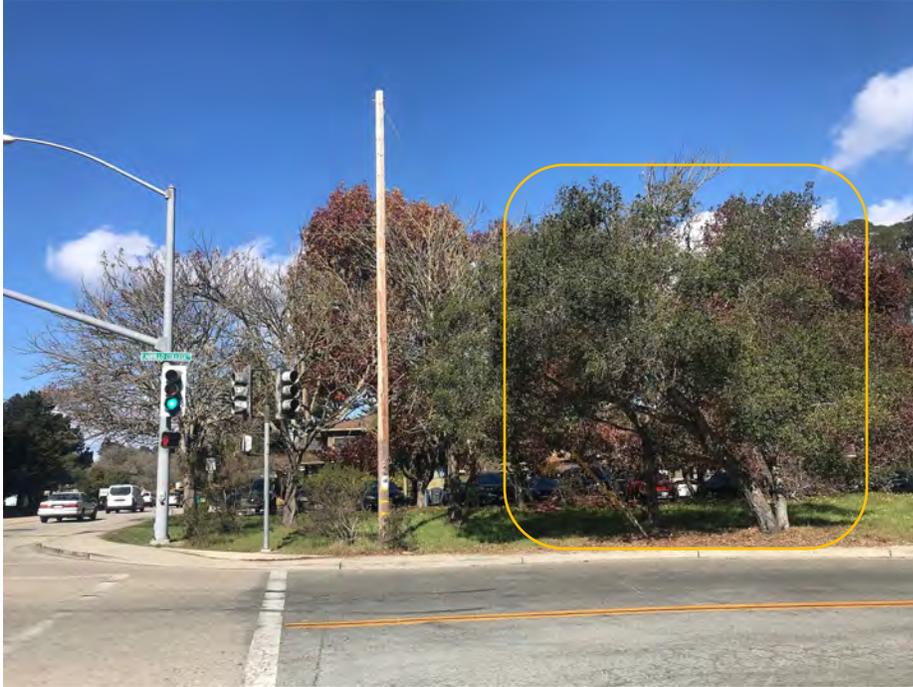
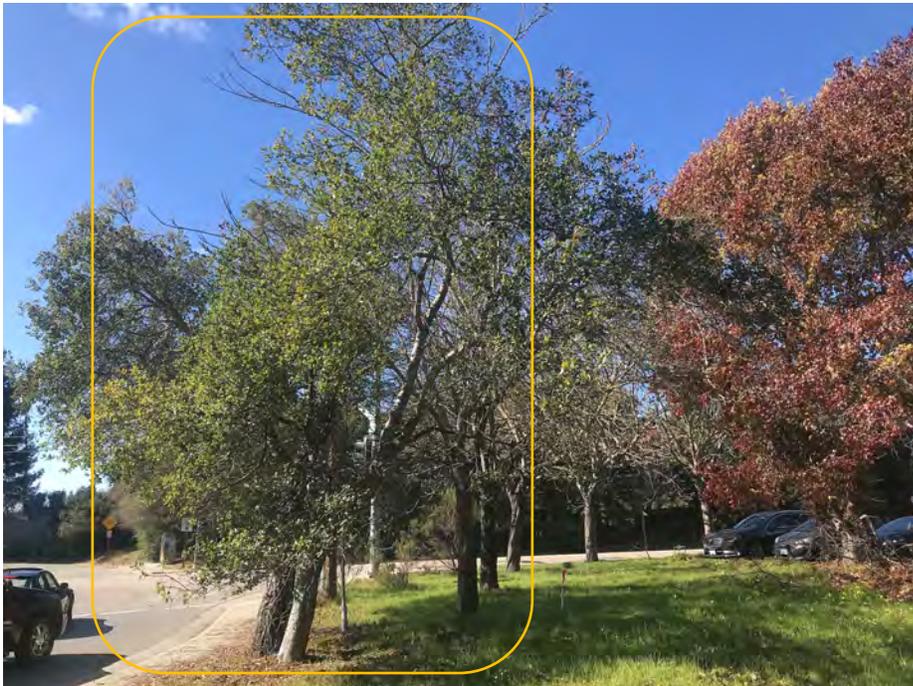
Tree #12A – 9.5-inch DBH Coast Live oak:

Both of these trees appear to be located on the Public Right of Way next to Cabrillo College Drive. The trees exhibit good health and they have fair structural conditions.

I determined that these trees will benefit from structural pruning work and that this work will also improve their appearance.

I determined that these trees must be protected during the construction period because of their close proximity to construction area.

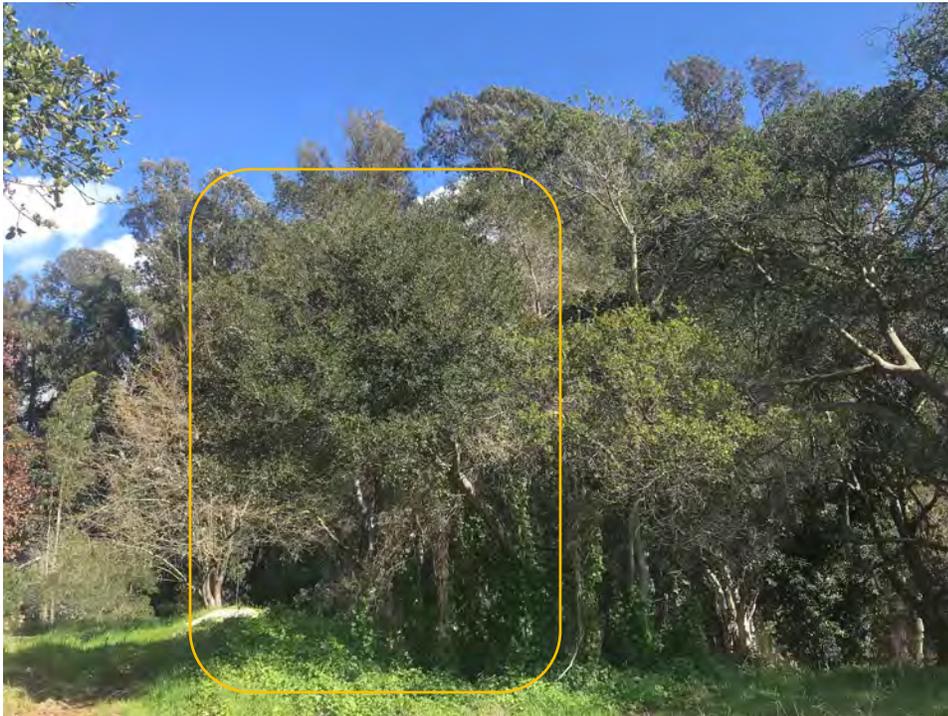
Tree #13 – 10-inch DBH Coast Live Oak:

These oaks appear to be located on the Public Right of Way and within the footprint of the proposed parking area respectively. They exhibit good health and they have fair structural conditions.

I determined that both of these trees may have to be removed because of their locations concerning the proximity of the proposed parking area for the housing facility.

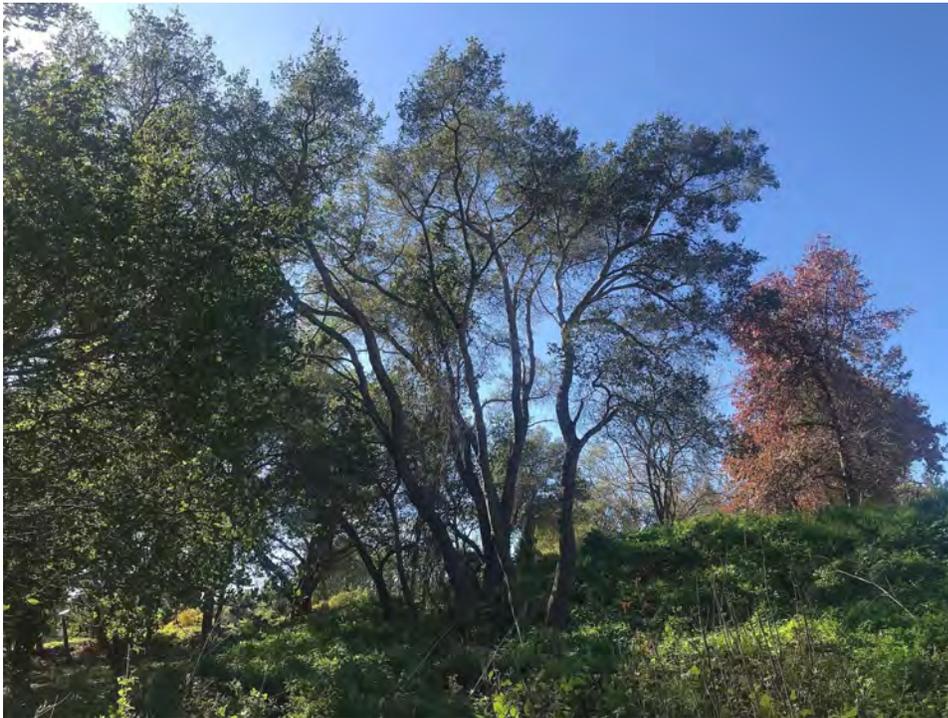
Tree #22 – 8.5-inch DBH Coast Live Oak:

All of these trees are suitable for preservation, based upon their good overall condition ratings.

I determined that these oaks must be protected during the construction period.

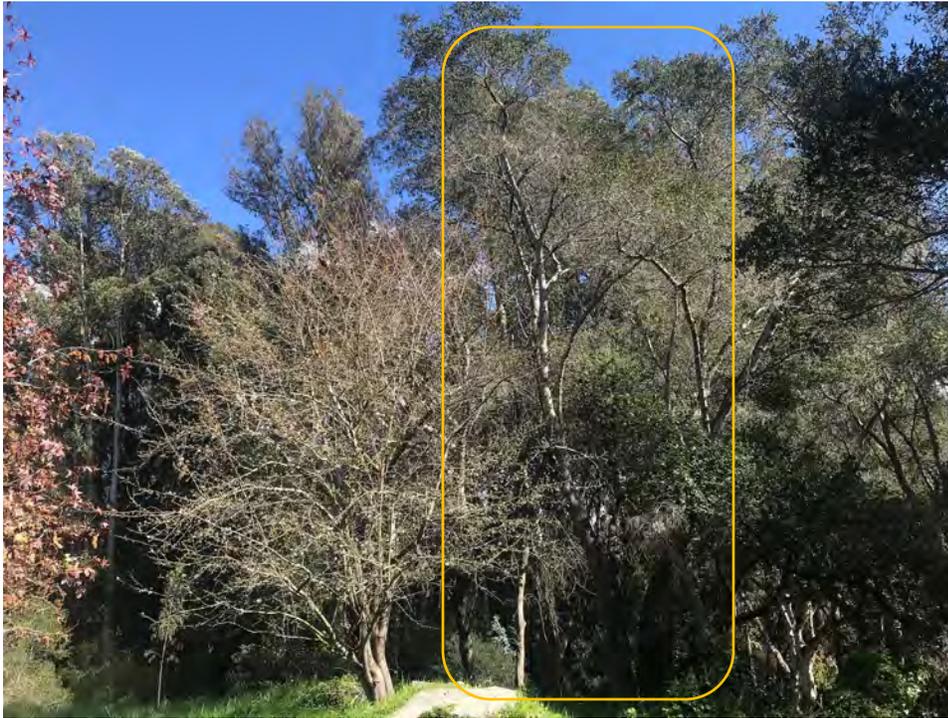
Tree #24 – 11-inch DBH Coast Live Oak:

I determined that these oaks will likely have to be removed because they appear to be located within the proposed construction footprint.

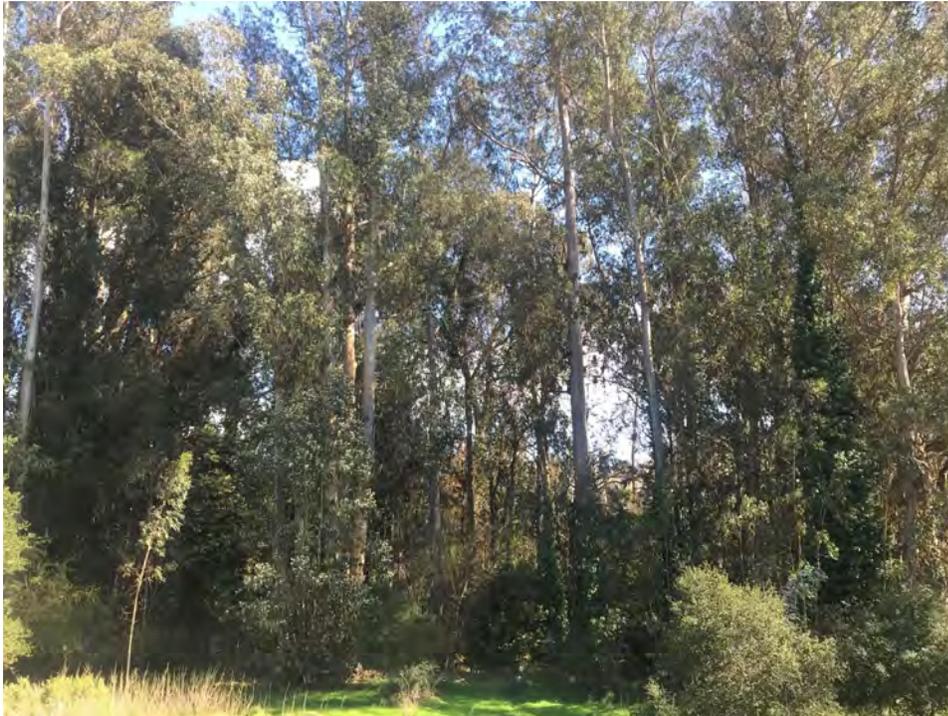
Tree #35 – 8.5-inch DBH Blue Gum Eucalyptus:

All of these eucalyptus trees appear to be located outside the proposed construction footprint, the majority of which are growing within the Riparian Zone. These trees are suitable for preservation, based upon their good overall condition ratings.

I determined that these trees must be protected during the construction period.

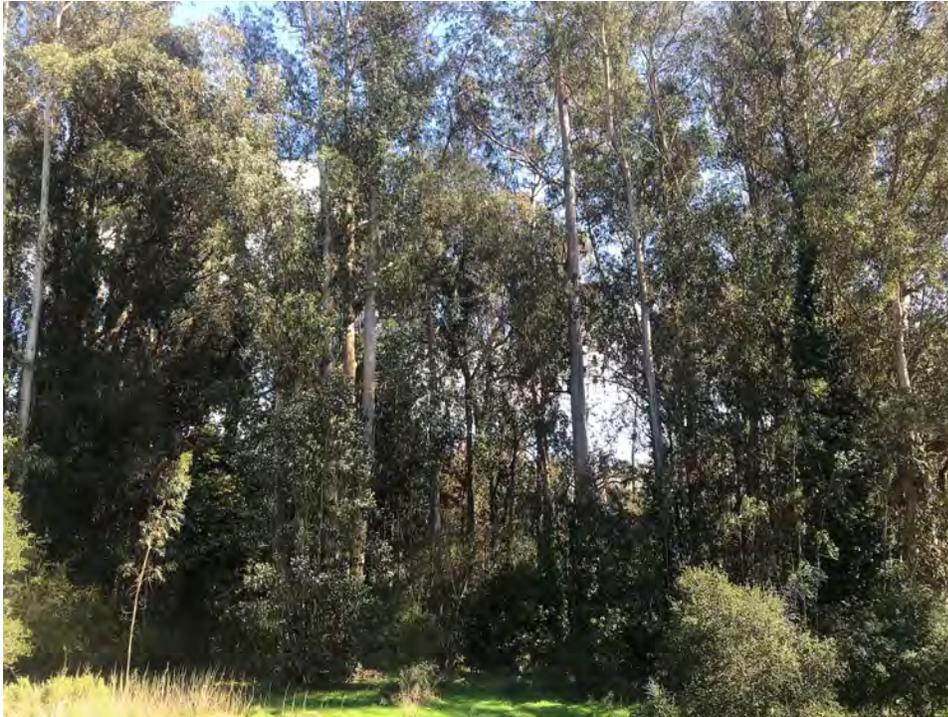
Tree #42 – 51-inch DBH Blue Gum Eucalyptus:

All of these large trees are located outside the proposed construction footprint and are within the Riparian Zone. They are suitable for preservation and protection during the construction period, based upon their good overall condition ratings.

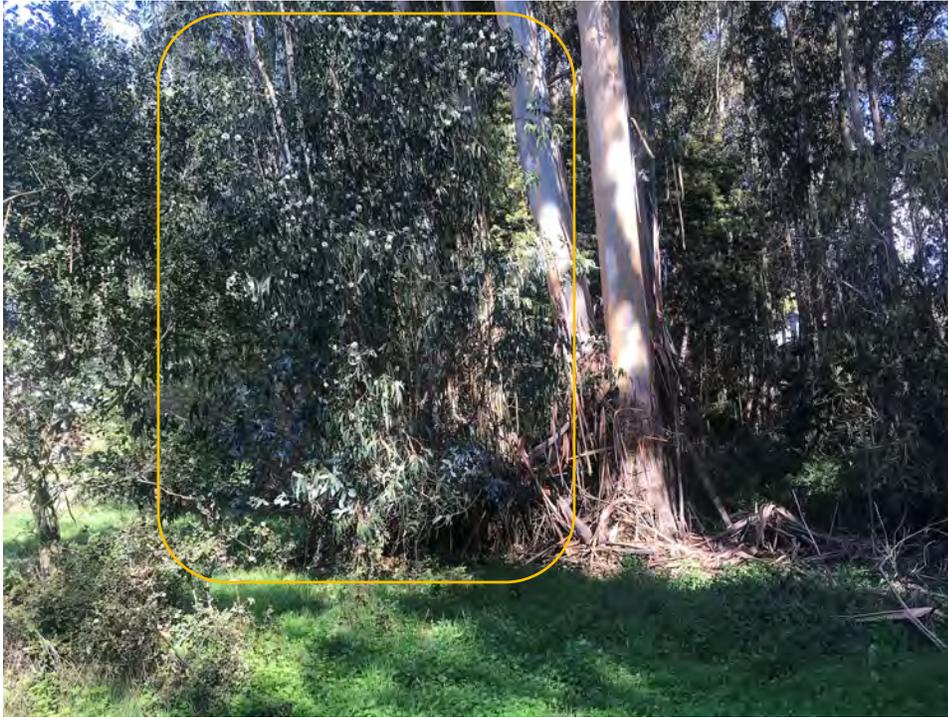
Tree #46 – 60-inch DBH Blue Gum Eucalyptus (measured near ground level):

This tree has regenerated from a stump, resulting in the development of multiple codominant stems.

I determined that this tree has a poor structural condition and that it will become increasingly vulnerable to failure as it grows larger over time. I determined that this tree is unsuitable for preservation. It is located within the Protected Riparian Zone.

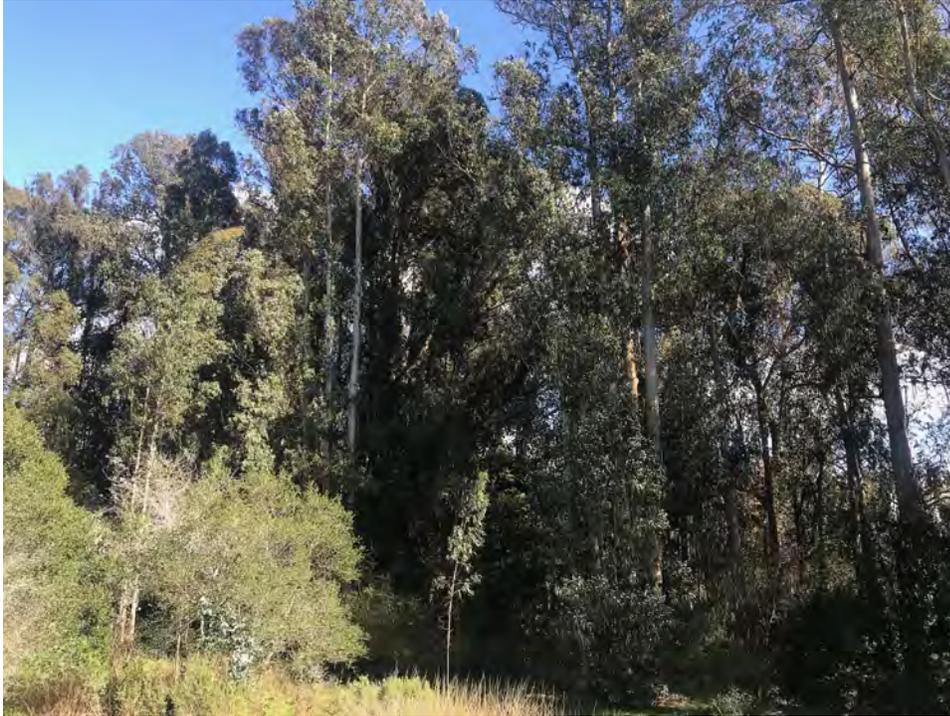
Tree #50 – 42-inch DBH Blue Gum Eucalyptus:

These large trees are located within the Riparian Zone.

I determined that these trees have good overall condition ratings and that they are suitable for preservation and protection during the construction period.

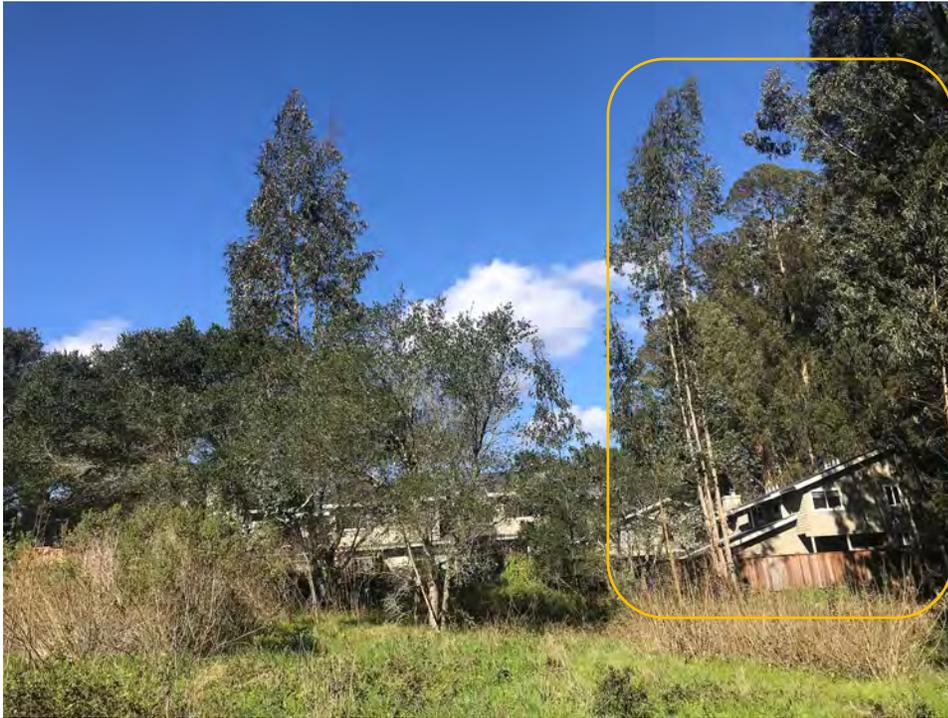
Tree #54 – 8 & 8-inch DBH Blue Gum Eucalyptus:

Both of these trees regenerated from cut stumps and they have developed multiple codominant stems, all of which share weak areas of attachment. These trees will become increasingly vulnerable to failure as they grow larger over time.

I determined that these trees are unsuitable for preservation because of their poor structural conditions.

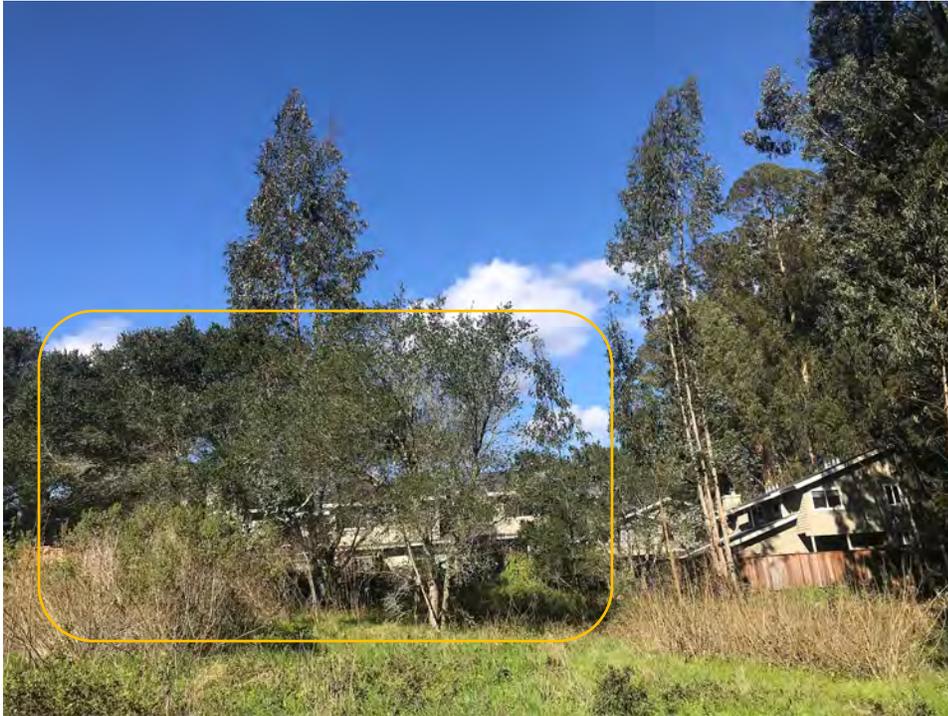
Tree #59 – 8-inch DBH Coast Live Oak:

Tree's #59 & #60 have poor health and structural condition ratings respectively, which makes them unsuitable for preservation.

I determined that all of these oaks are located within the proposed construction footprint, which precludes their preservation.

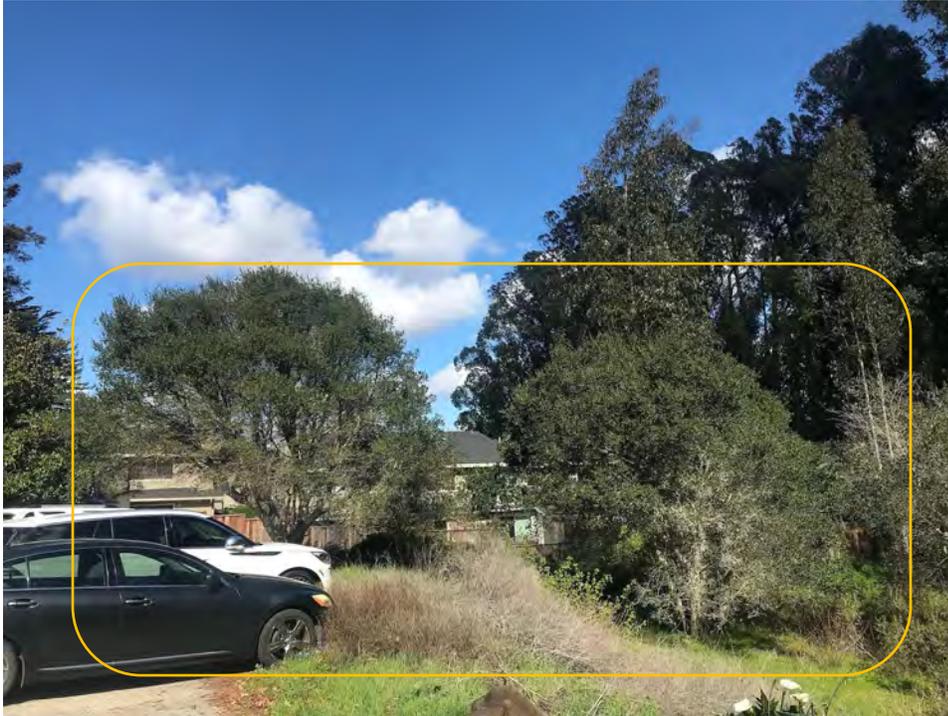
Tree #63 – 8-inch DBH Coast Live Oak:

Tree #62 has a poor structural condition, having regenerated from a stump. The areas of attachment in between the codominant stems are weak.

These oaks are located within the proposed construction footprint, which precludes their preservation.
