**Coastal Bluff Evaluation
SANDERS & ASSOCIATES GEOSTRUCTURAL
ENGINEERING, INC**

RE: COASTAL BLUFF EVALUATION
East Cliff Drive between 33rd And 36th Avenues
Santa Cruz County, California

COASTAL BLUFF EVALUATION
East Cliff Drive between 33rd and 36th Avenues
Santa Cruz County, California

**GEOLOGIC RECONNAISSANCE AND
DEGREE OF THREAT EVALUATION MAPS**

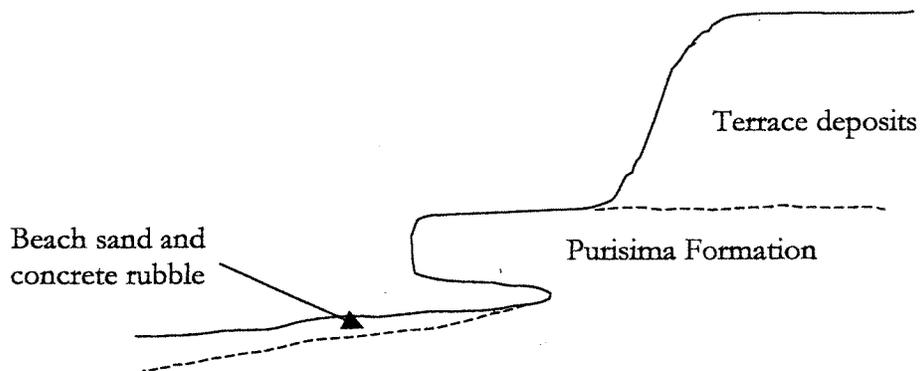
Figure 1 Schematic bluff profile showing the terrace deposits overlying the Purisima Formation. Wave-cut notches or undercuts are locally present in the Purisima Formation.

Wave-cut notches or undercuts are locally present in the Purisima Formation along the base of the bluff (Figure 1). Because the undercuts are locally filled with sand and concrete rubble, the full dimensions of the undercuts can only be approximated. Where measured from the face of the Purisima Formation bench, the undercuts are up to one meter high and extend up to 5.5 meters horizontally into the bluff.

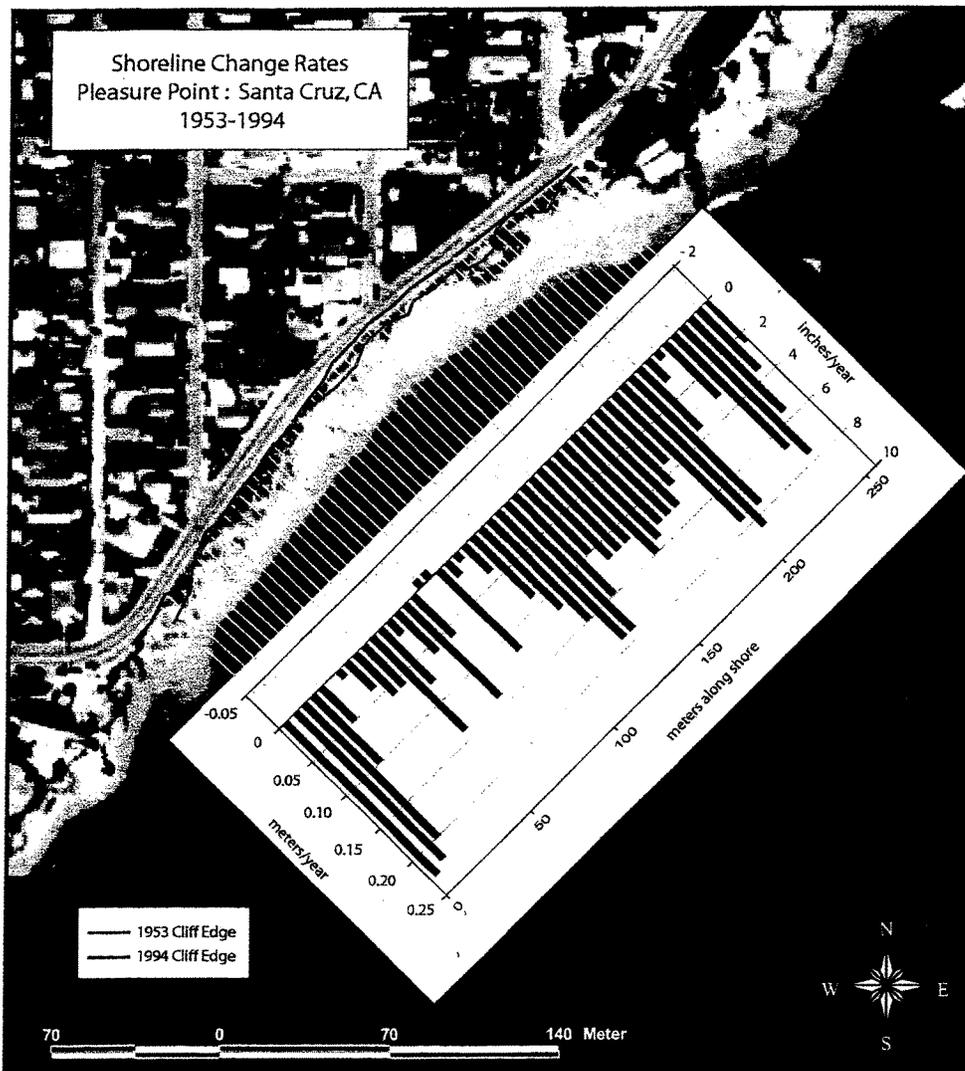
The site bluff was designated by Griggs and Savoy (1985) as hazardous with a high erosion risk. Long-term bluff erosion rates previously measured for the site area generally average about 0.3 meters (1 foot) per year (Griggs and Savoy, 1985; Foxx, Nielsen and Associates, 1998).

Figure 2 Long-term bluff erosion rates from 1953 to 1994 by Moore (1998). Positive values denote erosion.

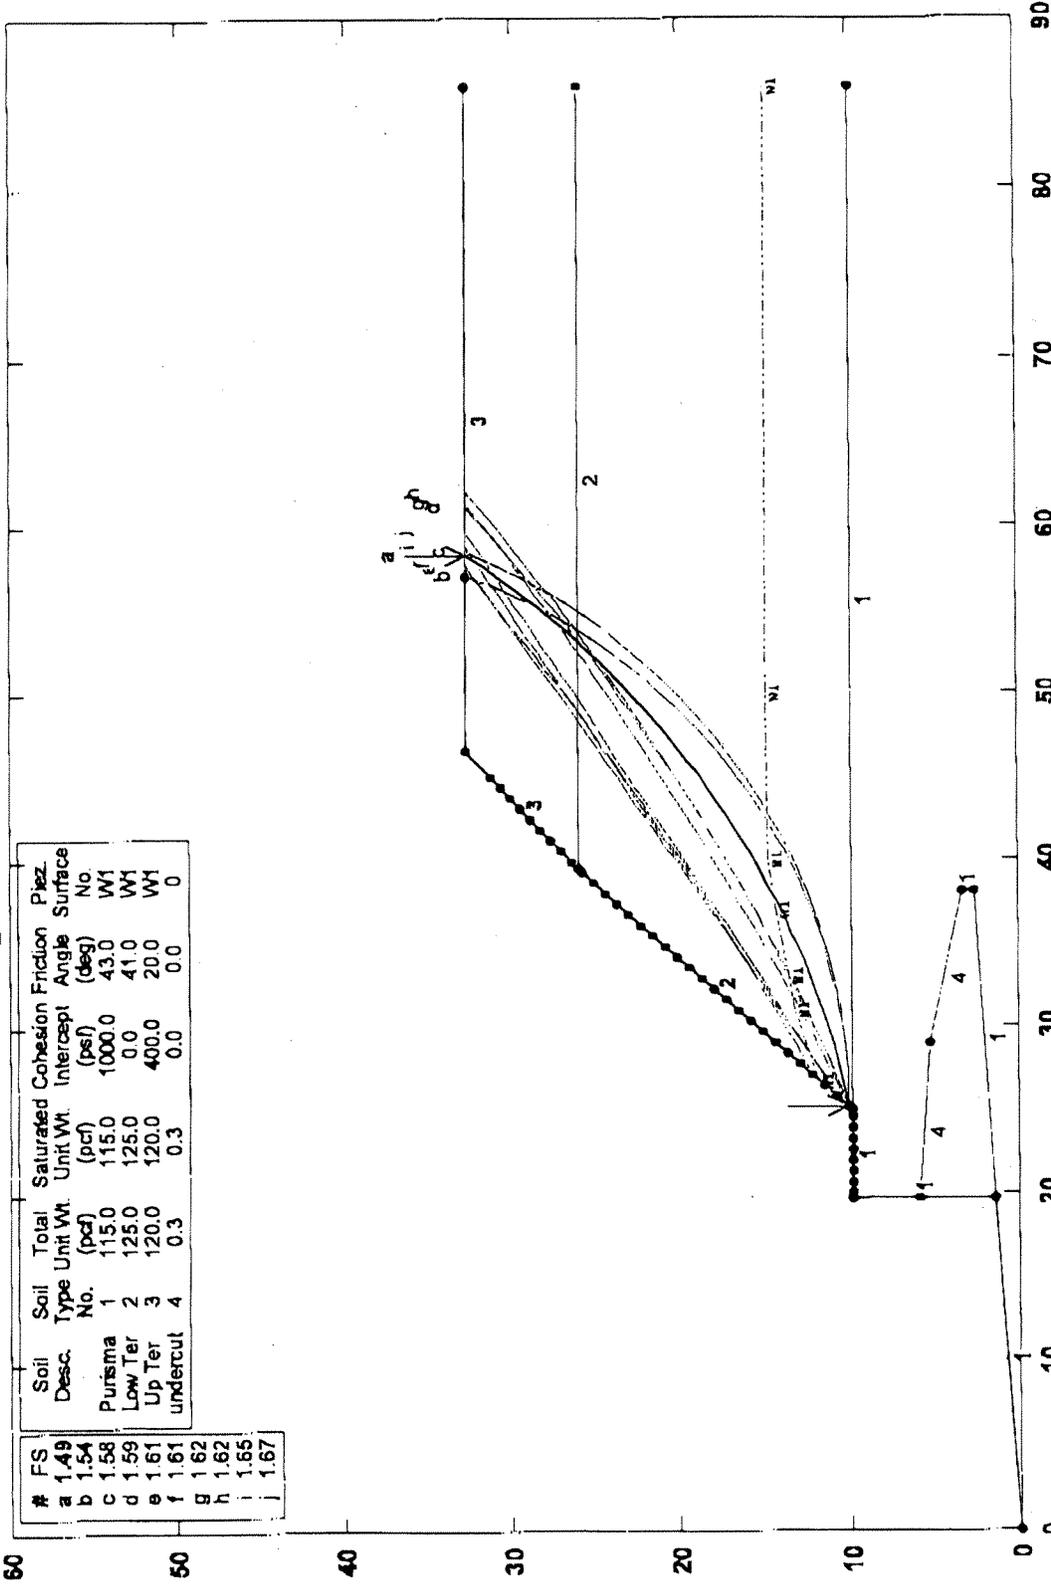
East Cliff Dr. Threat Evaluation Sta. 0+102 (FS = 1.5)
 F:\1-PROJ-1\RLF105_2.PL2 Run By: Renee L Fipplin 9/23/2005 8:57AM

#	FS
a	1.49
b	1.54
c	1.58
d	1.59
e	1.61
f	1.61
g	1.62
h	1.62
i	1.65
j	1.67

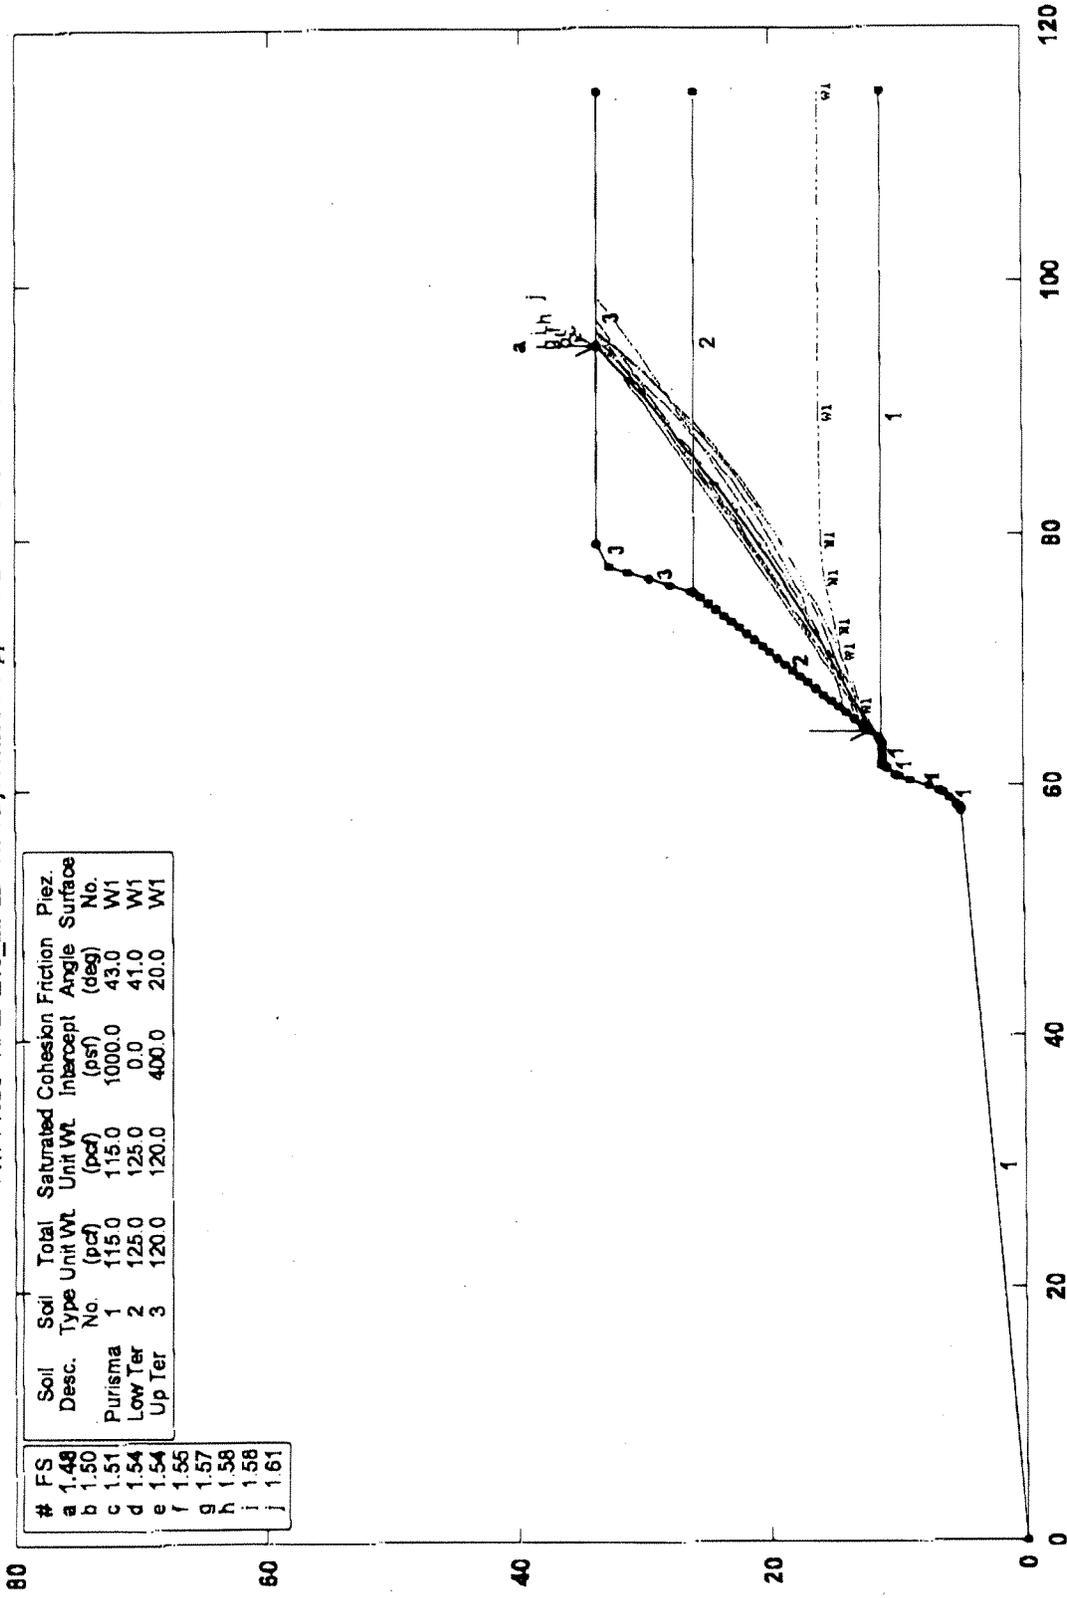
East Cliff Dr. Threat Evaluation Sta. 0+212 - FS = 1.5
 F:\1-PROJ-1\RLF1215_2.PL2 Run By: Renée L Fippin 9/22/2005 5:31PM

STABL6H FSmin=1.48
 Safety Factors Are Calculated By The Modified Bishop Method

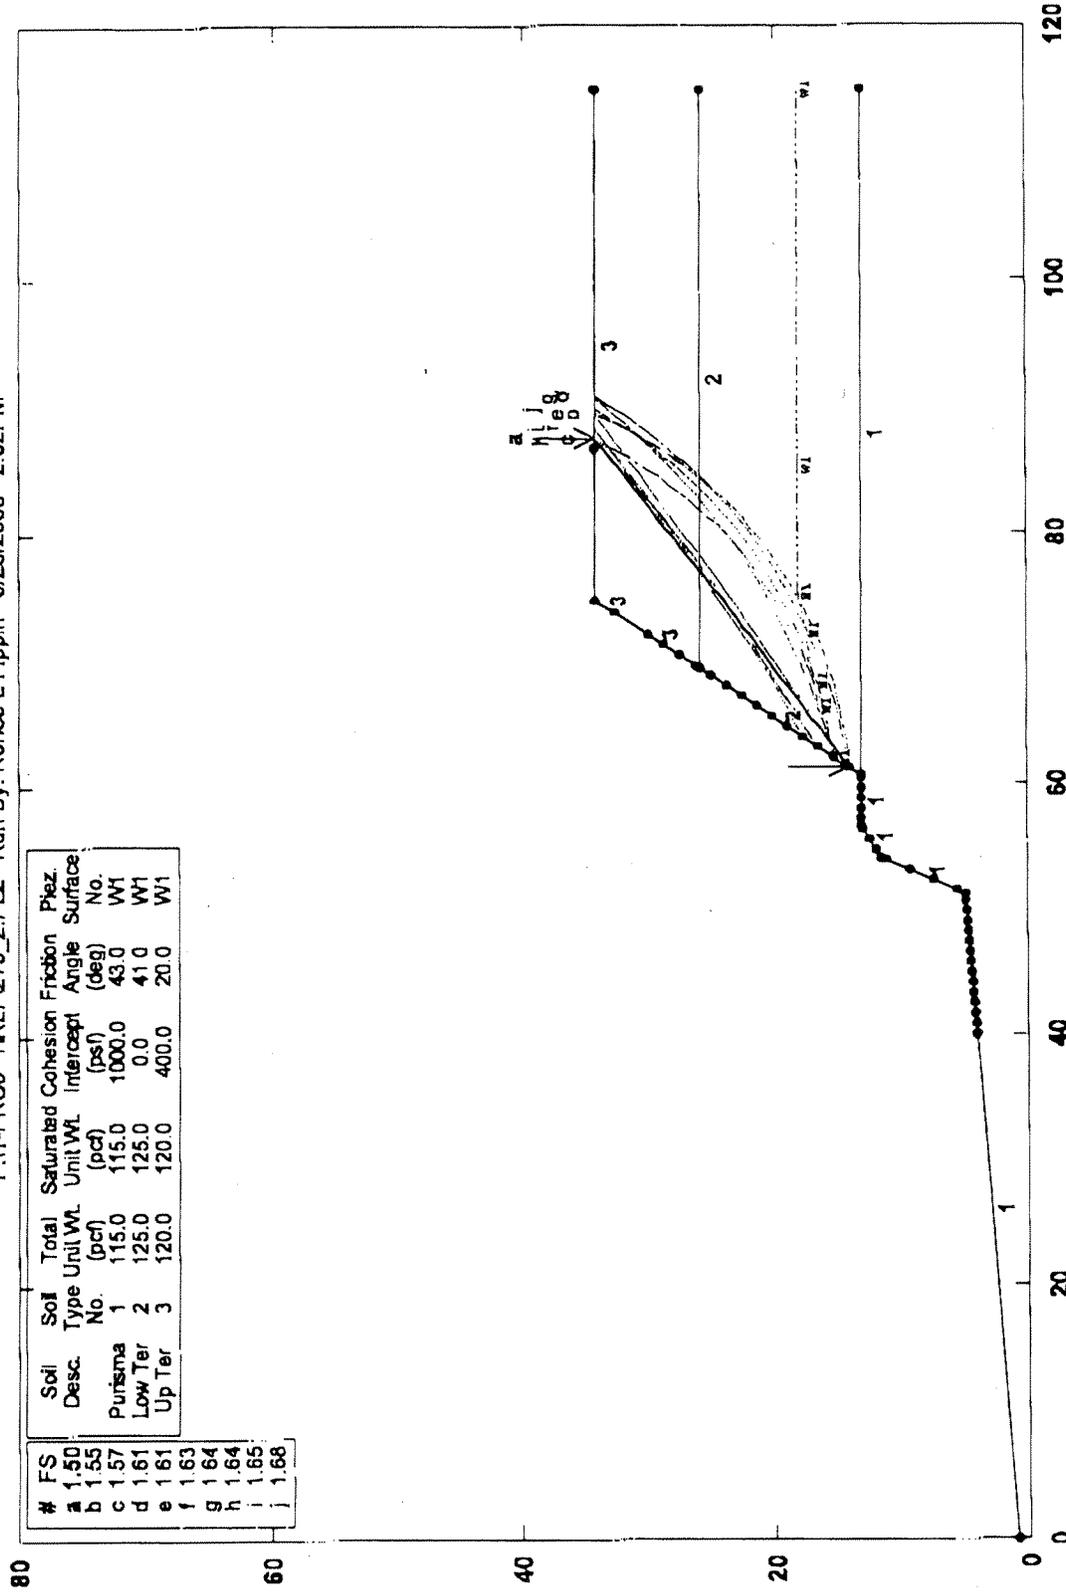
East Cliff Dr. Threat Evaluation Sta. 0+278 (FS = 1.5)

STABL6H FSmin=1.50
Safety Factors Are Calculated By The Modified Bishop Method

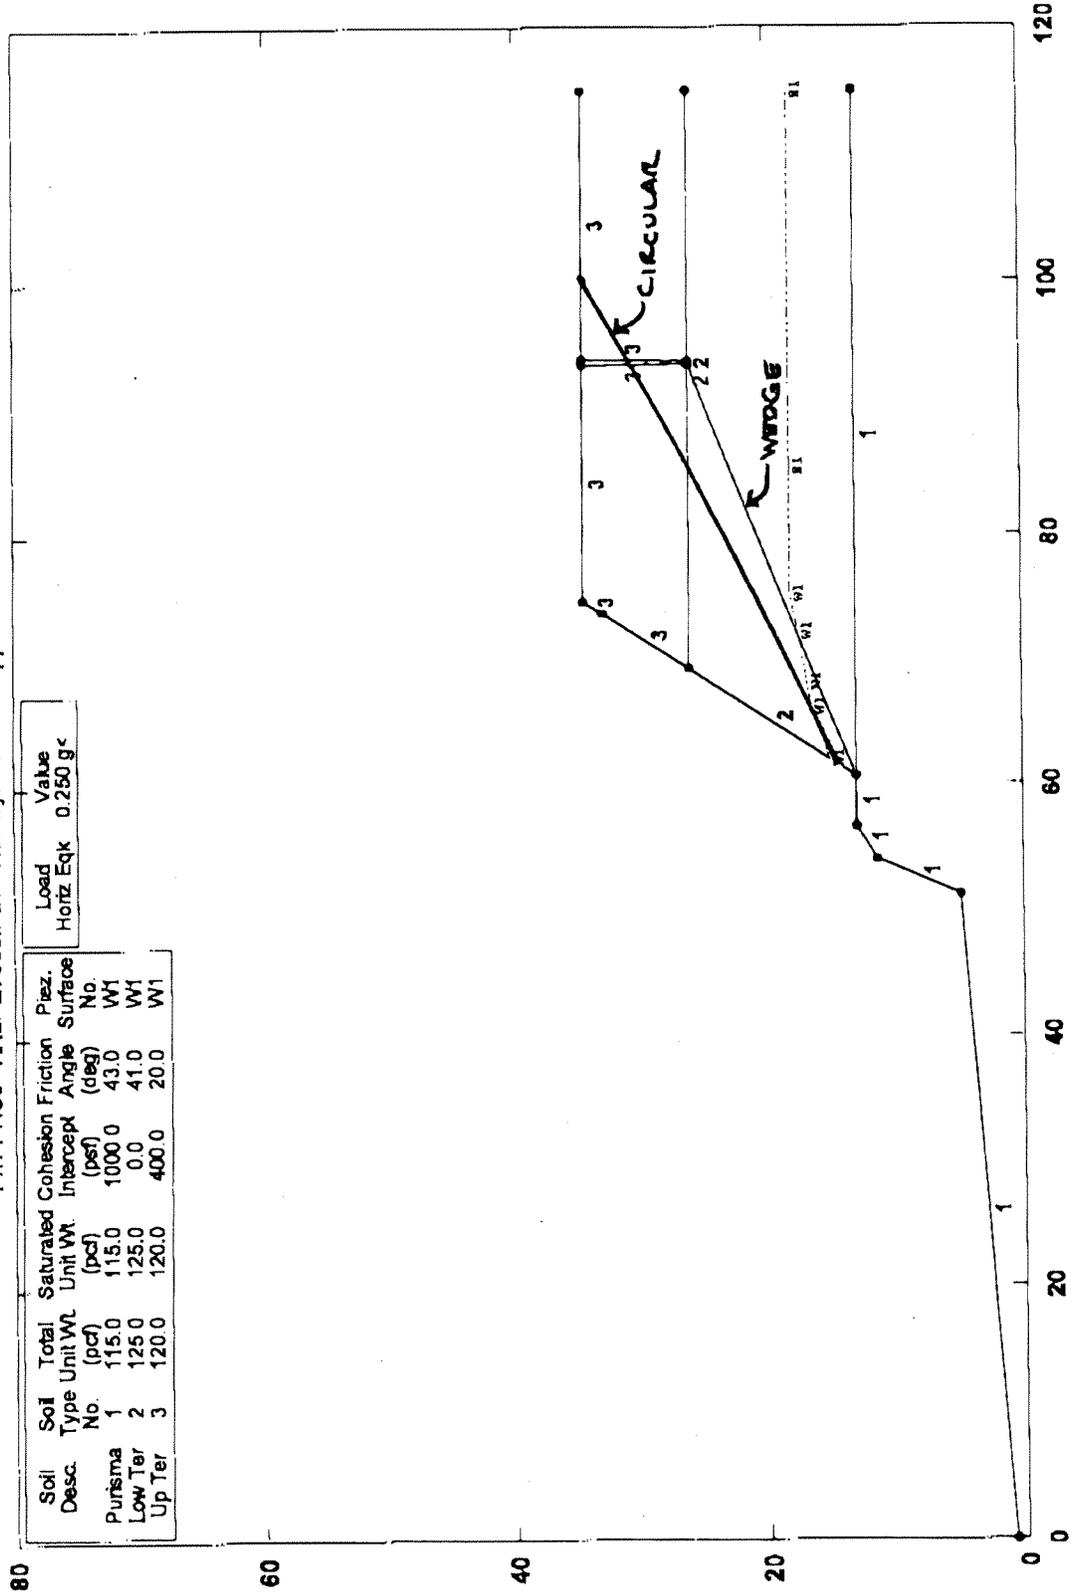
STABL6H FSmin=1.19
 Factor Of Safety is Calculated By The Modified Bishop Method

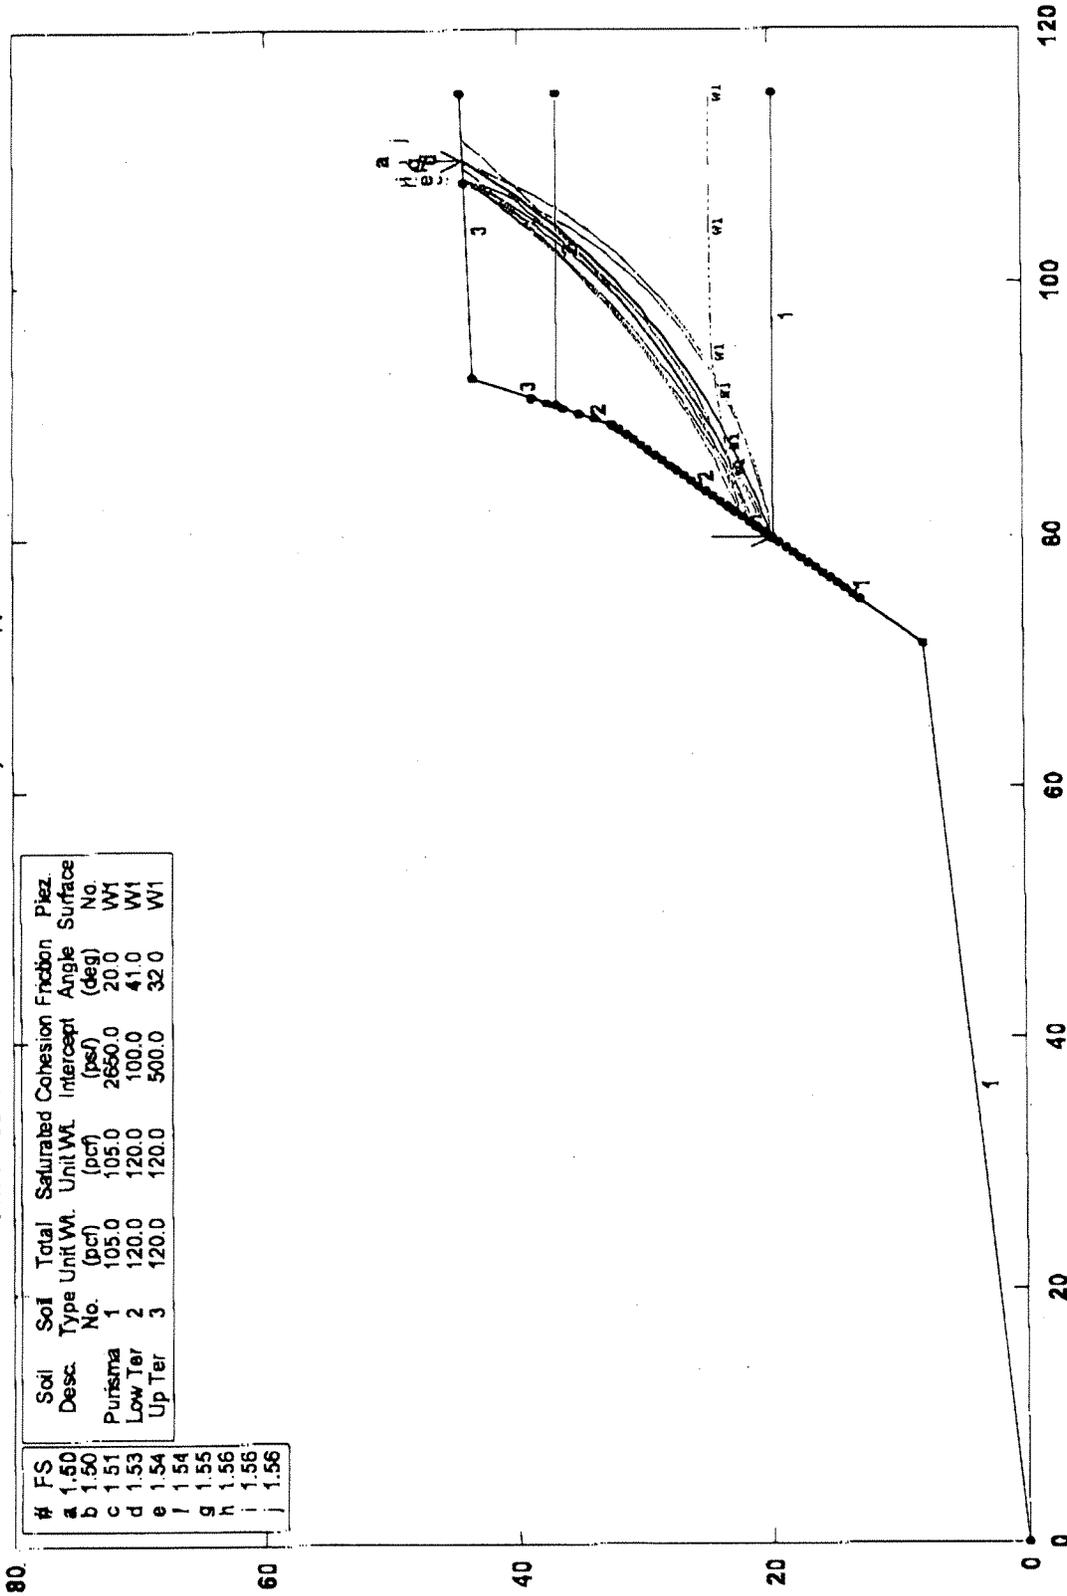
East Cliff Dr. Threat Evaluation The Hook
 F:\1-PROJ~1\RLFHOOK\WAT6.PL2 Run By: Renee L Fippin 9/23/2005 9:44AM

STABL6H FSmin=1.50
 Safety Factors Are Calculated By The Modified Bishop Method

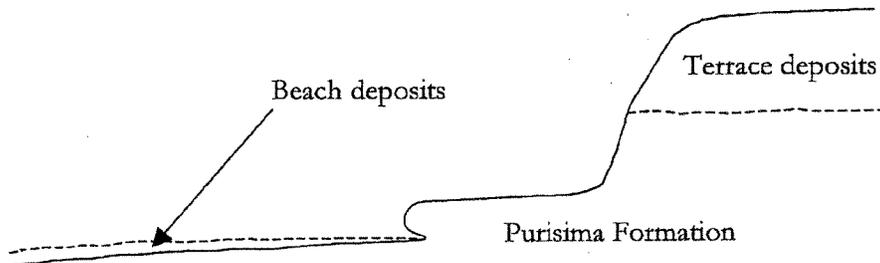
The general bluff configuration changes across the site. On the northeast side of the site, the bluff is generally linear and characterized by a steep bluff face with a prominent Purisima Formation bedrock bench at the toe of the bluff (Figure 1). The bedrock bench is about 1 to 2 meters (3 to 6.5 feet) above mean sea level (MSL) and extends up to 8 meters (26 feet) out from the toe of bluff (Sheet 2). Limited undercutting along the base of the bedrock bench is visible. In addition, preferential erosion of a bedrock fault by wave action has formed a sand-filled notch in the bedrock bench (Sheet 2). Faults generally represent weaker zones in the bedrock that may erode at a faster rate than the surrounding unfaulted bedrock.

Figure 1 - Schematic profile of the coastal bluff on the northeast side of site.
