Existing Conditions, Bluff View
Santa Cruz, California

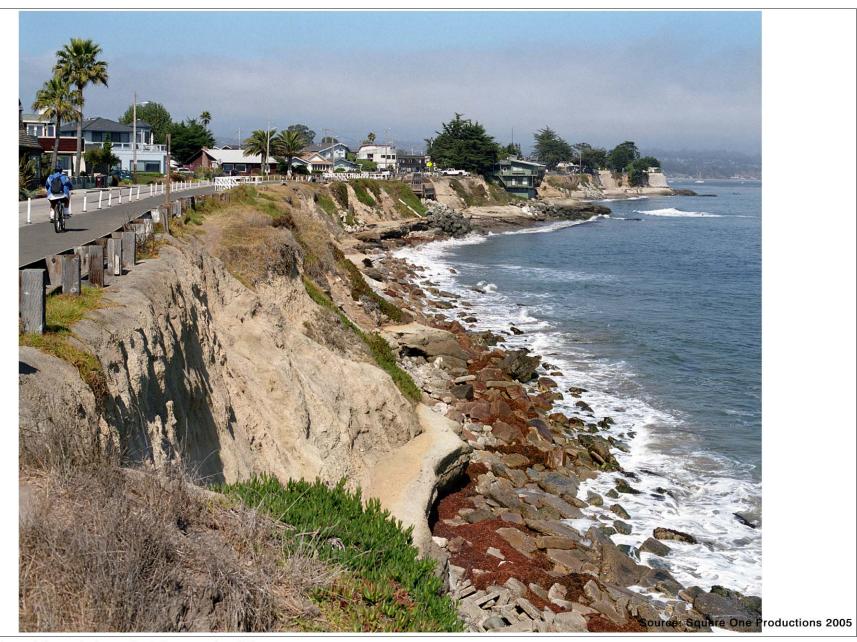
Existing conditions at the project area include concrete rubble, sculpted and colored soil nail walls constructed as emergency repairs in 2004 (lower left-hand corner of picture), white protective railing around areas of failed roadway, nonnative vegetation and minimal beach area due to the concrete rubble and rock riprap.
