MITIGATION MONITORING AND REPORTING PROGRAM for Application No. 231264

Subject: 275 Lee Road Biotic Report Review and Conditioned Biotic Approval

GEOTECHNICAL INVESTIGATION

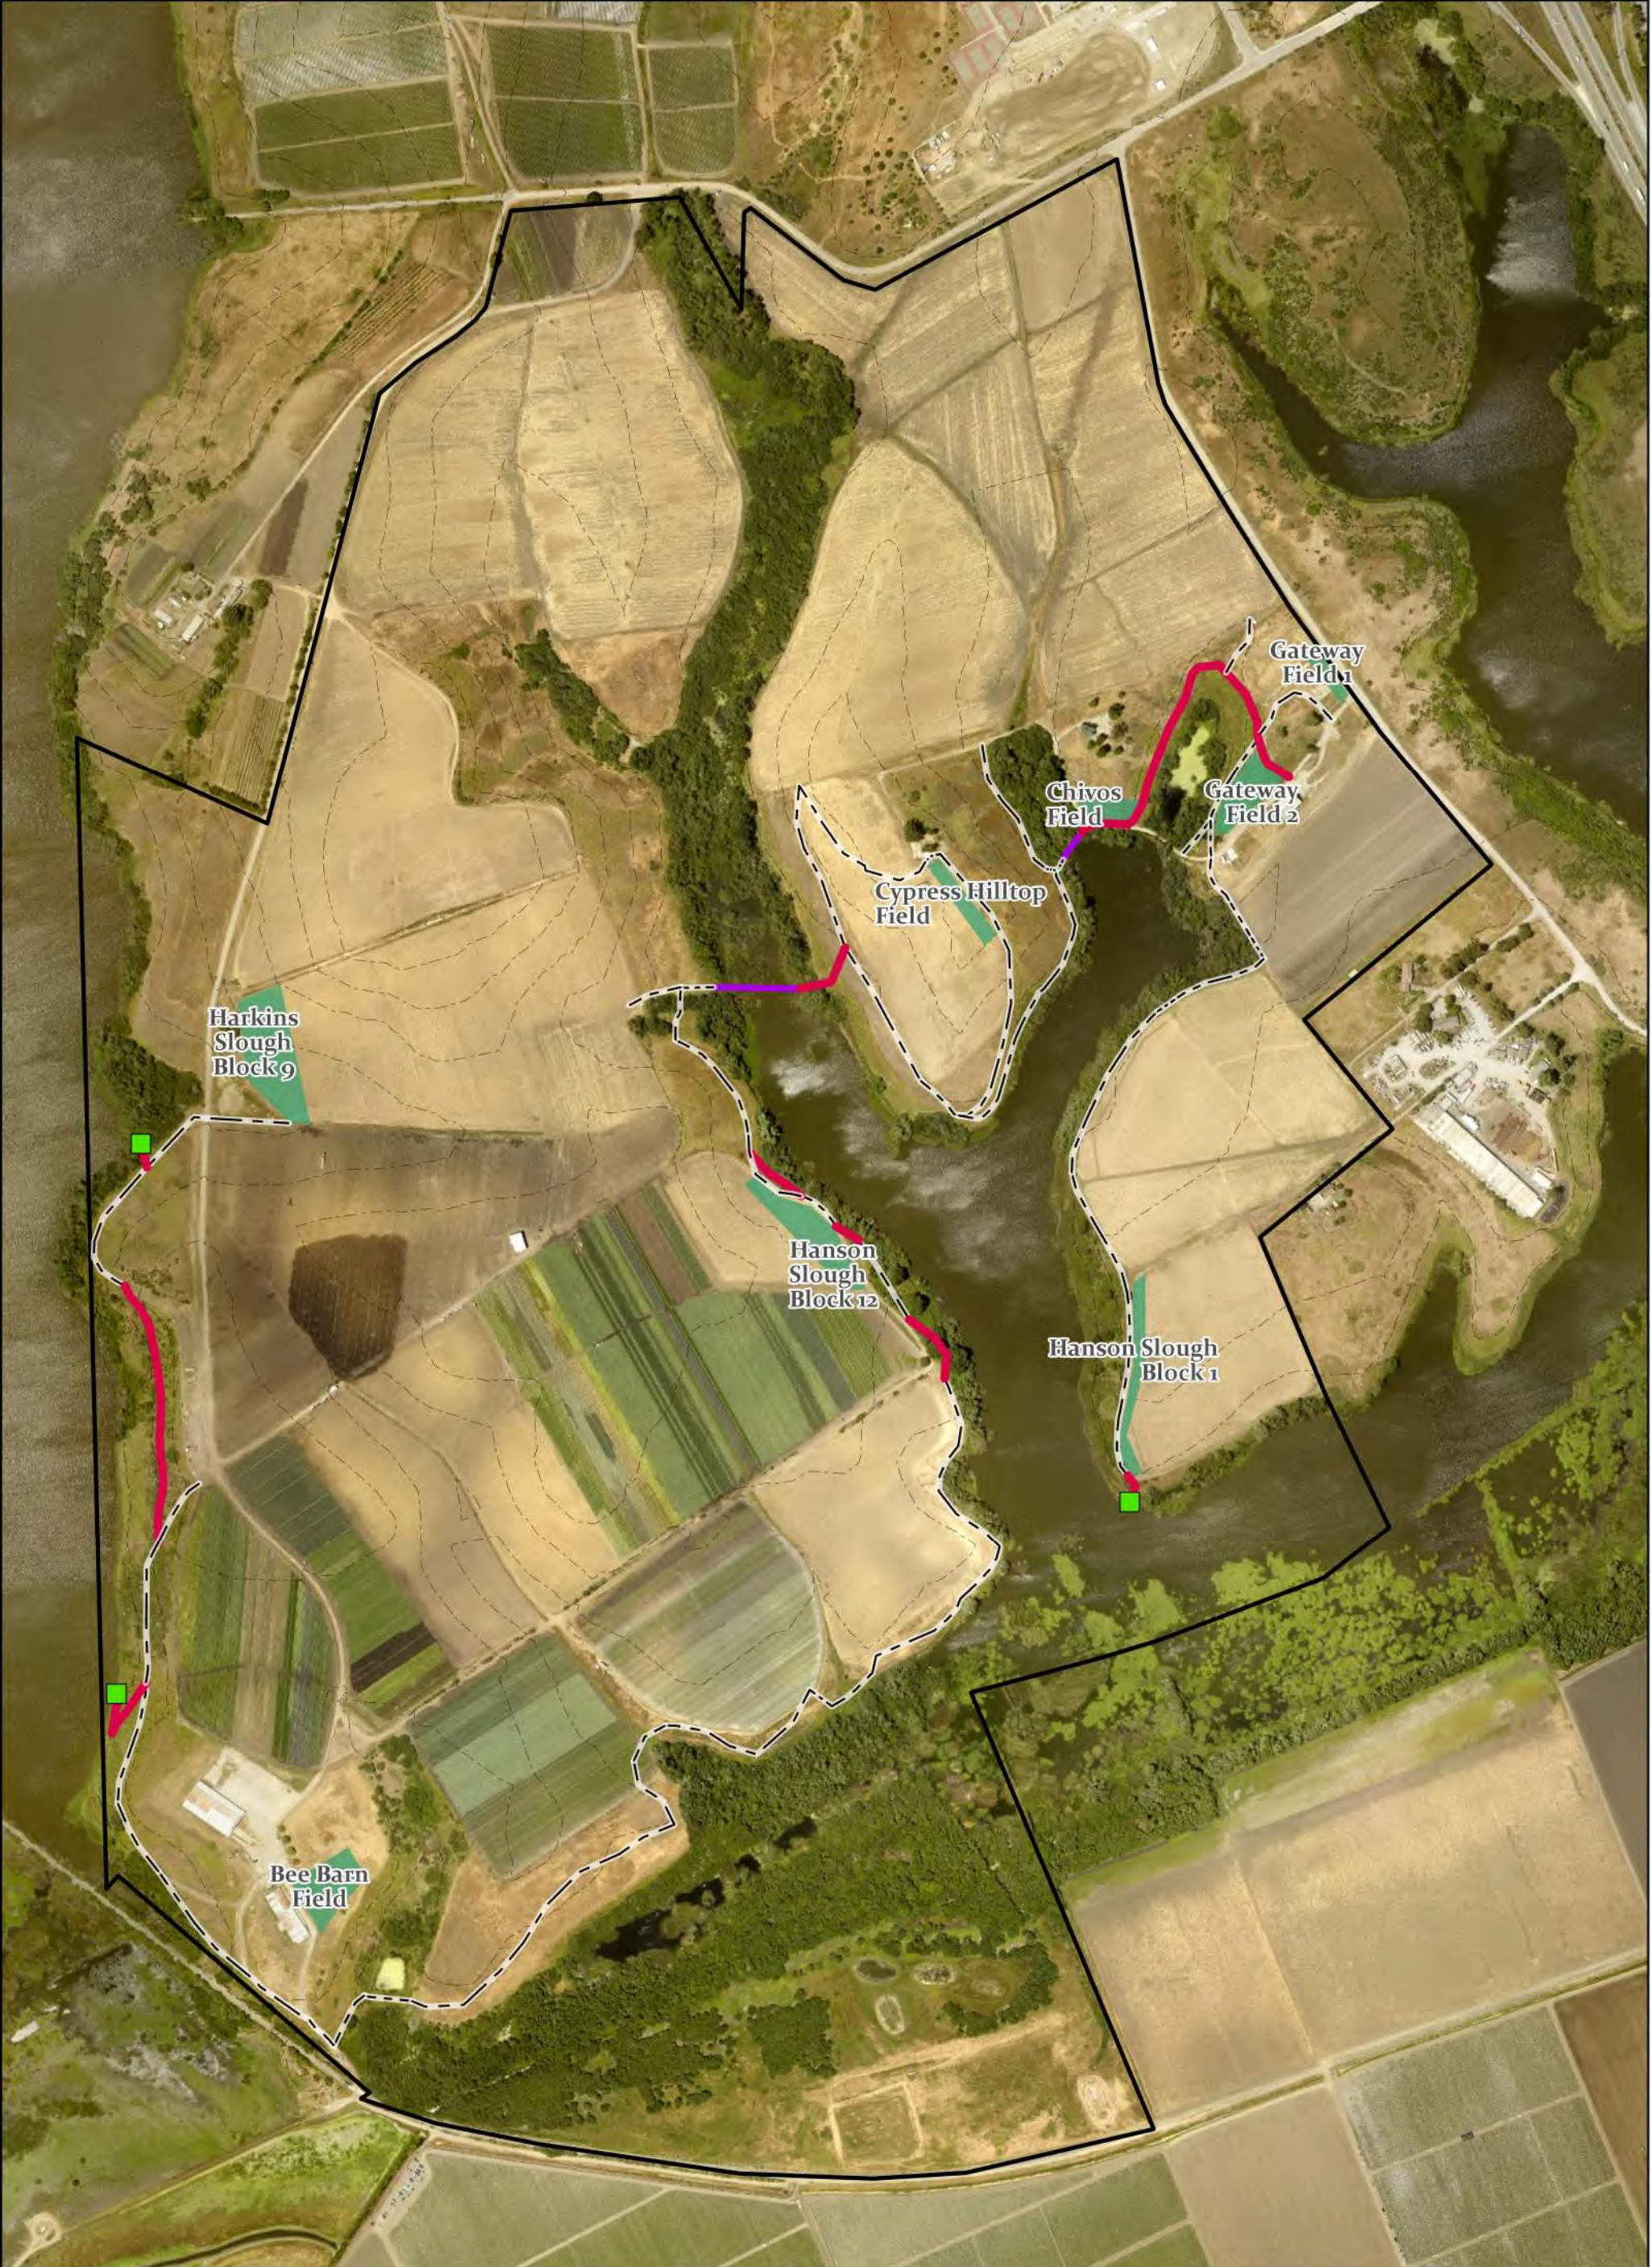
Figure 2a.
Watsonville Slough Farm Community Harvest Project

- Conceptual Trail
- Existing Trail
- Conceptual Boardwalk Crossing

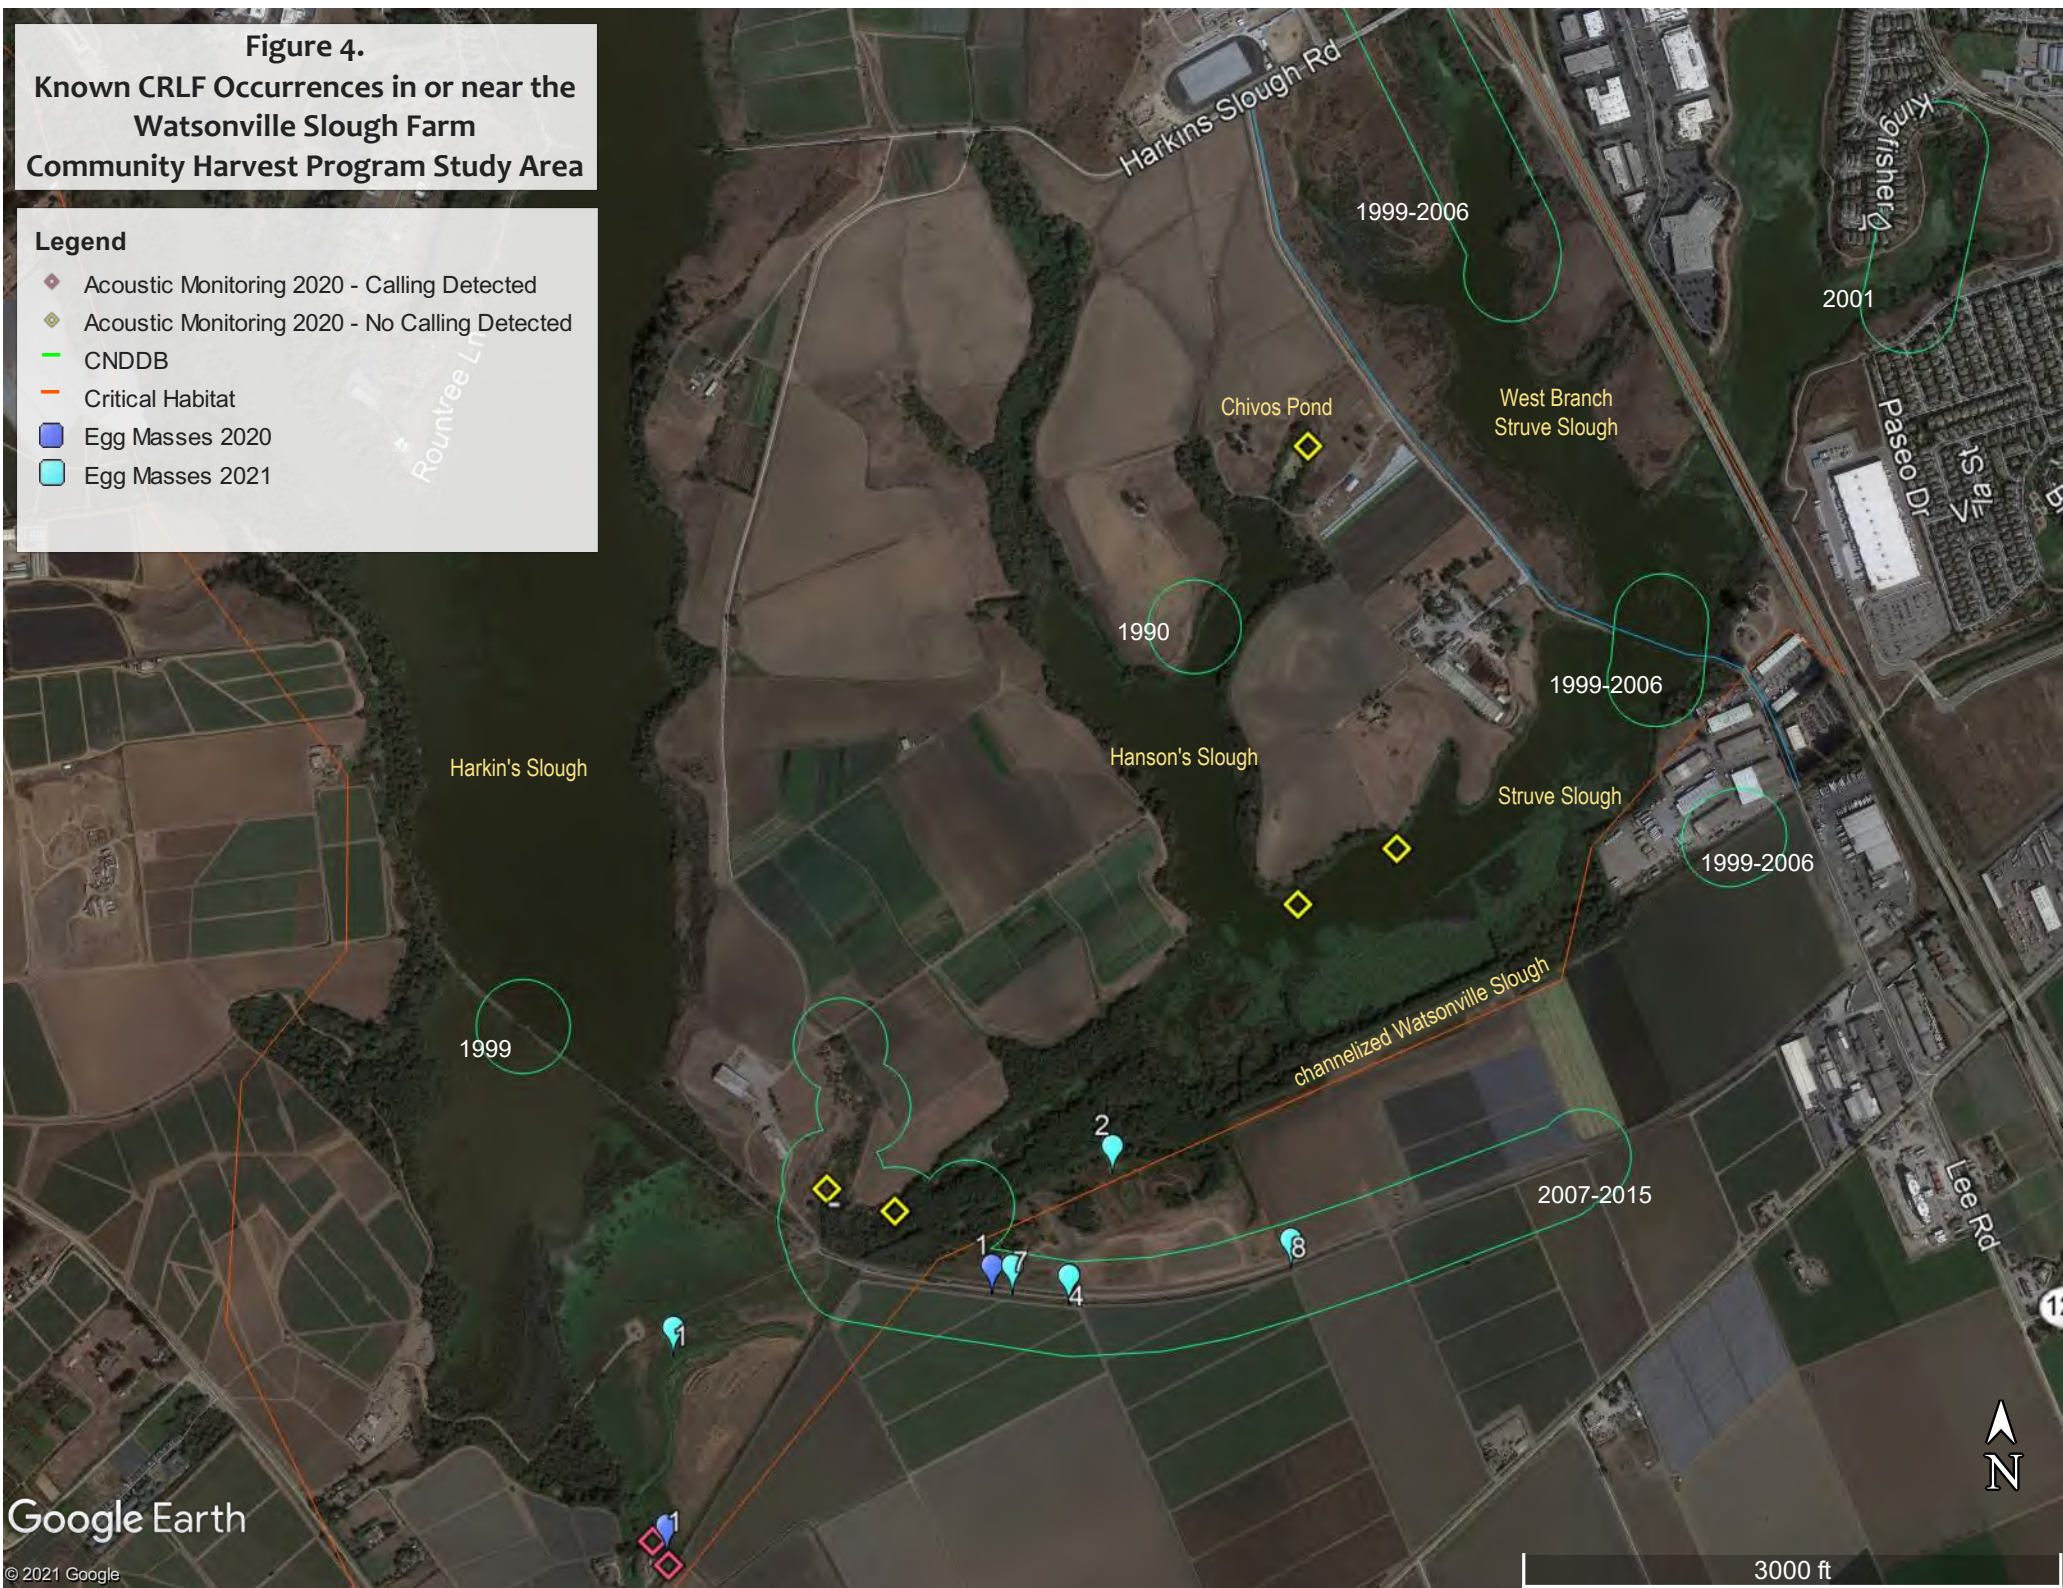
- ◆ Acoustic Monitoring 2020 - Calling Detected
- ◆ Acoustic Monitoring 2020 - No Calling Detected
- CNDDB
- Critical Habitat
- Egg Masses 2020
- Egg Masses 2021

Within the Study Area, CRLF are likely to utilize riparian, wetland, and upland habitats (oak woodland, coastal scrub, grasslands, and agricultural fields) for movement, dispersal, and refuge. These habitats are contiguous with aquatic habitats occupied by CRLF.
