NOTICE OF INTENT TO ADOPT A MITIGATED NEGATIVE DECLARATION

PROJECT: JOHNSON GRADING

PROJECT DESCRIPTION: The proposed project is a proposal to construct a 2,270 foot long driveway and single family dwelling. The associated scope of work includes approximately 2,100 cubic yards of excavation and 1,500 cubic yards of fill and the removal and replacement of an existing ephemeral stream crossing. The project requires Preliminary Grading Approval.

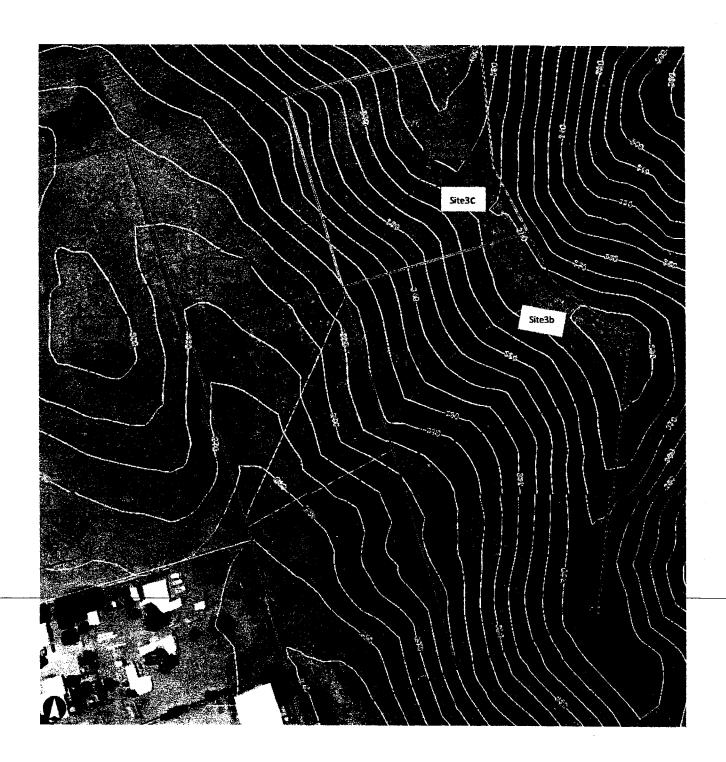
Site 3 requires application of ag buffer exception, if not approved the alternative sites are the lighter blue.

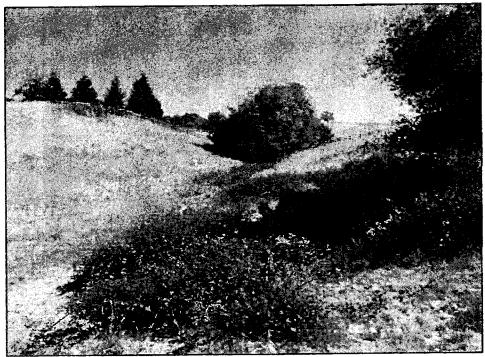
Figure 5. Seasonal wetland and riparian woodland near NW corner of project site, Corralitos, CA.

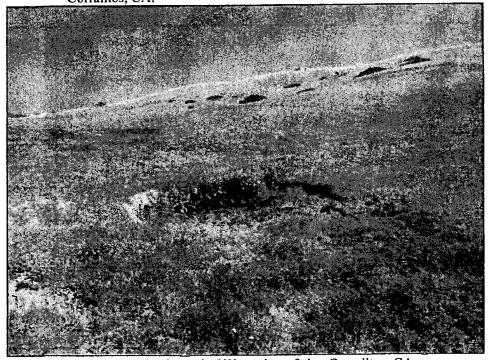
Figure 6. Seasonal wetland area in SW portion of site, Corralitos, CA.

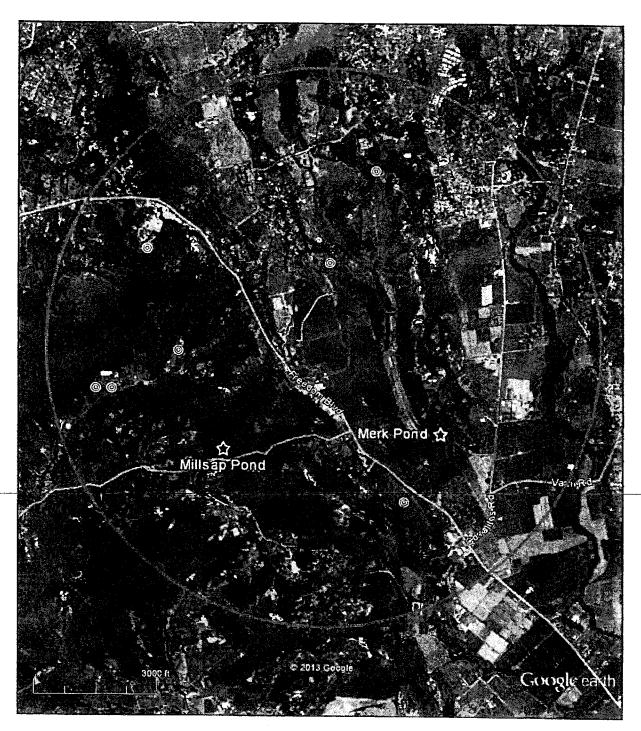
Figure 8. Aerial image of area within 1.2 miles of project site. White circles = potential SCLTS and CRLF breeding ponds.
