NOTICE OF INTENT TO ADOPT A MITIGATED NEGATIVE DECLARATION NOTICE OF PUBLIC REVIEW AND COMMENT PERIOD

PROJECT: MT. HERMON YOUTH RECREATION CENTER

PROJECT DESCRIPTION: The project is a proposal to construct an approximately 12-acre outdoor recreational/educational facility to include a ropes course, a mountain bike course, community garden, splash pool, sports field, a 6,673 square foot retail/recreation building, a 7,425 square foot day camp and classroom, and four utility structures totaling 1,492 square feet. A small bridge is also proposed to cross an existing swale. Proposed earthwork consists of 10,830 cubic yards of excavation and 17,068 cubic yards of fill. Requires a Development Permit, Soils Report Review, Biotic Report Review, Archaeological Report Review, Riparian Exception, Preliminary Grading Approval, and a Variance to allow a structure to be constructed to a height of 62 feet.

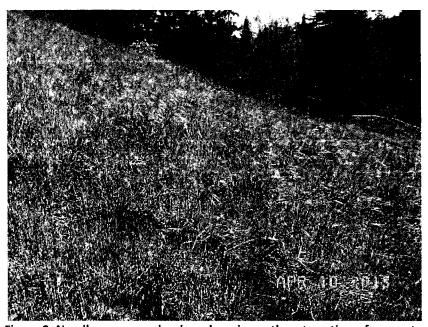
Figure 2. Needlegrass grassland on slope in northeast portion of property.

Needlegrass grassland was observed in the northeastern portion of the property (see Figure 1). The needlegrass grassland is characterized by the dominance of purple needlegrass (*Stipa pulchra*), a native perennial bunchgrass. One patch on the lower portion of the grassland measures approximately 20 feet x 30 feet. A larger patch is located on the hillside, abutting the property line to the east and scrub and woodland to the west and north, respectively. This grassland type supports purple needlegrass, with lesser amounts of wild oat (*Avena spp.*), ripgut brome (*Bromus diandrus*), and Italian/slender thistle (*Carduus sp.*). Other species observed include soap plant (*Chlorogalum pomeridianum*), hill morning glory (*Calystegia macrostegia*), vetch (*Vicia sp.*), California poppy (*Eschscholzia californica*), and scarlet pimpernel (*Anagallis arvensis*). Figure 2 shows the character of the needlegrass grassland area.

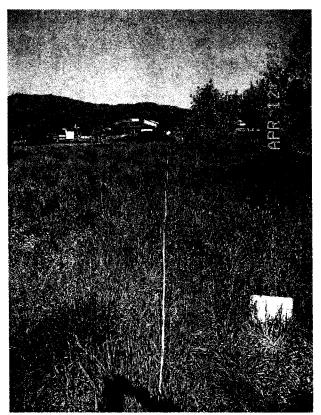
Figure 3. Rush-sedge meadow in central portion of property (transect A).

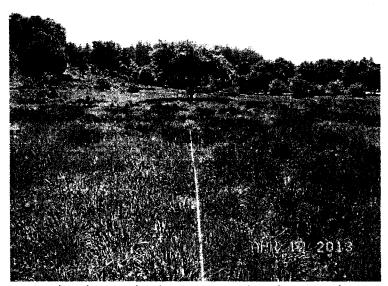
Figure 4. Rush-sedge meadow in western portion of property (transect C).

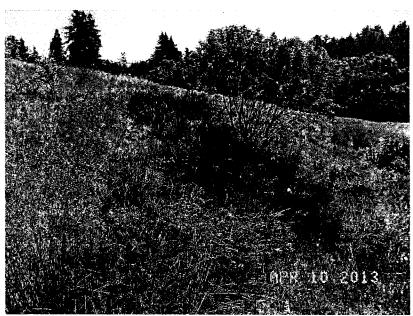
Figure 5. Small patch of rush-sedge meadow along hillside in central portion of property.

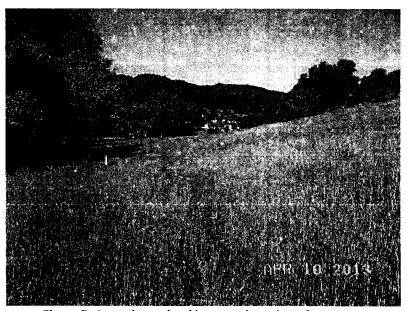
Figure 5. Annual grassland in central portion of property.

The 2012 field surveys found the annual grassland to be similar in distribution and species composition as documented in the 2008 biological report (with revisions previously noted). Although non-native grasses and forbs dominate the mapped annual grassland, two small patches of California oatgrass (*Danthonia californica*), a native perennial bunchgrass, was observed in the central portion of the property. The two patches each support 1-3 oatgrass plants amid the otherwise annual, non-native species. The location of these two patches is depicted on Figure 1. Figure 5 shows the character of the annual grassland.

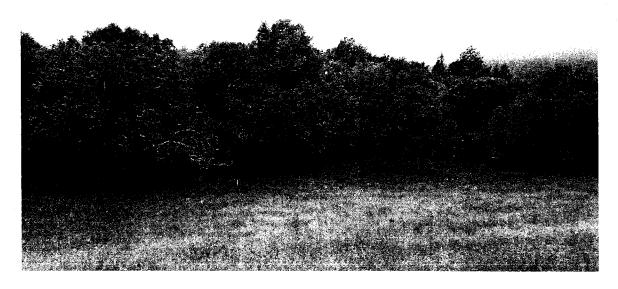
The southeast corner of the property is pictured below. It is densely forested with coast live oak (*Quercus agrifolia*), interior live oak (*Quercus wislizenii*), and box elder (*Acer negundo*).

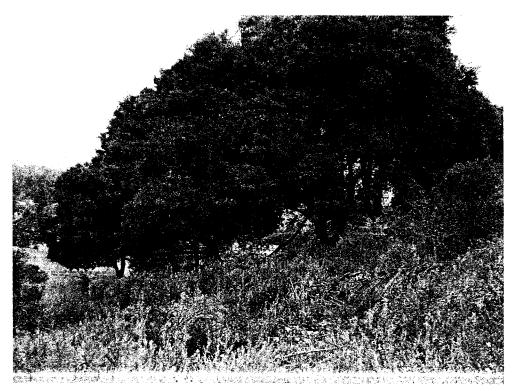
Several small groves of mature coast live oaks are growing on the lower northern slope. The trees have broad, low, spreading canopies typical of the species.

In general, the oaks are in good health, absent of serious structural defects. The box elder are poorly structured with suppressed structural form due to the dense growing conditions. Decay and dead branching are a dominant feature of this species on the site.
