**Coastal Bluff Evaluation
SANDERS & ASSOCIATES GEOSTRUCTURAL
ENGINEERING, INC**

RE: COASTAL BLUFF EVALUATION
East Cliff Drive between 33rd And 36th Avenues
Santa Cruz County, California

COASTAL BLUFF EVALUATION
East Cliff Drive between 33rd and 36th Avenues
Santa Cruz County, California

**GEOLOGIC RECONNAISSANCE AND
DEGREE OF THREAT EVALUATION MAPS**

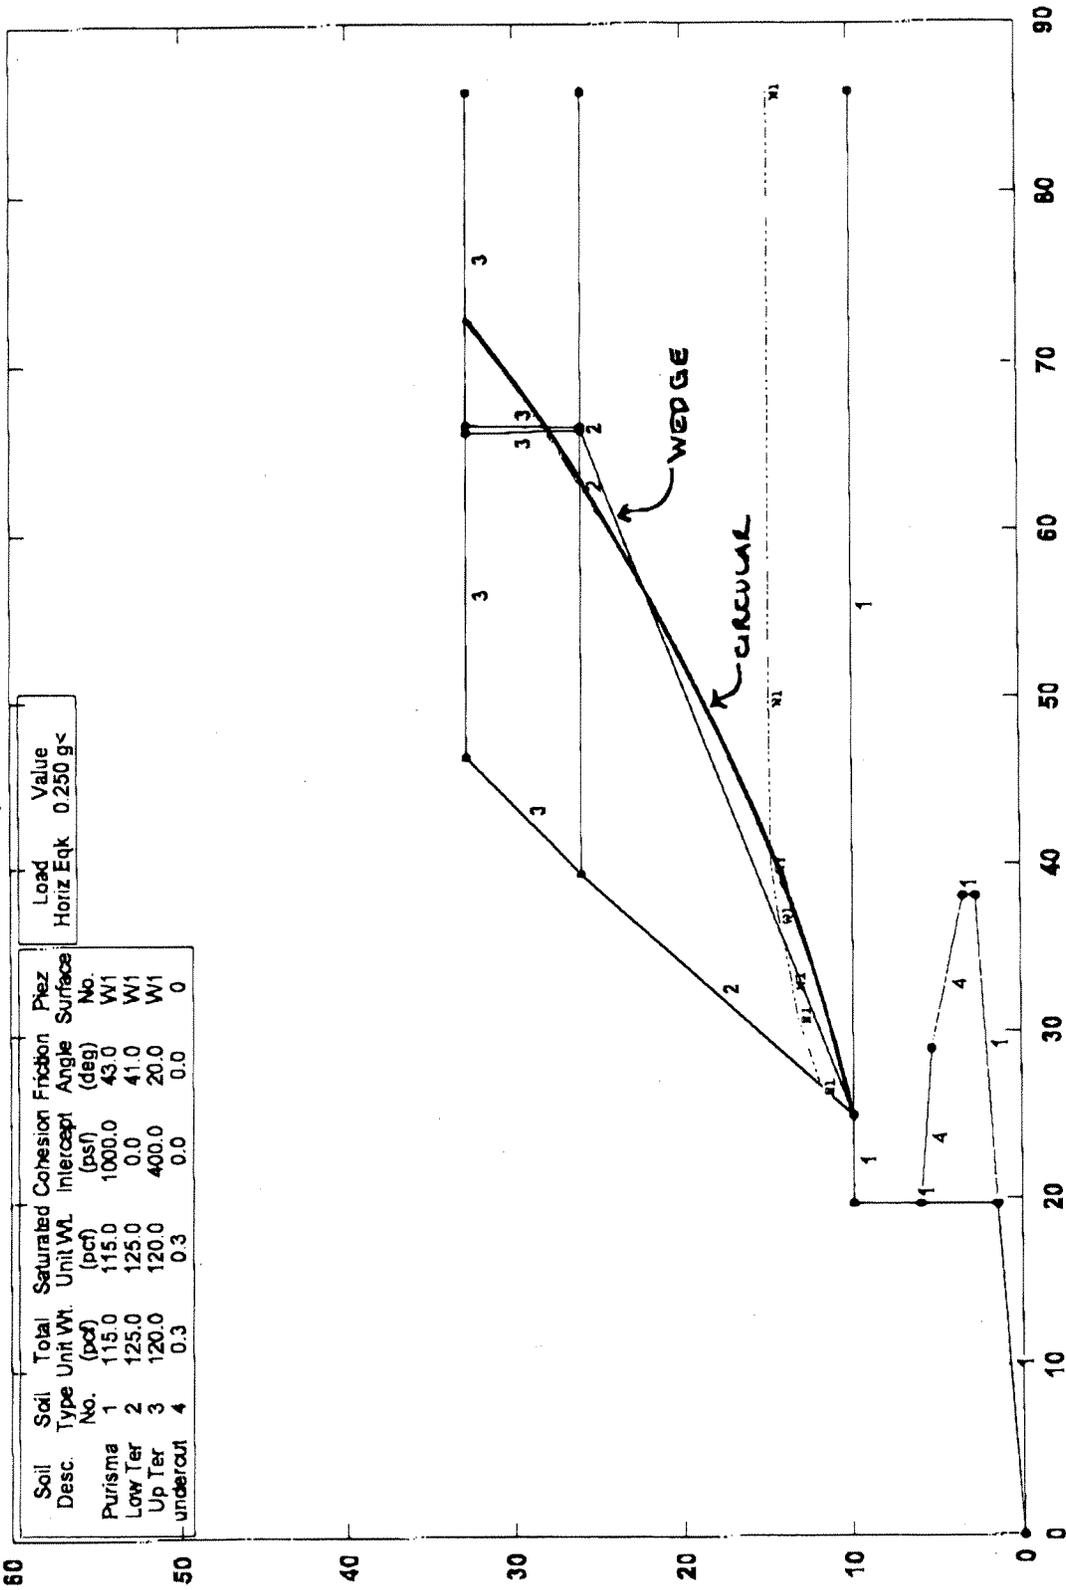
East Cliff Dr. Threat Evaluation Sta. 0+102 (19.5 ft)
 F:\1-PROJ-1\RLF105\1.PLT Run By: Renee L Fippin 9/30/2005 10:13AM

Soil Desc.	Soil Type No.	Total Unit Wt. (pcf)	Saturated Unit Wt. (pcf)	Cohesion (psf)	Friction Angle (deg)	Piez Surface No.
Purisma	1	115.0	115.0	1000.0	43.0	W1
Low Ter	2	125.0	125.0	0.0	41.0	W1
Up Ter	3	120.0	120.0	400.0	20.0	W1
undercut	4	0.3	0.3	0.0	0.0	0

Load Horiz Eqk	Value
0.250 g	0.250 g

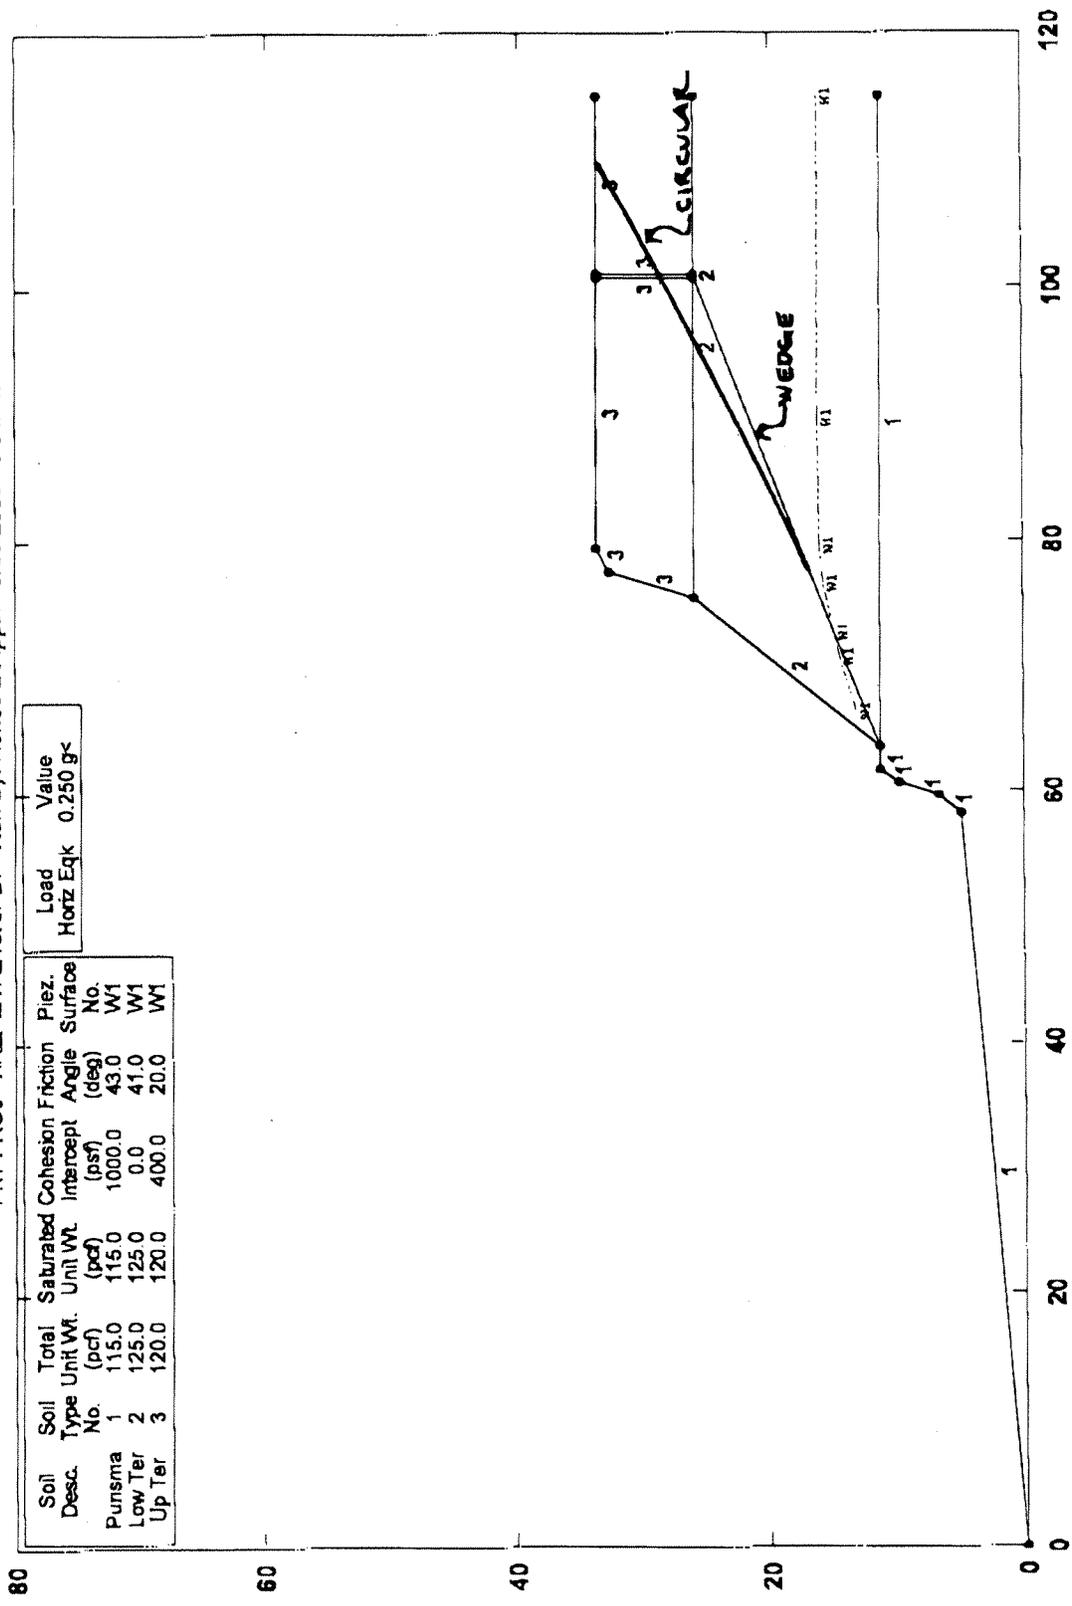
East Cliff Dr. Threat Evaluation Sta. 0+212 (21.5 ft)
 F:\1-PROJ-1\RLFASTA215K.PLT Run By: Renee L Fippin 9/30/2005 9:54AM

Soil Desc.	Soil Type No.	Total Unit Wt. (pcf)	Saturated Unit Wt. (pcf)	Cohesion (psf)	Friction Intercept (deg)	Piez. Surface No.
Punsma	1	115.0	115.0	1000.0	43.0	W1
Low Ter	2	125.0	125.0	0.0	41.0	W1
Up Ter	3	120.0	120.0	400.0	20.0	W1

Load	Value
Horz Eqk	0.250 g's

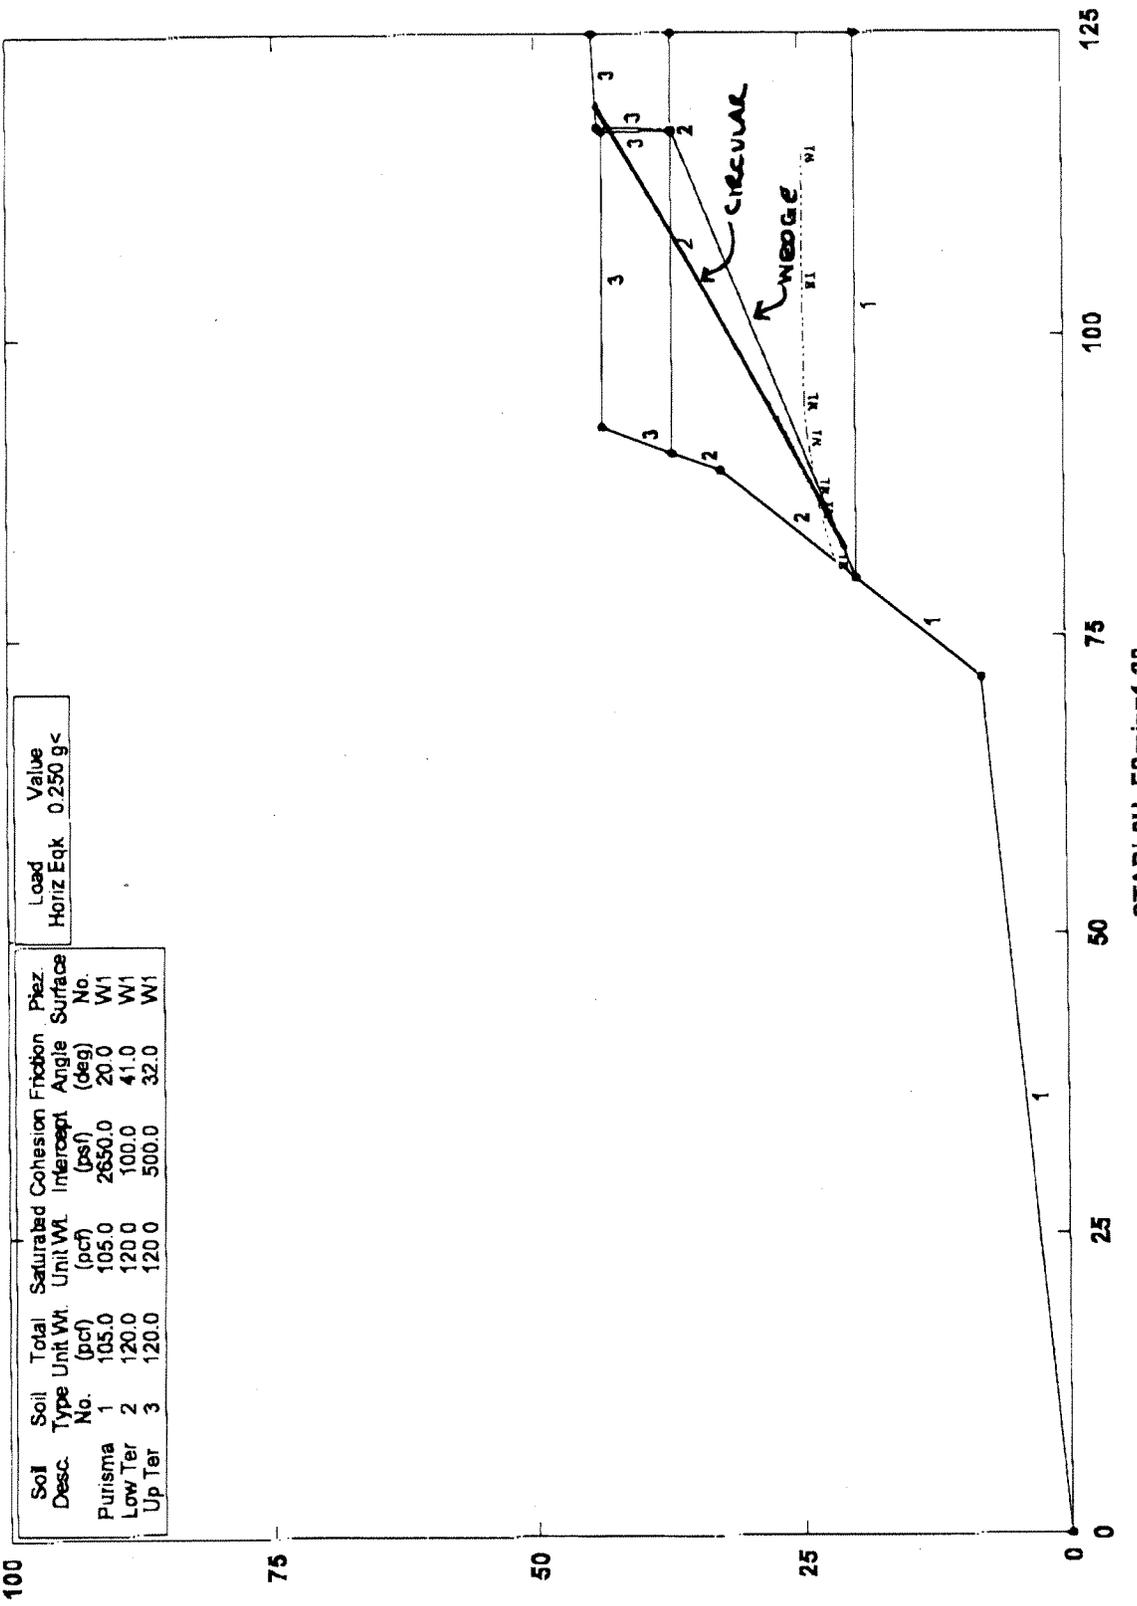
East Cliff Dr. Threat Evaluation The Hook - 24.5 ft

Soil Desc.	Soil Type No.	Total Unit Wt. (pcf)	Saturated Unit Wt. (pcf)	Cohesion (pcf)	Friction Angle (deg)	Piez. Surface No.
Purisma	1	105.0	105.0	2650.0	20.0	W1
Low Ter	2	120.0	120.0	100.0	41.0	W1
Up Ter	3	120.0	120.0	500.0	32.0	W1

Load	Value
Horiz Eqk	0.250 g<

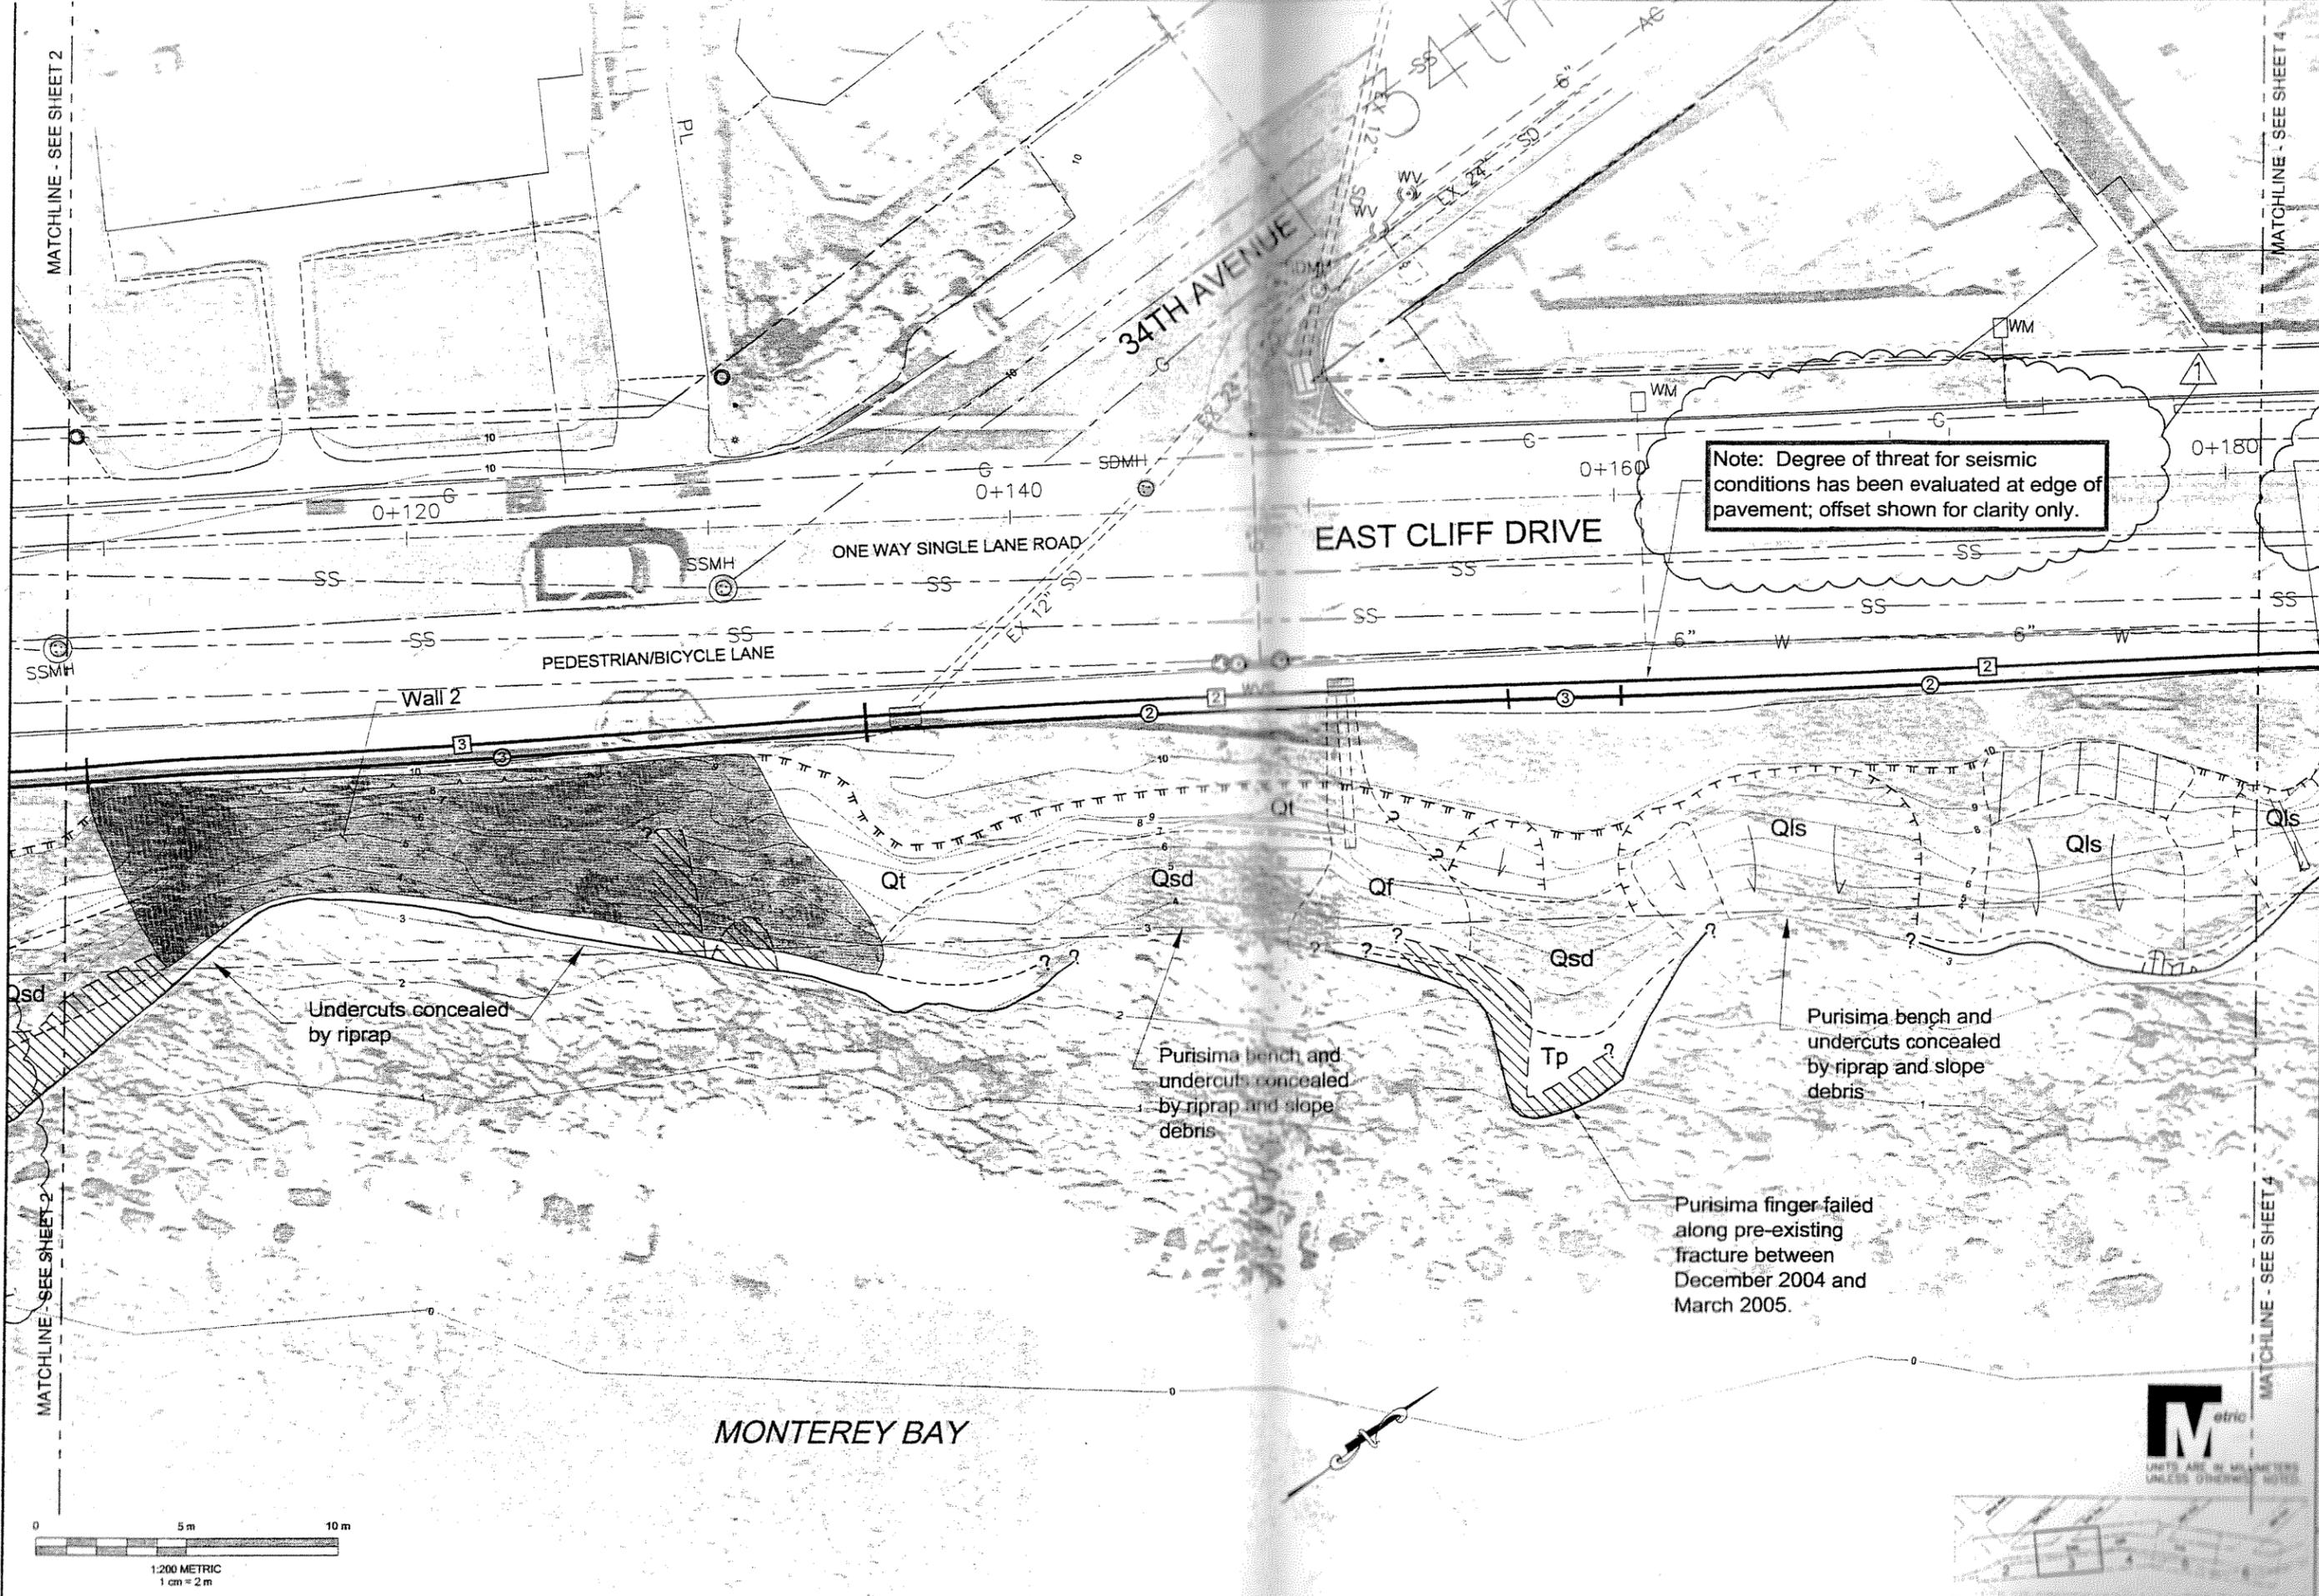
Undercuts concealed by riprap
